The Society for Protective Coatings

Considerations for Reconstruction
of a Bridge Exhibiting Staining
By Cynthia O'Malley, PCS, KTA-Tator, Inc.

Considerations for Reconstruction of a Bridge Exhibiting Staining

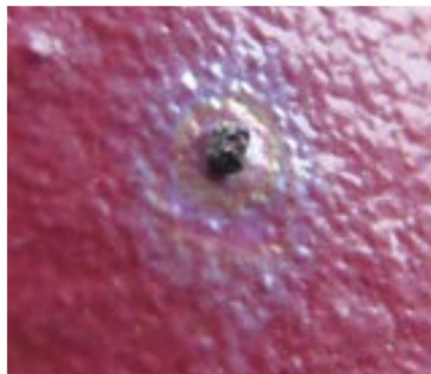
Fig. 1: Close-up of stain around particle embedded in the topcoat. Figures courtesy of KTA-Tator, Inc.

finish coat in many areas. The first area examined was on the truss steel on the west side of the bridge. There were noticeable spots in many areas, and these spots had an iridescent appearance. Upon close examination, it was found that most of the spots had a visible piece of contamination at the center of the spot (Fig. 1). In some cases, the contamination was embedded in the paint, with the very top of the contamination exposed. In other cases, the contamination was embedded in the top layer of the paint and could be removed with a fingernail.

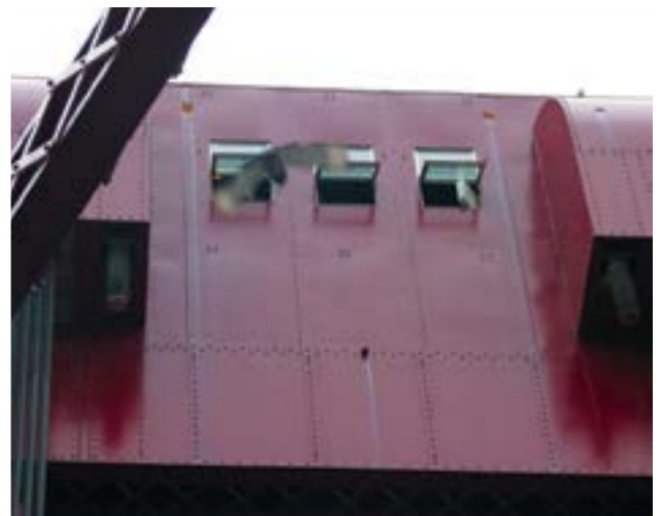
On the lift towers, several squares of coating were missing where metal pieces were reported to have been mechanically removed. Long iridescent stains and streaks were clearly visible starting at the bare steel area and extending vertically downward (Fig. 2). The bare steel areas were rusted.

Fig. 2: Streaks of staining on one of the bridge lift towers.

Further evidence that rust was the primary cause of the staining was found on the lift towers. As noted previously, there were several areas of uncoated and rusted bare steel. In these areas, long streaks of the iridescent staining were visible below the bare rusted

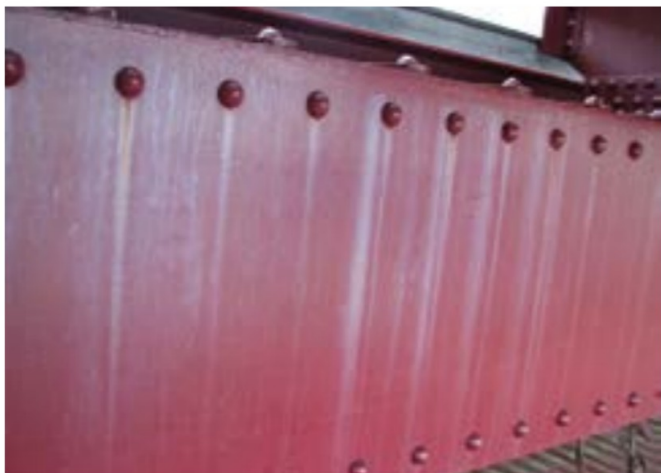
The staining was clearly more concentrated on the north side of the bridge (Figs. 3 and 4, p. 14). The most severe area was on a section of

Fig. 3: Staining on north box chord.

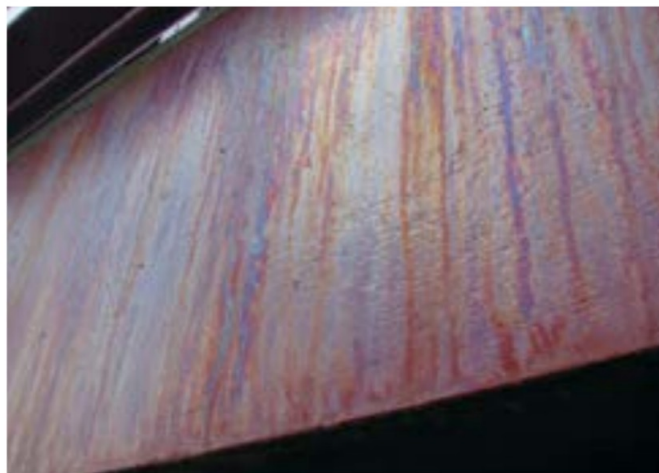
Fig. 4: Severe staining on north fascia.

fascia directly beneath and bordering the road deck, where the staining covered up to 50 percent of the surface. In other areas, staining was less severe but clearly visible. In the middle and on the south side of the bridge, staining was visible, but only as small spots or vertical streaks.

staining. Streaking typically occurred in areas where rust bleed emanated from crevices. Some of the most concentrated areas were apparent on the north face beneath the deck, where rust streaking originated from the gap between the steel and the concrete deck. Other areas of severe staining occurred directly below locations where lattice work was connected to the beams with rivets. This configuration creates several areas where steel surfaces could mate and form a back-to-back connection. These areas are difficult to seal with paint, and ultimately water enters. When water enters these areas, the steel corrodes and the corrosion products are carried away with the water (i.e., rust bleed), eventually depositing on the surface of the coating.

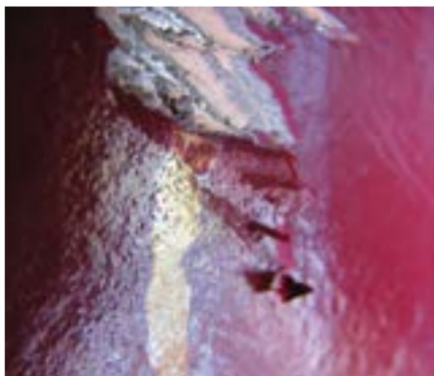
Fig. 5: Close-up of stain streak in sample area.

compared to a sample that was removed from an area where no staining was evident. The examination of the stained samples revealed that the composition of the staining was primarily iron (likely as an iron oxide). The analysis did not identify any other elements on the unstained coating. The results of the analysis indicate that the stain was primarily composed of iron compounds.

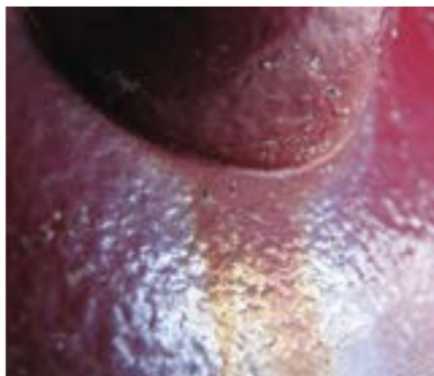
bridge members, the edges had a gap in the coating between the chord and the riveted lattice piece. The stains also consistently appeared on or directly below rivets. In many areas on the north side, staining was visible on virtually every rivet, although the degree of staining varied considerably from rivet to rivet.

Fig. 6: Close-up of stain underneath rivet.

To avoid similar issues on future projects, attempts should also be made to apply additional coatings around rivets in order to reduce the amount of rust bleeding. Also, it may be advisable to apply a penetrating sealer (i.e., an epoxy penetrating sealer) around the back-to-back connections where rust bleed originates from crevices. The penetrating sealer will wick into and seal the crevice, helping to reduce rust bleed from those areas.

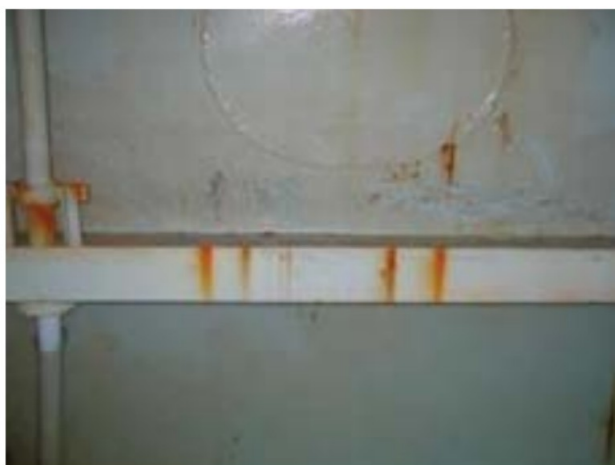
Fig. 1: Initial coating deterioration at weld beads and edges. Figures courtesy of the authors.

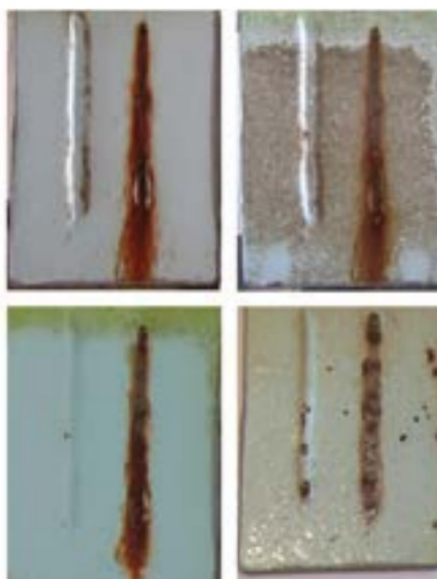
Fig. 2: System 1 at three (top, left), six (top, right), 12 (bottom left) and 40 months (bottom right) of exposure.

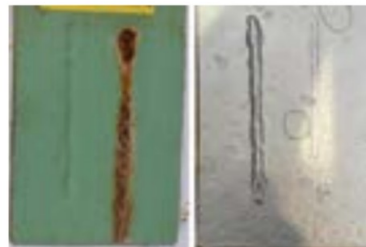
Fig. 5: System 3 polyamide epoxy 15-mil-thick coating at the end of exposure (left) and after coating removal at 40 months alternate seawater immersion (right).
