the performance of various protective lining materials in highly corrosive wastewater environments. This article presents real world performance has the protection of the pro

by Randy Nixon,
Corrosion Probe, Inc.

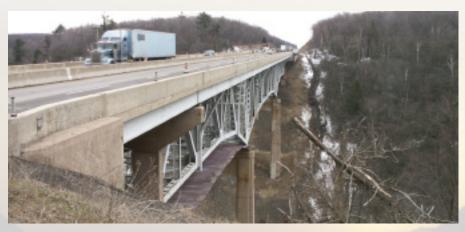
Fig. 8: The bridge showed no corrosion when viewed from a short distance.
Figures 8-10 courtesy of Mike O'Donoghue
