Evaluating a Crude Oil Loading Berth for Maintenance Coating

by Thomas J. Marchesani, PE, Sagittae, LLC

Quality and Durability of Different Polyethylene Pipe Coating Solutions

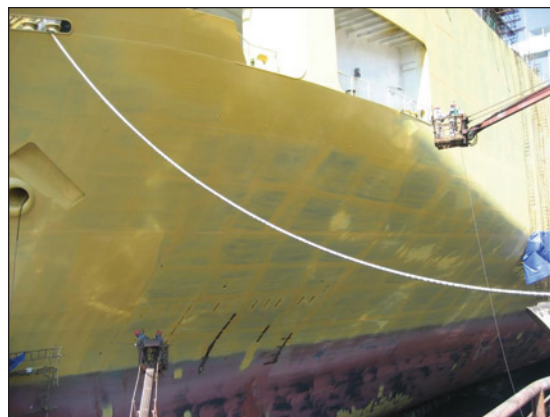
The see-through condition of the self-inspecting paint indicates on this hull that the coating has not been applied yet to the correct dry film thickness. Photos courtesy of Nippon Paint Marine Coatings Co.

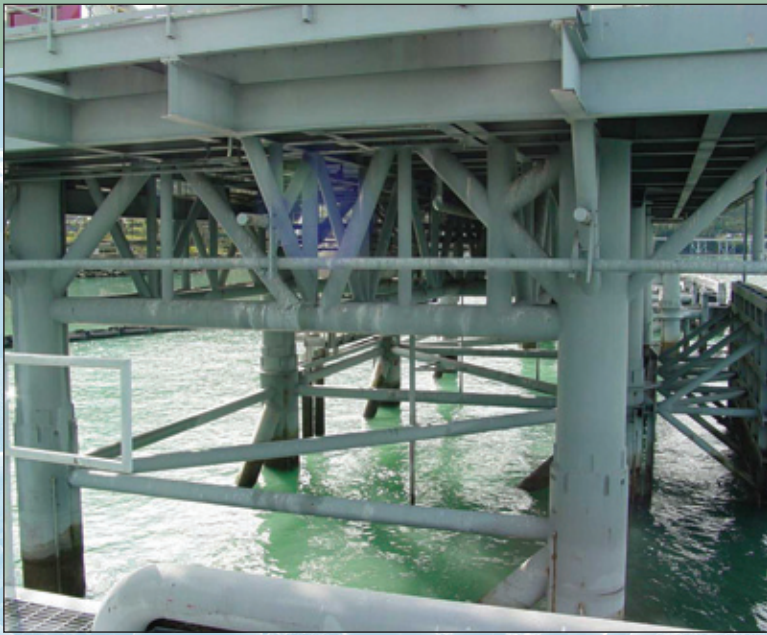
*Fig. 1: (Facing page) Crude oil loading berth
(Above) Main loading platform support structure. Photos courtesy of the author*

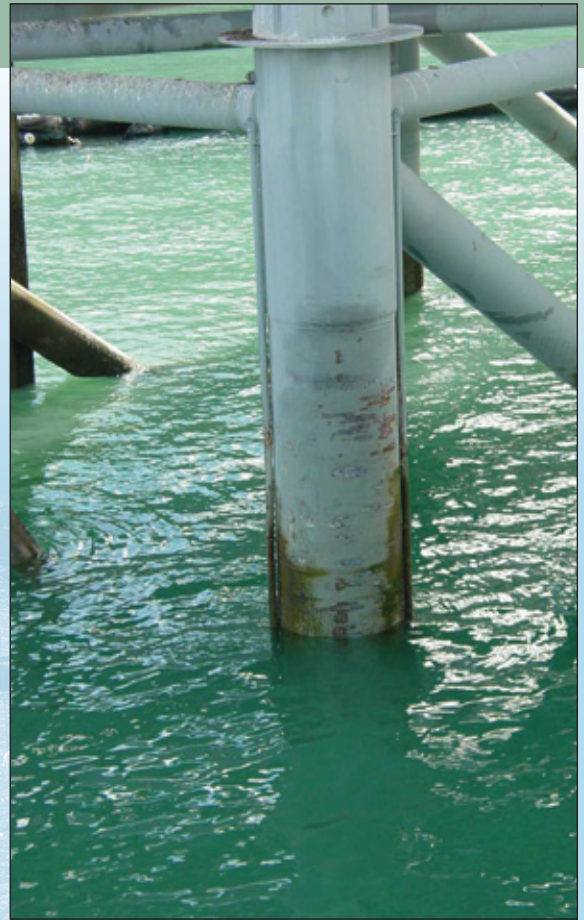
BOC piling in splash zone showing mechanical damage and marine growth

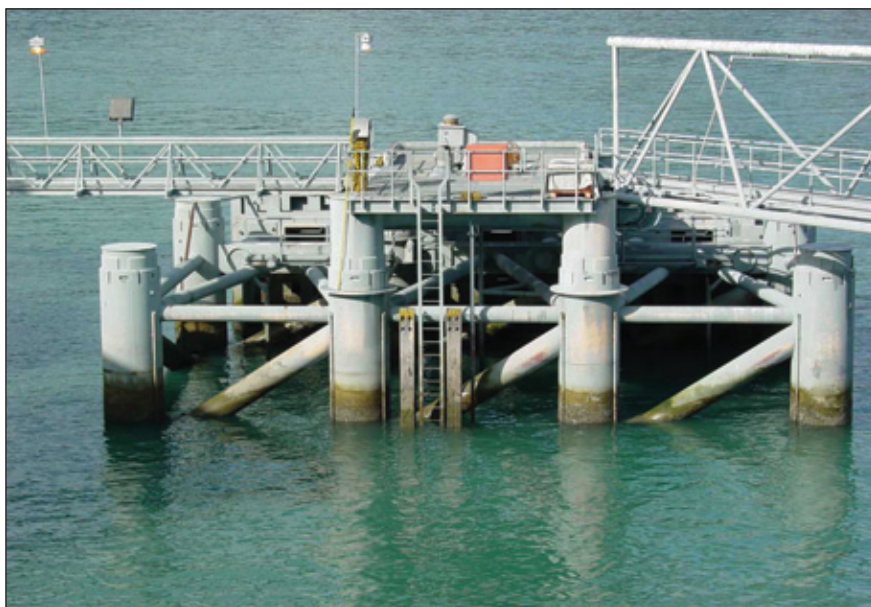
Primary berthing dolphin at high tide

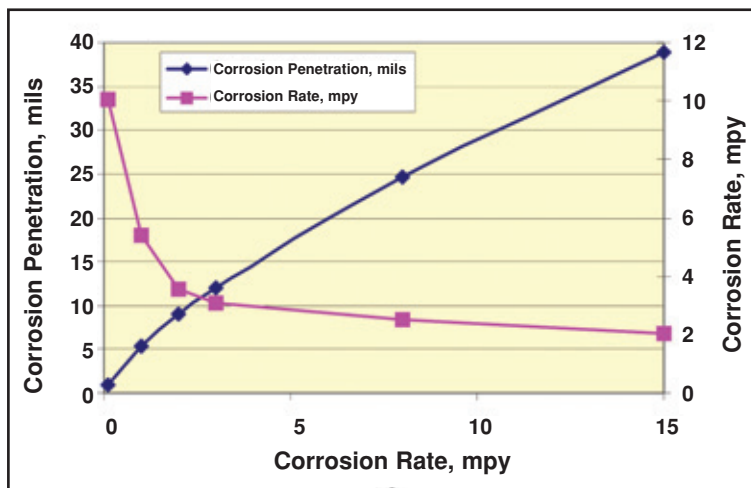
Fig. 2: Effect of time on corrosion penetration and corrosion rate

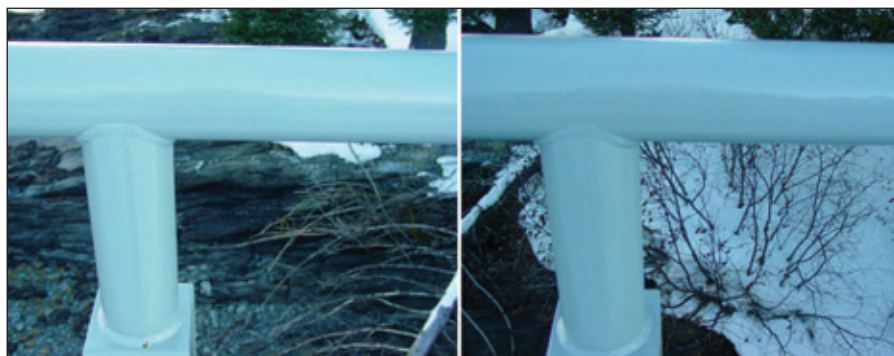
Coating test patches – guard rail

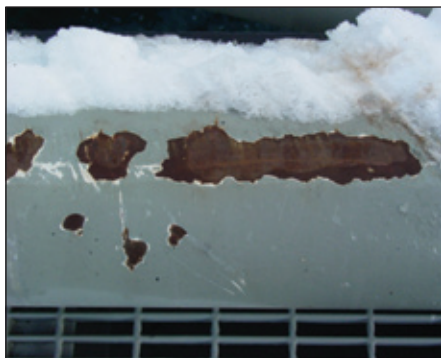
Coating failure on berthing dolphin bull

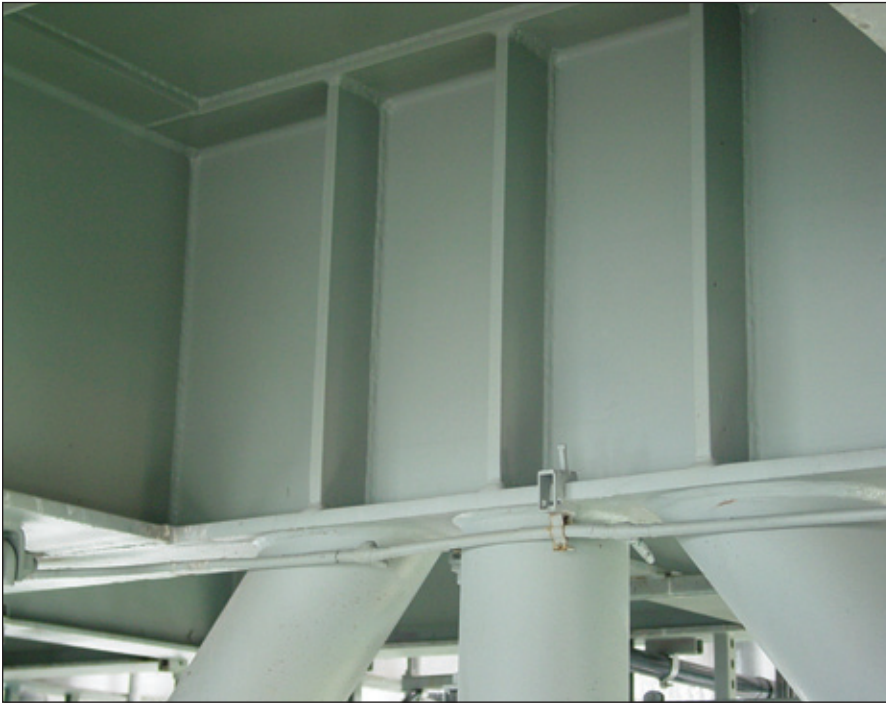
Structural steel beneath main loading platform showing no chalking or edge failure

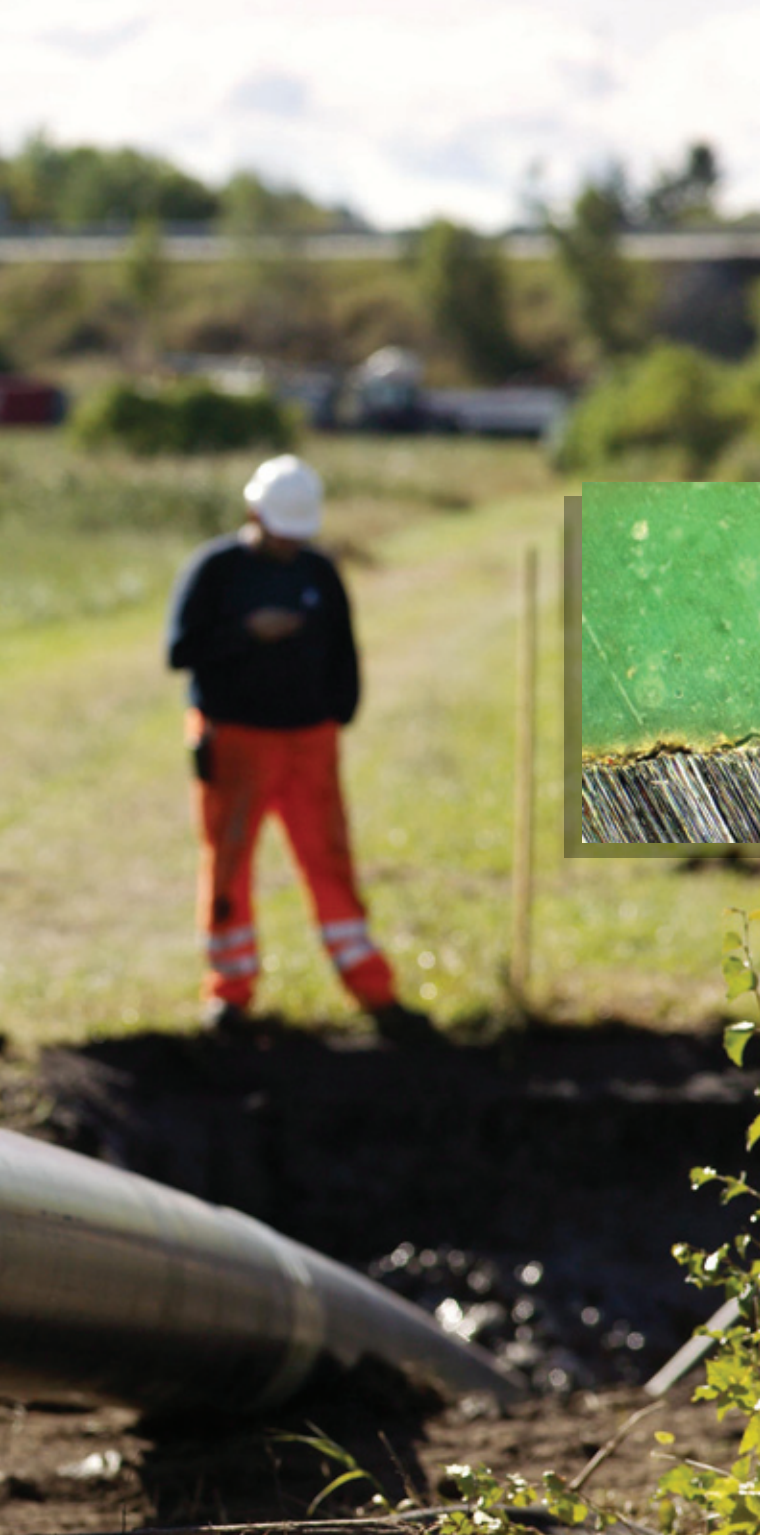
*Holiday detection on coated pipeline
Photo courtesy of Borealis Business Unit Pipe, UK*

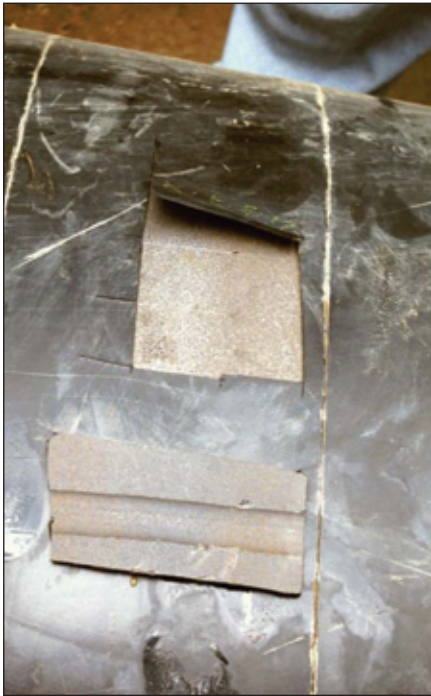
Fig. 2 (Above and right): Problems associated with 3-layer PE coatings. Photos courtesy of David Norman, Corrosion Control Ltd.

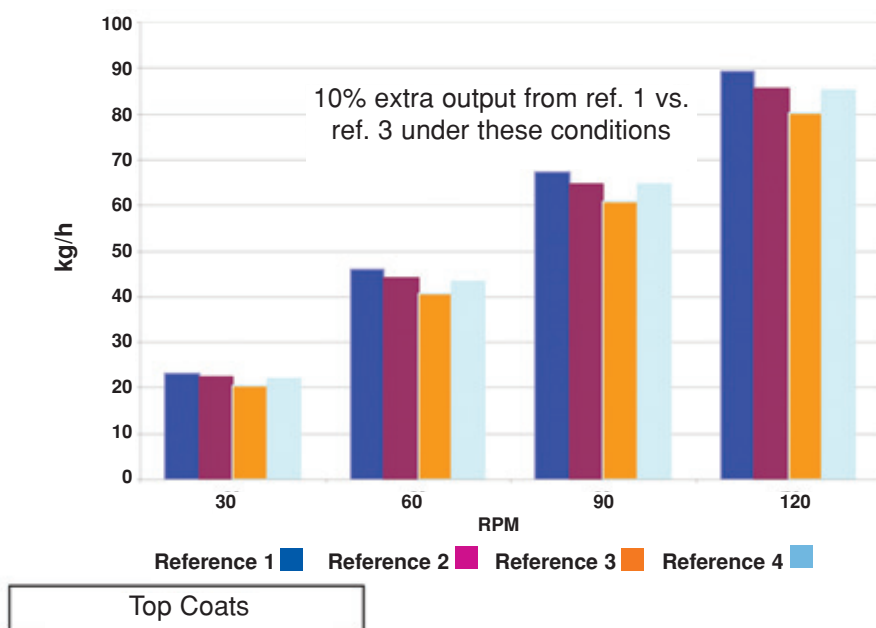
Fig. 6: Processing output at different speeds at Krauss-Maffei 45/30 D

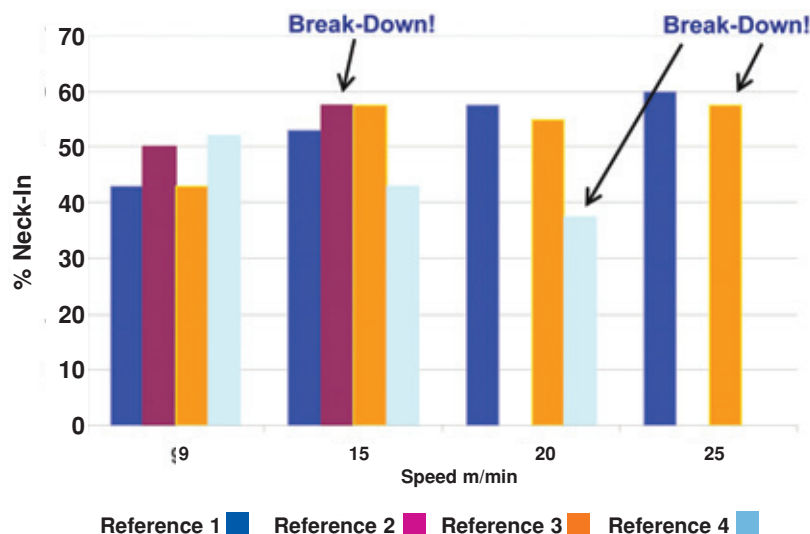
Fig. 7: Neck-in at different processing speeds

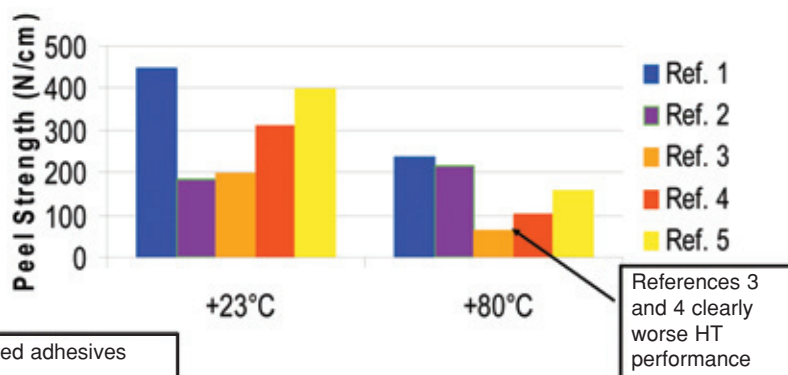
Fig. 11: Peel Strength

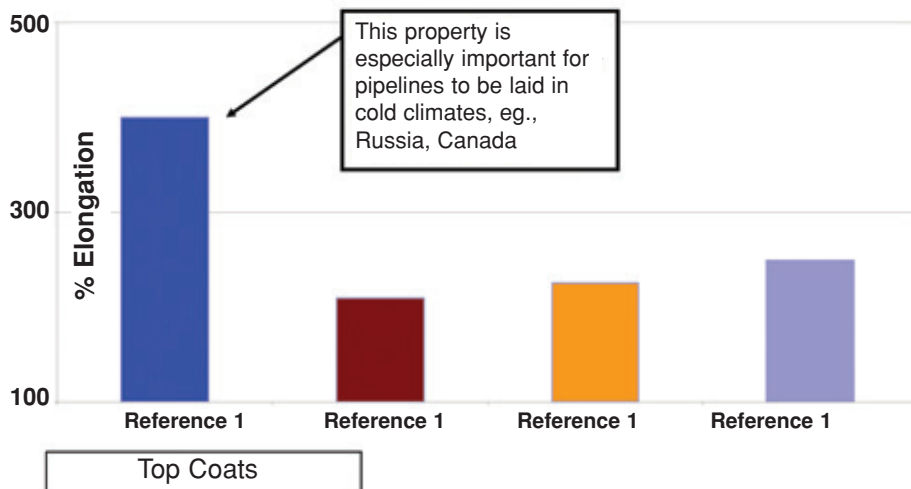
Fig. 12: Low-temperature properties (Elongation at break: -15°C [-9 F], 50 mm/min, 2 mm pressed plate)

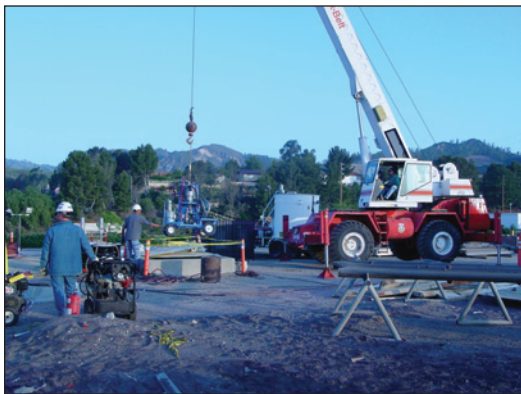
Plural-component spray system being lowered into shaft leading to water transmission tunnel. Safe practice is needed even before work begins.

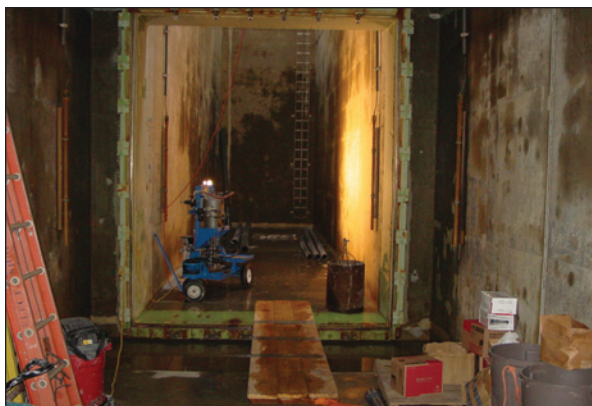
Plural-component spray equipment inside water treatment structure prior to spray application.
