Pittsburgh Hosts Annual Bridge Conference; SSPC Sponsors Coating Session

Hubble, Bubble, Tests and Trouble:

Overcoating the Caruthersville Bridge

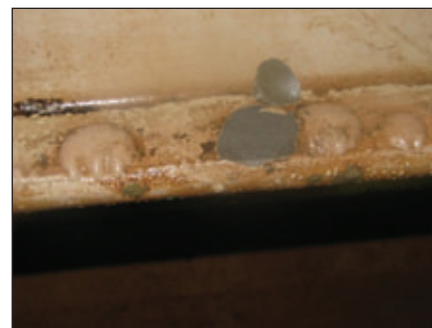
Fig. 2: Blister with no oxygen permeation (without rust)

exterior water line. In some cases, when the blisters were opened, there was no rusting on the surface, and the underlying steel appeared to be as originally blast cleaned. In other cases, rusting could be found on the steel at the center of the blister and on the underside of the blister cap (Figs. 2 and 3).

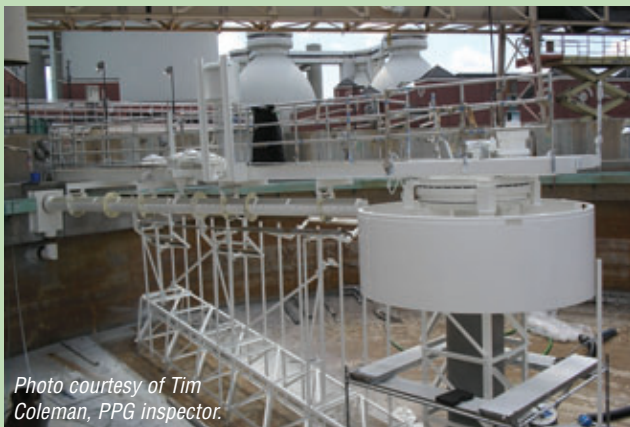
The Deer Island Waste Water Facility is 20 years old, and the previously coated structures in the clarifier tank needed to be repaired. The contractor worked with the coatings representative to assess the area and identify surface preparation needs and

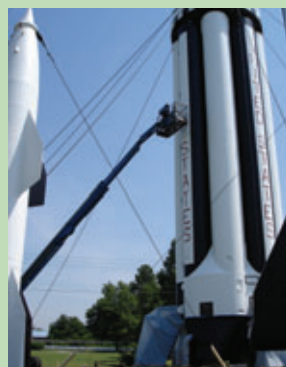
The blue rocket support bases were blasted with an aluminum oxide grit encapsulated in polymer sponge to an SSPC-SP 6, Commercial Blast finish. Rocket bases were primed with a high-solids epoxy and finished with a high-solids polyurethane.

Rocket bodies were cleaned to SSPC-SP 3, Power Tool Cleaning, to remove flaking and loose paint. The

painters used the glove bag method of containment, with power tools to remove, contain, and vacuum loose paint and debris. Chalking paint was sealed. Rust spots were primed with one coat of a universal primer, followed by two coats of acrylic coating.

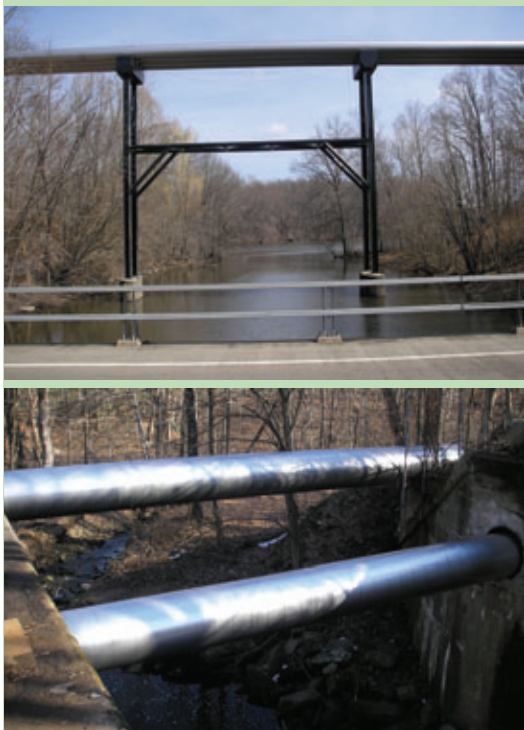
Top: Hackensack River Siphon
Bottom: Naurashaun Brook Siphon
Photos courtesy of Alpine Painting and Sandblasting Contractors

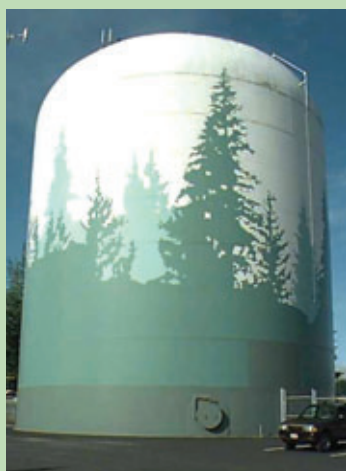
Silver Lake's original one-million gallon water tank had a tree mural, which was visible from almost all angles of the area. Over the years, the tank had become a landmark within the community. The last several years saw rapid development in the area, and

a new 8-million gallon tank was needed to accommodate the growth. The community insisted it be painted with a similar tree mural. Pictures of the previous mural were scanned and computer technology was able to mimic the design. The painting contractor prepared the steel

to SSPC-SP 6, Commercial Blast Cleaning.

The exterior of the tank was coated with a two-component, moisture-cured, zinc-rich primer for the interior and exterior of steel potable water tanks. This was followed by a polyamide epoxy; an aliphatic acrylic polyurethane that is highly resistant to abrasion, wet conditions, corrosive fumes, chemical contact, and exterior weathering; and a clear coat used to enhance

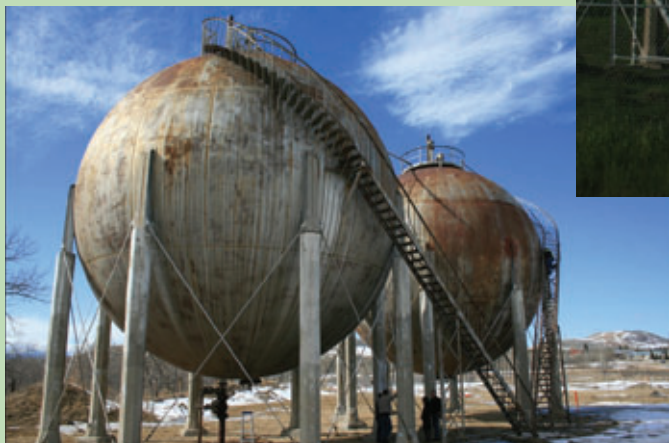
the Alberta Government in restoring the spheres to their original appearance. The existing coating system was lead-based, so the entire project had to be completely contained, and the spheres were abrasive blasted to an SSPC-SP 10, Near-White, finish. The new coating system was chosen primarily to offer corrosion protection. A two-coat application of a high-performance, surface-tolerant epoxy was applied at 4–8 mils dry film thickness per coat. To gain the desired aesthetic appearance, a single coat of a quick-dry aluminum enamel was used.

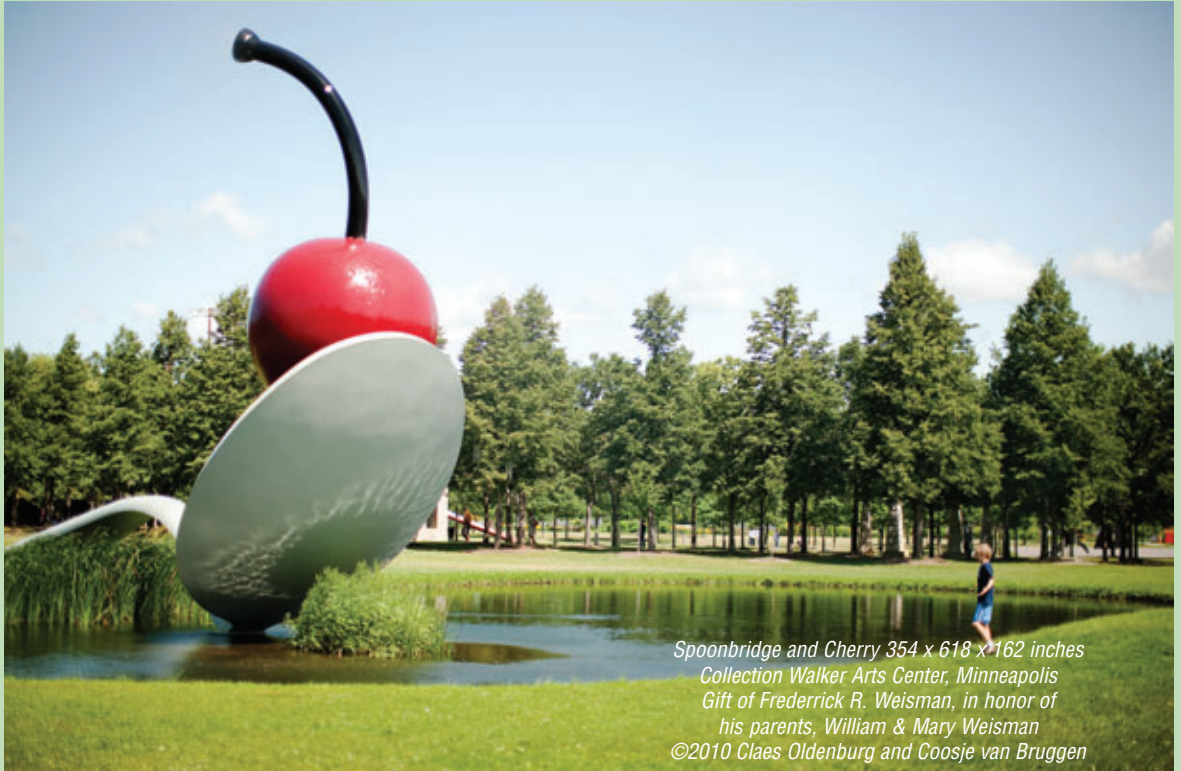
*Spoonbridge and Cherry 354 x 618 x 162 inches
Collection Walker Arts Center, Minneapolis
Gift of Frederick R. Weisman, in honor of
his parents, William & Mary Weisman
©2010 Claes Oldenburg and Coosje van Bruggen*

After 30 years without rehabilitation, the cherry portion of the Spoonbridge and Cherry Sculpture at the Walker Art Center had to be recoated. The cherry had to be removed from the sculpture and transported to a shop for reconditioning. The iconic aluminum structure, which, according to the Art Center, weighs 1,200 pounds (not counting the spoon), was blasted to bare metal, primed, and then faired smooth with multiple coats of epoxy. It was then coated with two coats of marine urethane followed by two coats of clear coat.

Unique issues surrounding this project were the need for a cherry red urethane that would retain its color and gloss in an immersion situation and the need to fair out the structure to make it look perfectly smooth when the skeleton and sheeting were roughly welded aluminum panels.

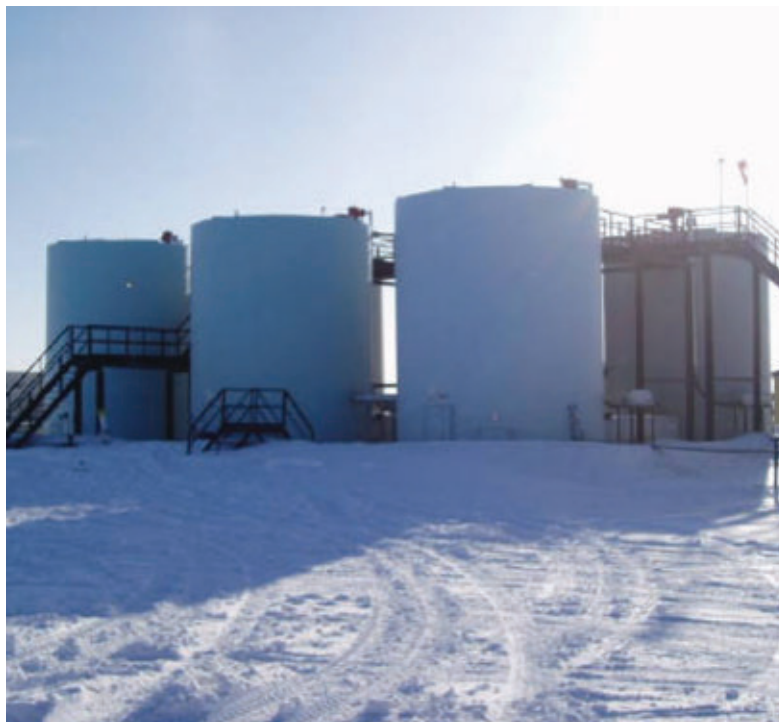
Fig. 4: Un-insulated tanks in Canadian oil patch—hot cargo with a large cold wall effect in winter. Lined with Coating A (a two-coat epoxy novolac) at 12-18 mils total DFT. No coating breakdown in real life performance after 15 years.

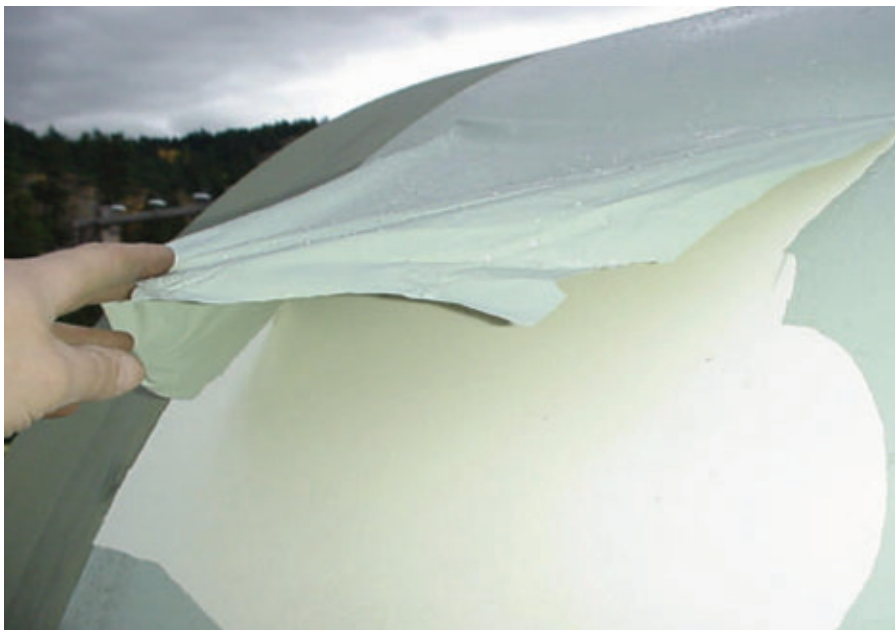
Fig 5: Example of a polyurethane finish coat applied beyond the recoat window of an epoxy mid-coat. Intercoat adhesion between the polyurethane and epoxy mid-coat is best determined by wet adhesion testing as opposed to dry adhesion testing.

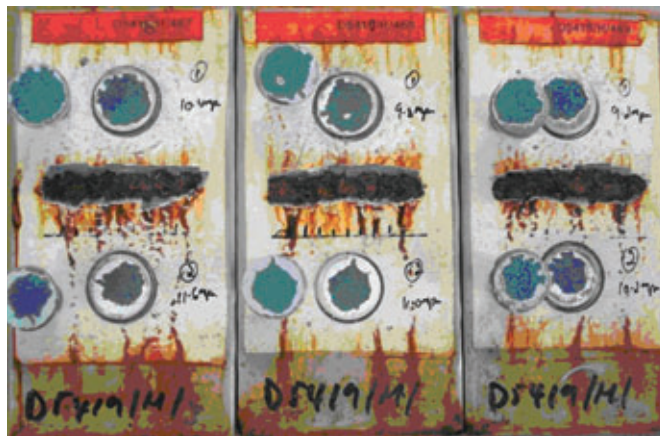
Fig. 8: Three panels tested per ISO 20340 for scribe cutting. The left and middle panels passed; the panel on the right failed; hence, the problem with assigning arbitrary pass-fail values.

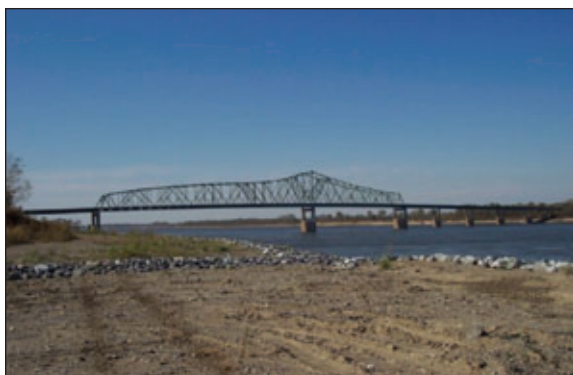
Fig. 2: General side view of Caruthersville Bridge.

was applied to all of the structural steel. An additional two coats were applied in the field to floor beams and lateral braces, while an additional three coats were applied to members at the bridge deck level. Figures 1 and 2 depict the original coatings of the bridge.

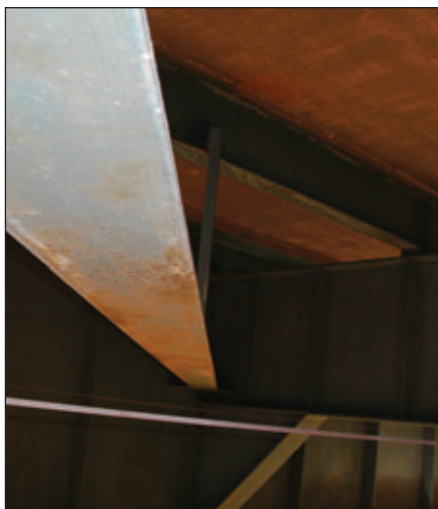
Fig. 3: Corrosion on bottom flange

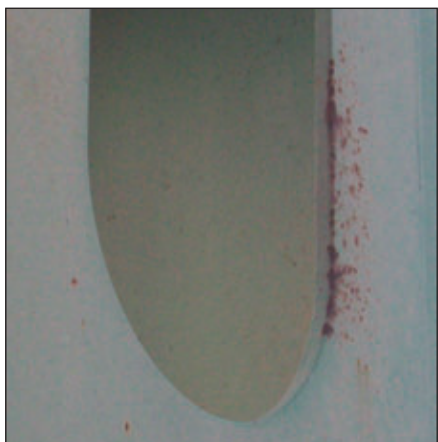
Fig. 4: Edge corrosion

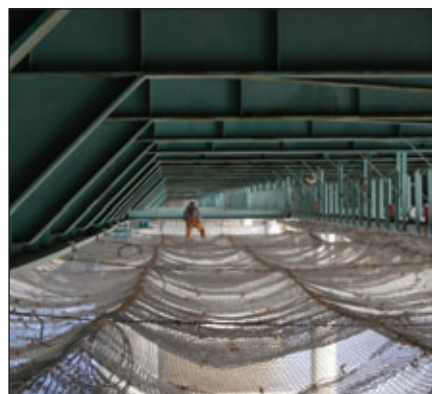
Fig. 5: Containment chain link system

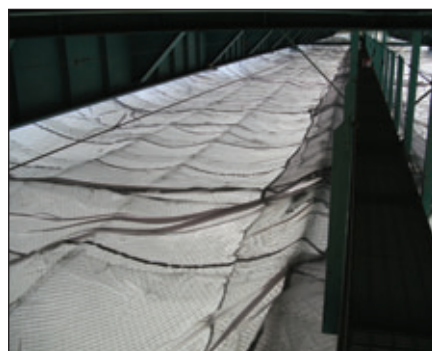
Fig. 6: Containment with tarpaulin

included these components: A2-Flexible, B1-Air Impermeable, Support Structure C2 –Flexible, D1-Full Seal Joints, Entryway E4-Open Seam, Air Make Up F2-Open and Input Air Flow G2 Natural. The containment system also followed the design of a Class 2W containment, with these components: A2-Flexible, B3a-Water Impermeable, Support Structure C2 –Flexible, D1-Full Seal Joints, Entryway E3-Overlap, Air Make Up F2-Open, and Input Air Flow G2 Natural (Figs. 5 and 6).

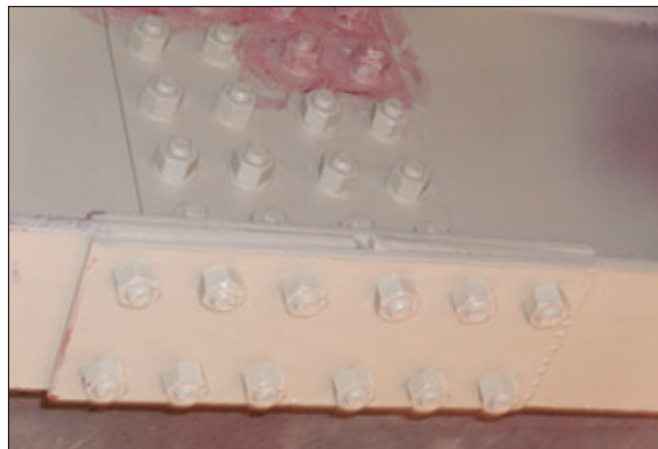
Fig. 9: Bleeding and color migration of the primer through the topcoat during striping of the topcoat.

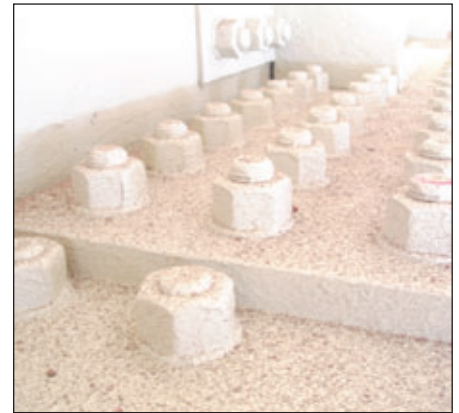
Fig. 10: Foreign particles on the surface of the coating.
