The Case of the Failing Railing

Maintaining the Electric Grid

Comparing Test and Field Performance of Thick-Film Elastomeric Polyureas

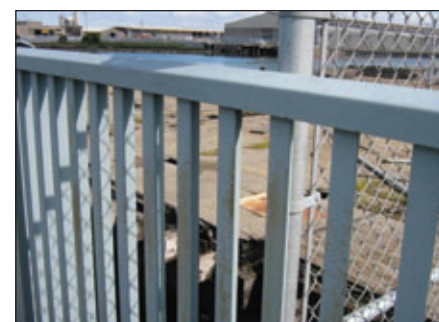
Fig. 2: An example of the condition of the handrail on the east side of the bridge and along the southern end of the west side. At this location, rust was observed on almost every picket.

A site visit to examine the condition of the coating system revealed infrequent areas of pinpoint rusting on the west handrail from the north end of the bridge down to the midpoint of the drawbridge portion. The pinpoint rusting was only found on 1–3 of the 5 pickets of the railing sections running the length of this section of the bridge (Fig. 1). However, along the south end of the bridge and the entire length of the east handrail, almost every section exhibited pinpoint rusting, as did every picket in the affected rail sections (Fig. 2).

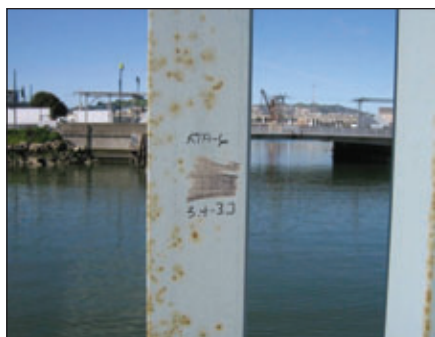
Fig. 3: The substrate had been profiled, but only two coats of paint were visible with the naked eye. The gray primer appeared to be missing.

When the coating was forcibly disbanded from the rusted area, only two coating layers were clearly visible (Fig. 3). In some cases, there may have been some traces of a thin gray primer. The substrate was to have been abrasive blast cleaned to SSPC-SP 6, Commercial

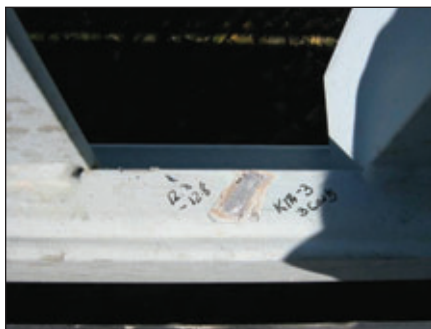
Fig. 4: An example of the conditions found on the bottom rail of the handrails.

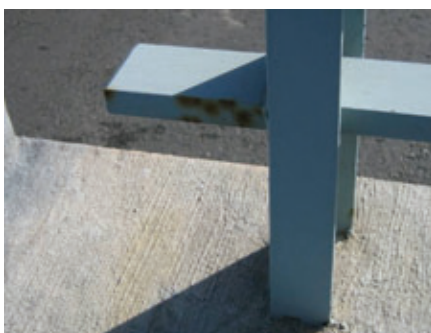
Fig. 5: Typical condition of the end pieces on the guardrail showing general rusting.

The rusting on the ends of the guardrail was a result of the surface preparation performed in the field.

Although the surface was abraded (scratched), it was not prepared to the degree recommended by the coating manufacturer to provide long-term corrosion protection. Some rust was still present, and the usual peak and valley profile that is required for steel in exterior exposure was not imparted to the surface.

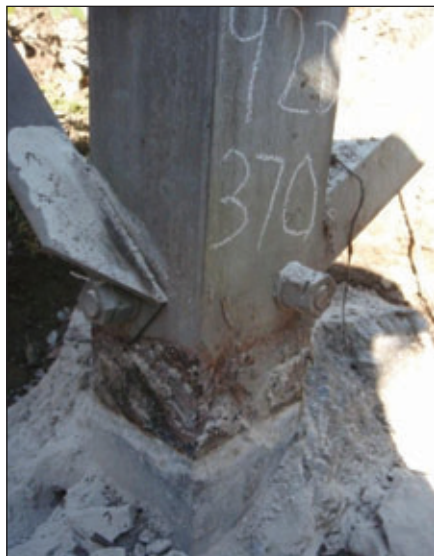
Fig. 2: The below grade surface, often called the footing or foundation, is a major area of maintenance concern. Figs. 1-5 courtesy of the author.

or foundations (Fig. 2). It is important to address both areas as part of a maintenance program. Protecting the above grade section of a structure does no good if it topples over due to failure from corrosion at the groundline, just as maintaining the footings does not succeed if the arms fall off from rust-through. A comprehensive program involving inspection, repair, and mainte-

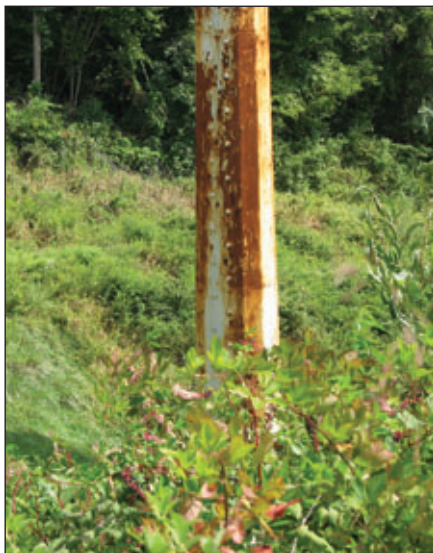
Fig. 3: On some older steel structures, the steel footing is in direct contact with the ground.

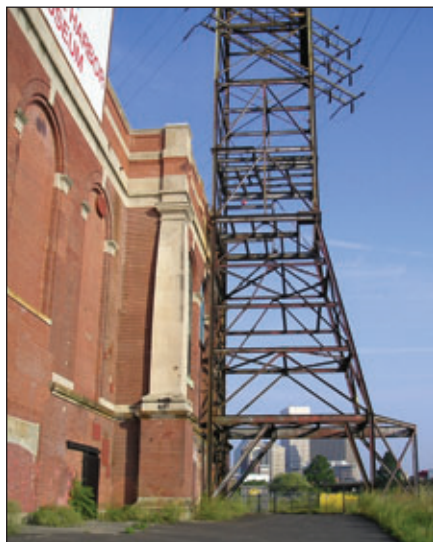
Fig. 4: Steel latticework can trap moisture, causing accelerated corrosion.

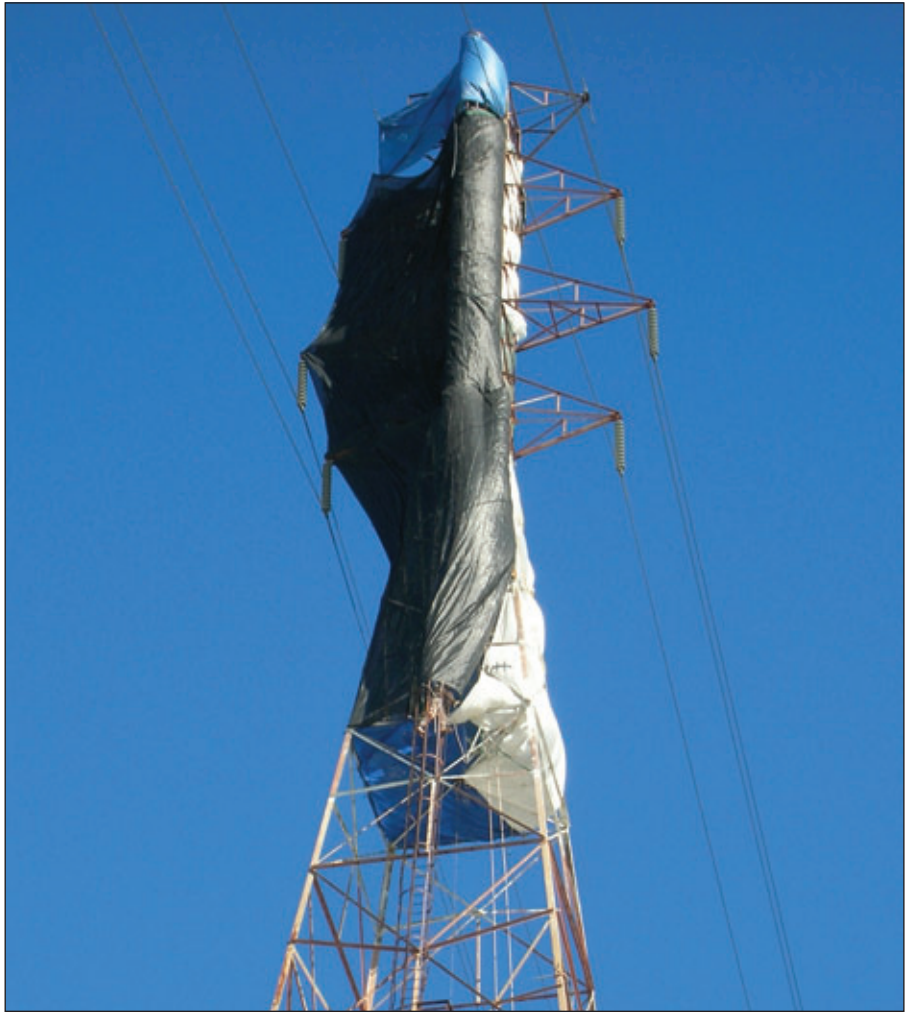
*Fig. 6: State and Federal laws require containment of lead paint to protect workers, residential areas, and the environment.
Courtesy of Savannah River Crossing, Georgia Power Company*

To further complicate the situation, the original coatings on transmission structures may contain lead. If the specification requires the removal of old paint from the structure, it is essential to determine whether or not there is lead present in the old coating. If present, procedures in accor-

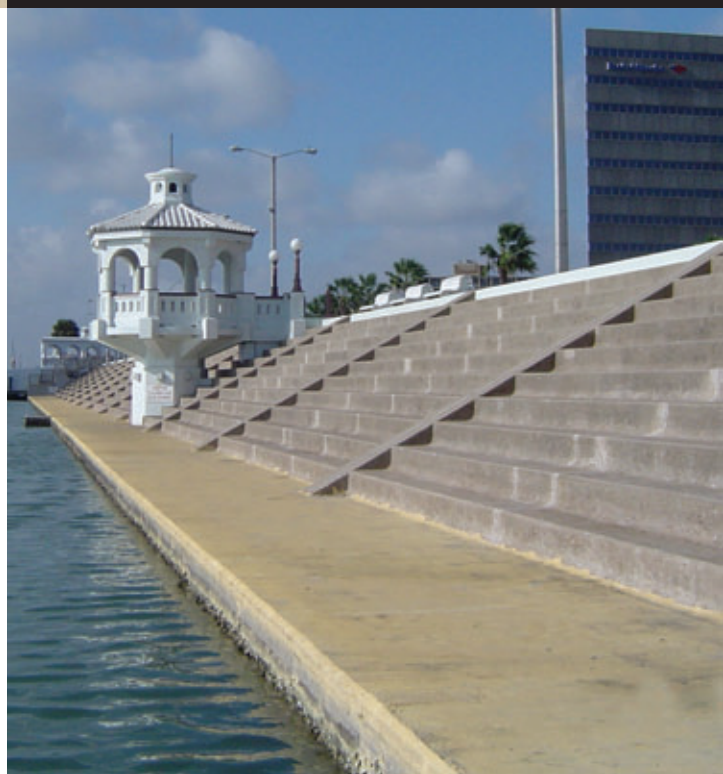
Spray-applied, proprietary aliphatic amina-modified polyurea on sea wall in southern U.S. Before (top) and after 5 years of service (bottom). System is still in service. All photos courtesy of the author.

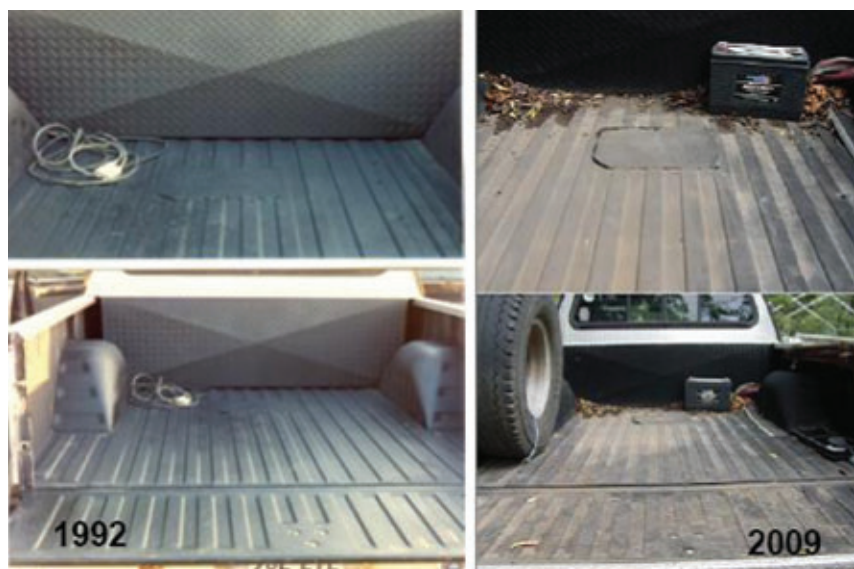
Fig. 2: Bedliner—before and after

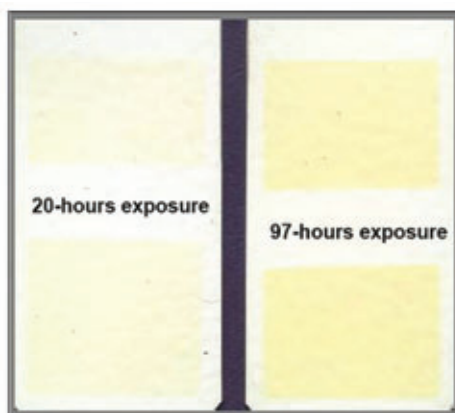
Fig. 3: Aliphatic modified aromatic polyurea QUV weatherometer exposure, UVB-313 Bulbs

Further data has shown no loss of gloss or chalking after 4,000 hours' exposure under SAE J 1960 for an automotive specification.²¹ The requirements under the specification are 3,600 hours exposure with a 2.0 delta E (ΔE) color change maximum and a 90% gloss retention at 60 F angle.²²⁻²⁴ This would be equivalent to automotive paint specifications, and we all expect the paint on our automobiles to last a long time and not fade or wash out within a few years. None of the aftermarket, spray-applied, aromatic bedliner systems will meet the testing and require-

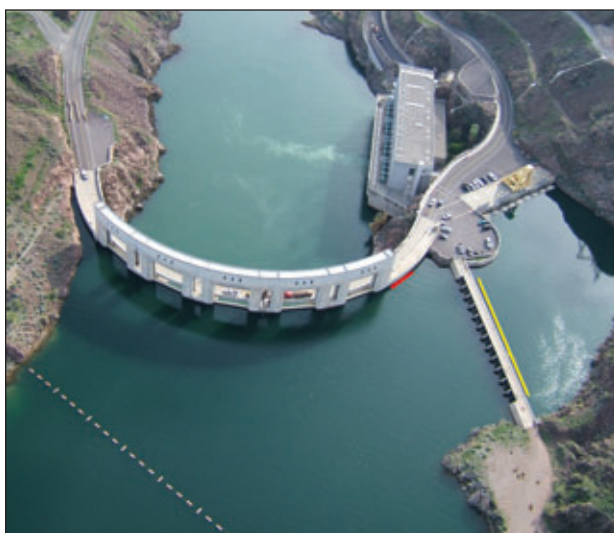
Fig. 1: Aerial photo of Parker Dam. Red line indicates static conditions; yellow line indicates dynamic conditions.
All photos courtesy of the author

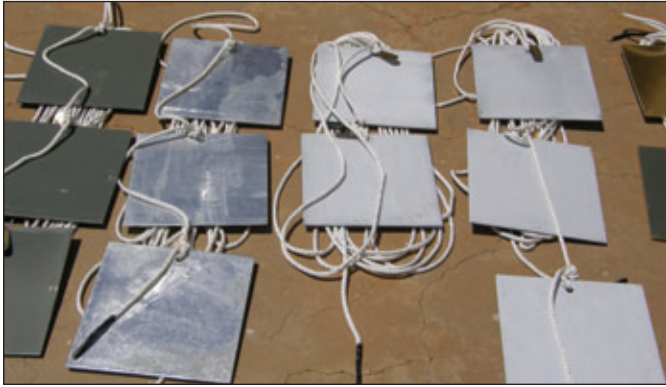
Fig. 2: Coated square foot steel plates used for static testing. From left to right: zinc-rich epoxy, galvanized, 85-15 zinc-aluminum metalized, 100% zinc metalized, and copper metal.

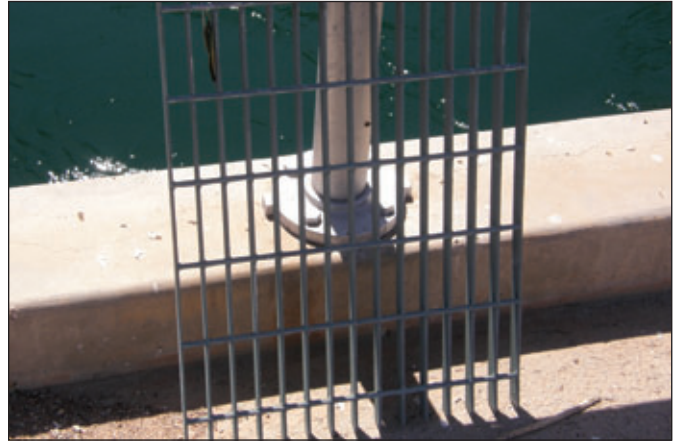
Fig. 3: Coated steel floor grate used for dynamic testing.

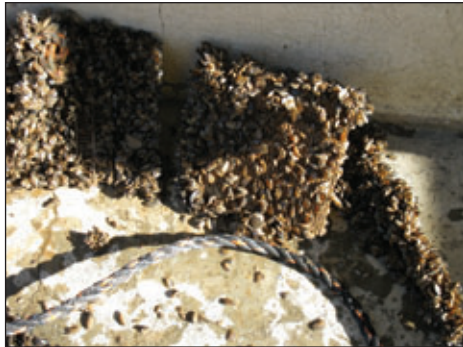
Fig. 5: 90/10 Copper/nickel alloy in static conditions after 4 months of exposure.

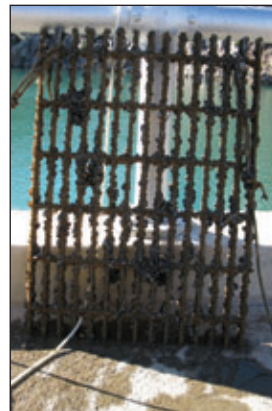
Fig. 6: 100% zinc metallized grate at 7 months exposure.
