JOURNAL OF PROTECTIVE COATINGS & LININGS

17 Cases from the F-Files: The Shop-Coated Pipeline That Cracked

In-Situ Coating of Corroded Pipelines in the Canadian Oil Patch

The Shop-Coated Pipeline That Cracked

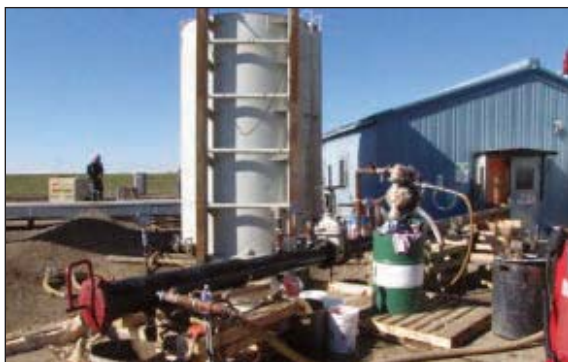
Photos courtesy of Nathan Campbell, EnerClear
Fig. 1: Pig launcher setup

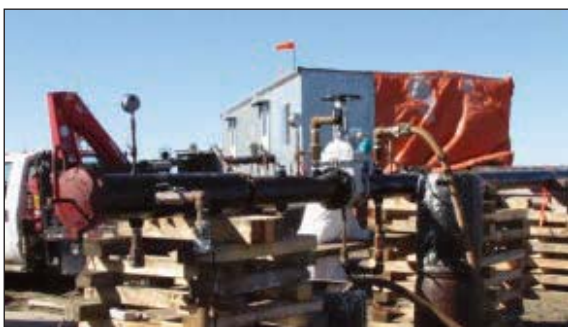
Fig. 2: Pig receiver setup

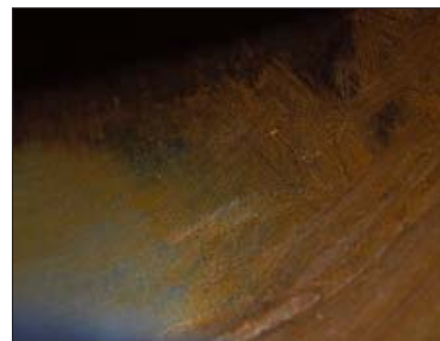
Fig. 3: Pipe wall internals after scale build up and majority of wax removed. Some wax remains and mill scale is also evident around the weld areas.

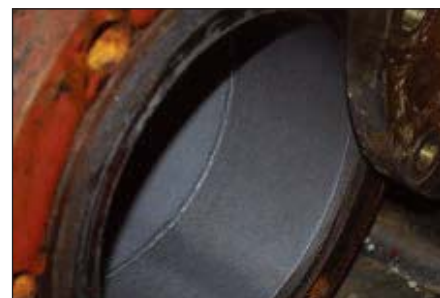
Fig. 4: Pipe wall internals after removal of wax, deposits, and mill scale.

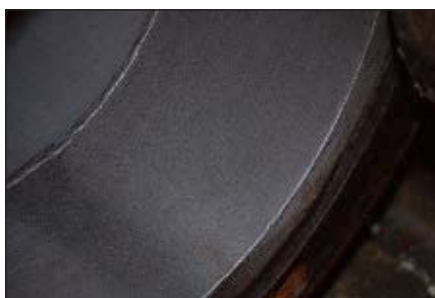
Fig. 5: Final inspection of pipe wall internals prior to running drying agents in preparation for first coat.

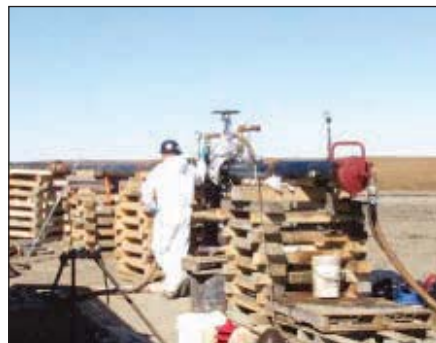
Fig. 6: Worker monitoring back pressure on receiving end as coating run is in progress.

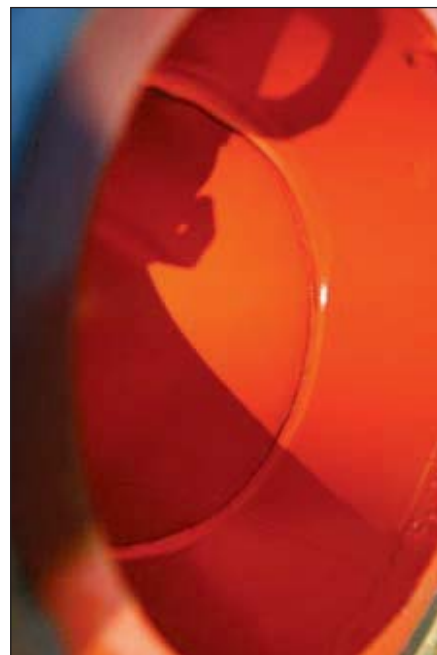
Fig. 7: First coat averaged 3 mils DFT, an additional 2 coats were applied to achieve the required 10-12 mils DFT.

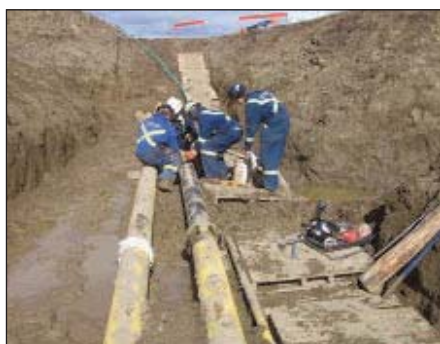
Fig. 8: EnerClear personnel inspecting the final application of coating for DFT adhesion and cure at mid-point spool.
