*The Voice of SSPC: The Society for Protective Coatings*

### 24 When Undercover Agents Can't Stand the Heat: Coatings in Action and the Netherworld of Corrosion Under Insulation

This article reports on research into coatings primarily for the undercover realm of corrosion under insulation. The authors used a suite of accelerated laboratory tests to evaluate four engineered coatings for several properties, including suitability for cyclic CUI at 400 C, a property that several facility owners requested.

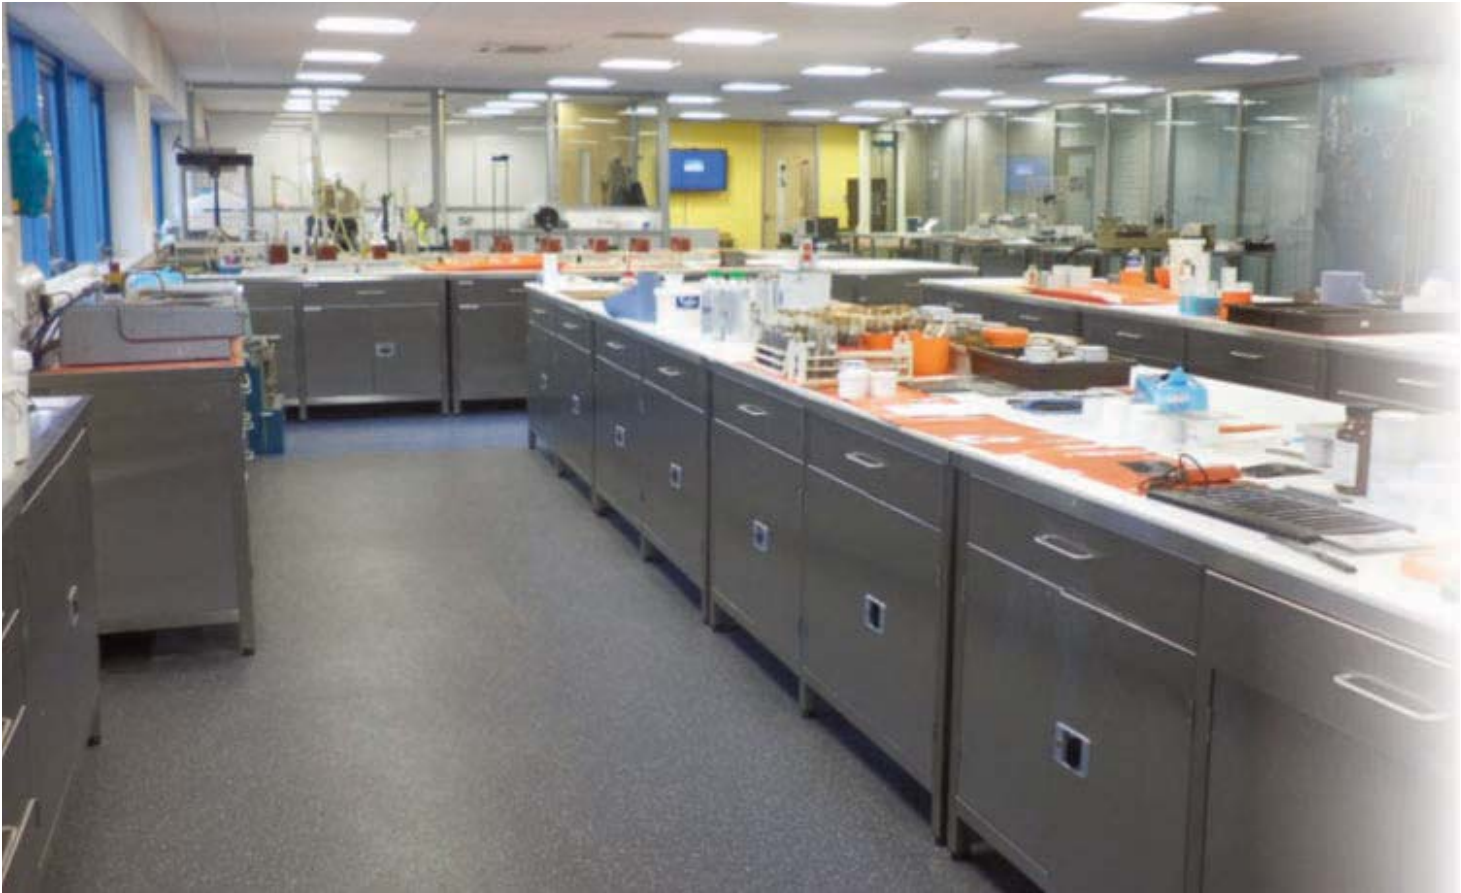
*Fig. 1: High-tech coatings lab  
Photos courtesy of the author.*

Most reputable coating manufacturers carry out their performance testing according to industry-recognized testing standards (Figs. 1 and 2). Standards have one purpose—to put it simply, standards make a test as repeatable as possible. It does not guaran-

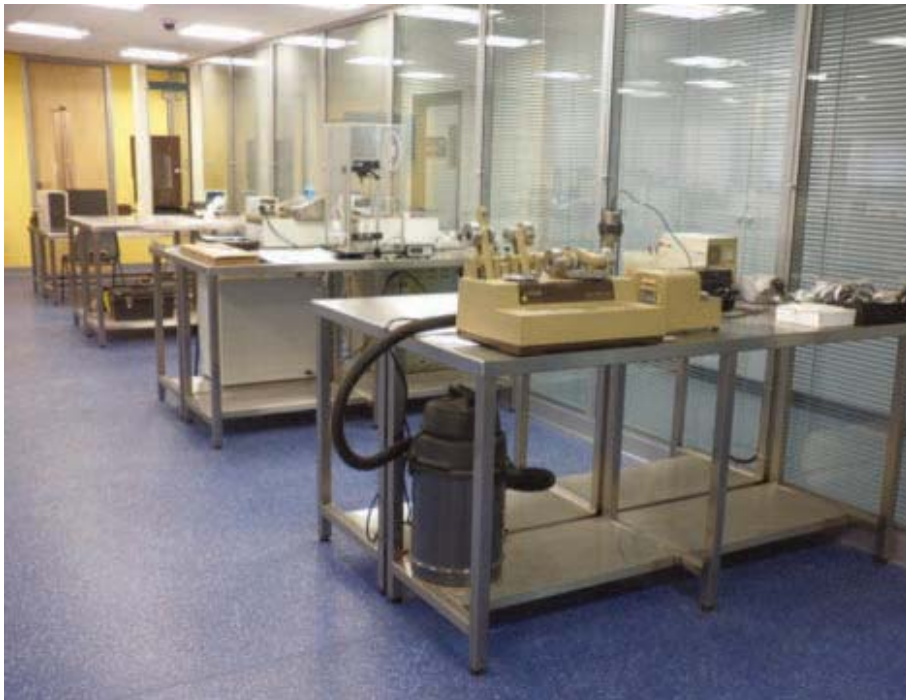
Fig. 2: Performance testing equipment

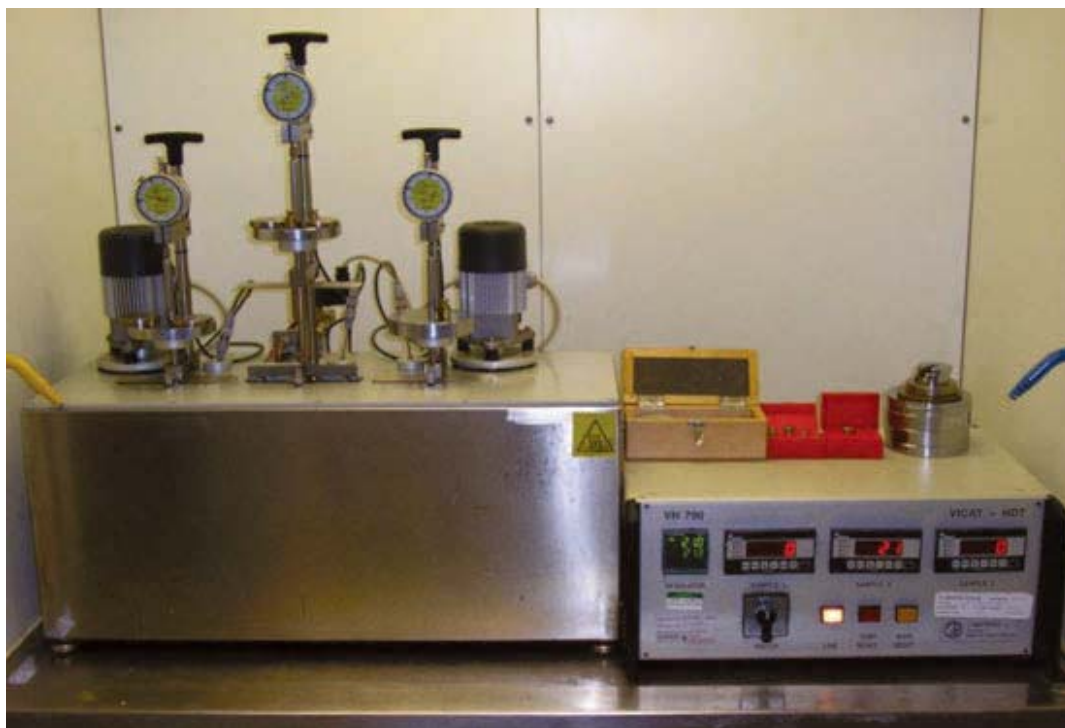
Fig. 3: VICAT heat distortion temperature equipment

The heat distortion temperature is

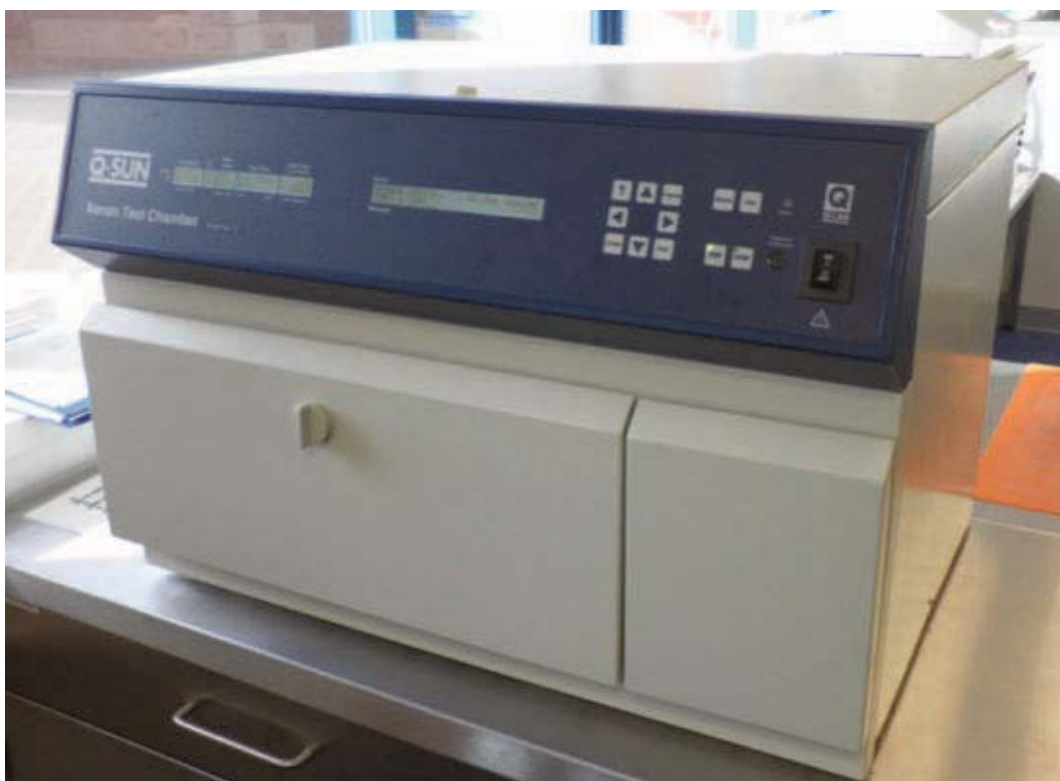
Fig. 4: Lab-based accelerated UV chamber

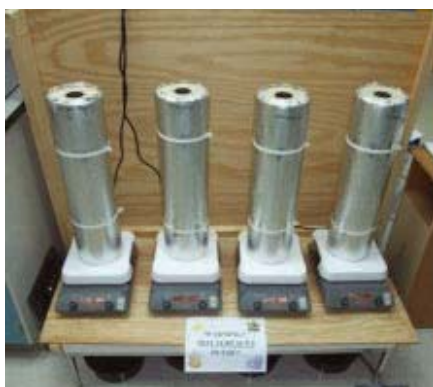
Fig. 2: Experimental set-up (Left to Right: TSA, Coating #1, Coating #2, and TMIC)

The temperature of the pipe under the insulation was determined by placing thermocouples

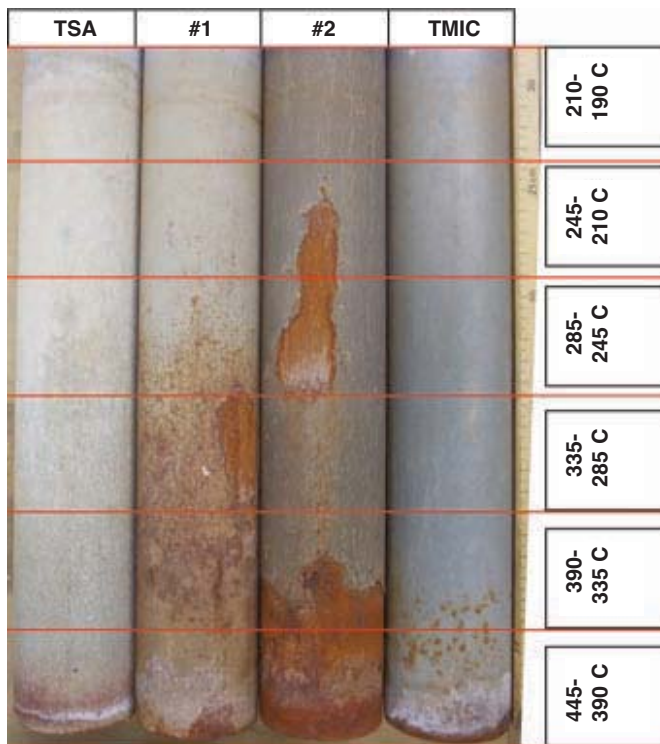
Fig. 7: After cyclic immersion in salt solution with dry out

Figure 7 shows the coated pipe samples after

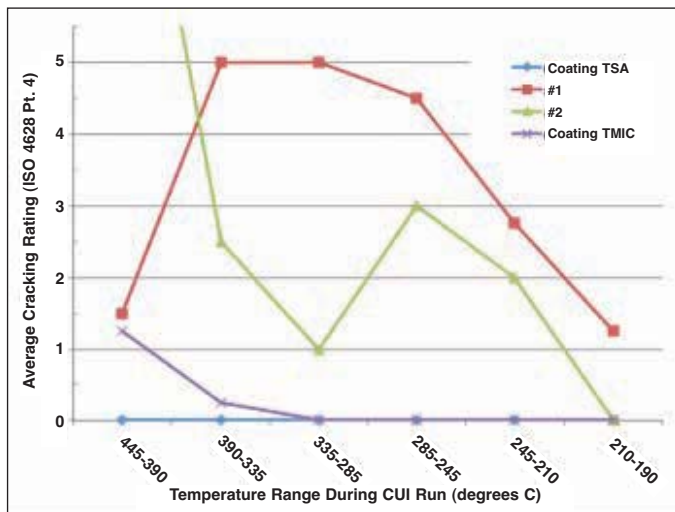
Fig. 9: After cyclic immersion in salt solution with dry out—average cracking

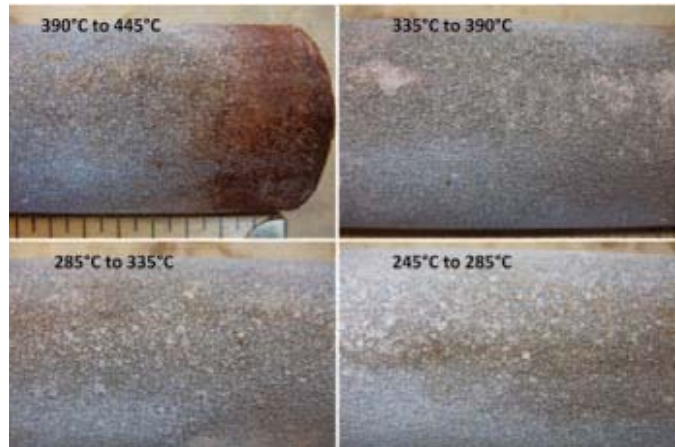
Fig. 11: TSA after CUI cyclic testing

Subsequent exposure to cyclic salt immersion and dry heat produced little change in the TSA. It showed no significant increase in rusting and did not blister, flake or crack. Visually the TSA became more dulled

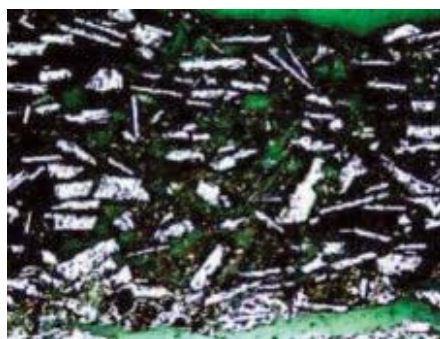
Fig. 26: SEM image of Coating #2 after image analysis to evaluate coating porosity after exposure at 400 C showing porosity level of 9% in the matrix (200 x)

The cracks were filled with epoxy during sample preparation, helping to keep the coating sample intact during preparation (Fig. 25). These cracks served as a pathway for oxidation and corrosion on the substrate. Based on the space within the coating filled with fluorescent green epoxy, at 400 C, the apparent porosity of Coating #2 was about 9% (Fig. 26).

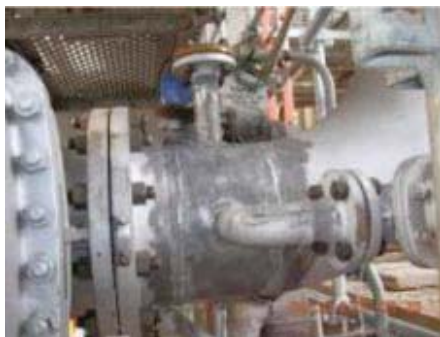
Fig. 29: Preparation of TSA weld joints

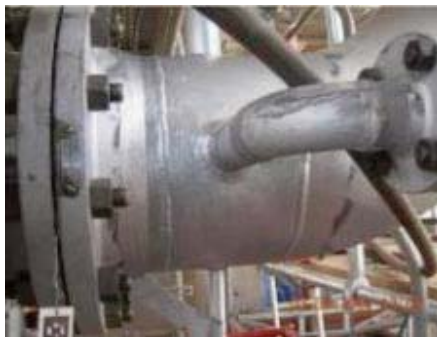
Fig. 30: TMIC applied to protect TSA weld joints

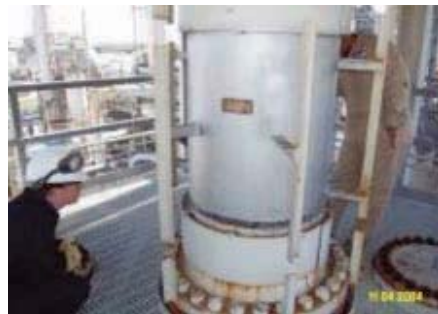
Fig. 31: Inspection of TMIC after 1 year in service showing no coating breakdown or rusting
