JPCL Issues and Articles

From JPCL, July 2012 | Free Product Information

Progress Brings Problems to Wastewater Systems

The case of...surprise blistering and rusting on a new tank lining system

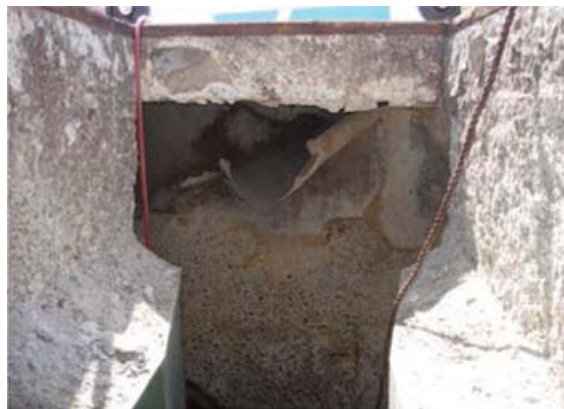
Many wastewater treatment systems in the U.S. predate World War II, but some systems built after WWII have deteriorated significantly, sometimes fewer than 20 years. All photos courtesy of Sauereisen.

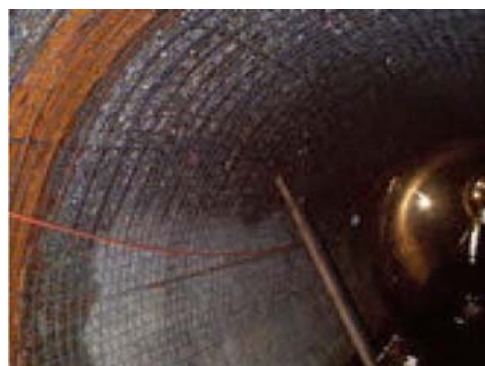
Fig. 1: Replacement of rebar to rebuild structural integrity.

Since the concrete loss was so significant, more than 14,000 sq. ft. of a steel reinforcement and cementitious gunite had to be applied before applying the first square foot of a protective lining system.

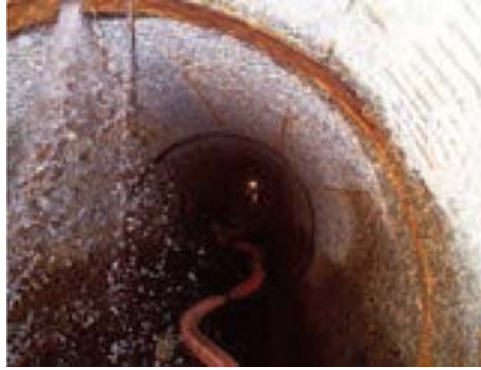
Fig. 2: Active water inflow and infiltration in tunnel.

Thus, because of changes since WW II, biogenic corrosion, combined with direct chemical attack from sewerage pollutants, can be extreme. In 2005, authorities in a suburb of New York City examined a 30-year-old, 84-inch diameter, 2,200-lineal foot main trunk sewer built 20 feet below grade. Extensive biogenic corrosion meant that over 4½ in. of Portland concrete overlay and rebar had to be repaired (Fig. 1). There was also extensive wear from abrasion, and the amount of inflow was measured in gallons per minute (Fig. 2).

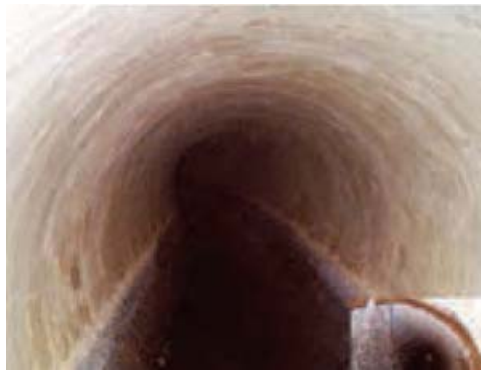
Fig. 3: Complete restoration and rehabilitation of the crown section of tunnel.

After a review of several competing technologies such as polyurethane, polyvinyl chloride, epoxies, and high-density polyethylene, a 100% solids epoxy material was chosen to maximize the life expectancy of the structure. This lining was applied via a peristaltic pump using a nozzle to minimize the downtime of the trunk line, thus saving the municipality an extensive amount of capital. Quality Assurance and Control were monitored at the factory: Sample batches were subject to standard QC tests before shipment of the product to the jobsite, where a strict application protocol was enforced. In accordance with ASTM and NACE standards, a holiday detection program was instituted to detect any voids or discontinuities in the lining system. Upon completion, the trunk sewer was placed back in service and has been operational ever since (Fig. 3).

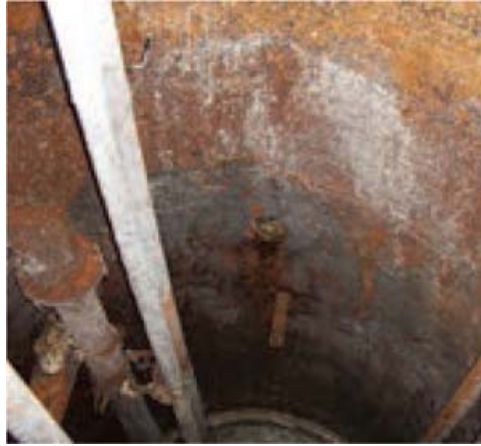
Fig. 4: Corrosion and surface cracking in concrete wet well.

A 20-year-old underground wet well in a suburb had suffered extensive corrosion and degradation due to biogenic corrosion, mild manufacturing chemical attack, and abrasion (Fig. 4). A strong, unpleasant odor accompanied the degradation and corrosion, so long-term odor control was an imperative part of the repair. Based on the physical characteristics of chemical, permeation, and abrasion resistance, coupled with extensive 3rd party testing and over 20 years of documented case histories, a hybrid polymeric lining system was selected.

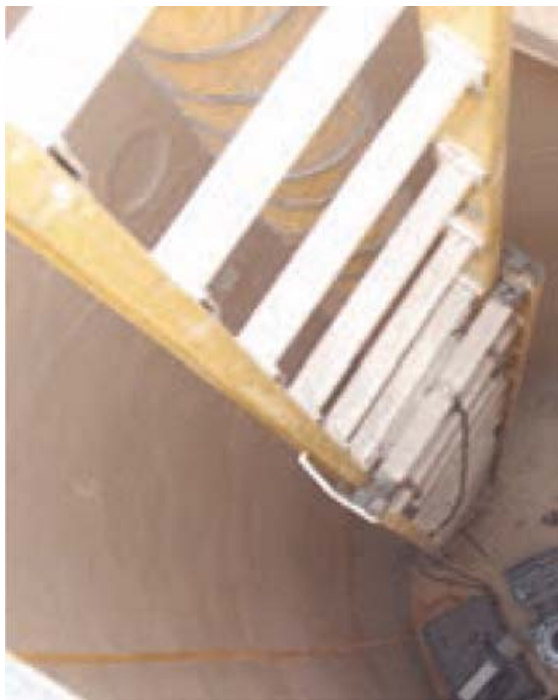
Fig. 5: Finishing touches on a rehabilitated wet well.

The structure was taken out of service briefly so it could be pressure washed and abrasive blasted to remove contaminants and provide an acceptable substrate for rehabilitation. A blend of cementitious and polymer-modified patching materials was used to restore the Portland concrete wet well to its original state. Then, 100% solids hybrid polymer lining materials were applied (Fig. 5). Since all the materials applied were from the same manufacturer, a warranty was provided to increase the end users' ability to "sleep at night."

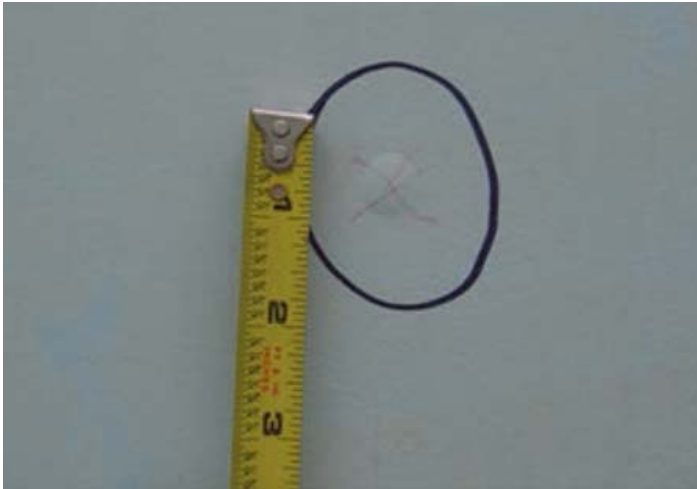
Fig. 1: Unbroken, liquid-filled blister. All photos courtesy of KTA-Tator, Inc.

Blistered areas in the tank shell lining system were isolated to a few locations and were present in concentrations of 6 to 10 blisters, which ranged in size from approximately $\frac{3}{4}$ to 1 inch in diameter (Fig. 1). Some blisters were intact, while others had a small pinhole on the surface, from which a red-colored rust stain was seeping. Blister caps were removed from intact blisters to expose the underlying steel substrate, which showed a darkened, black appearance (Fig. 2).

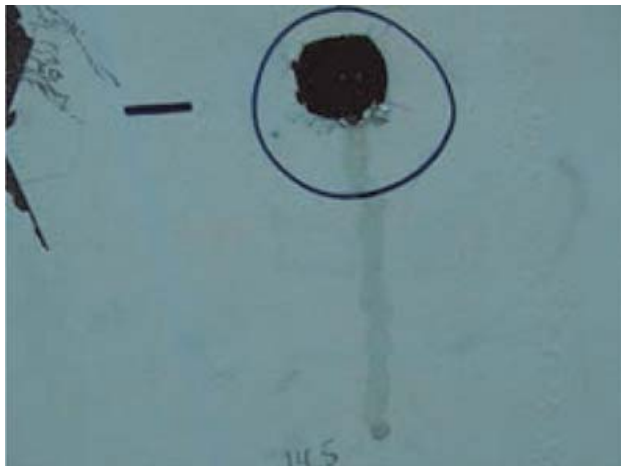
Fig. 2: After blisters were manually fractured, the underlying steel substrate showed a blackened appearance.

All of the steel beneath the removed areas exhibited the same black color as was observed when the blister caps were removed. The backside of the lining chips that were removed from these areas also had the same black-colored residue. At the point where adhesion improved, the appearance of the steel beneath the removed lining changed from the black color to a clean, bright metallic appearance and surface roughness that is consistent with Near-White metal blast cleaned steel.

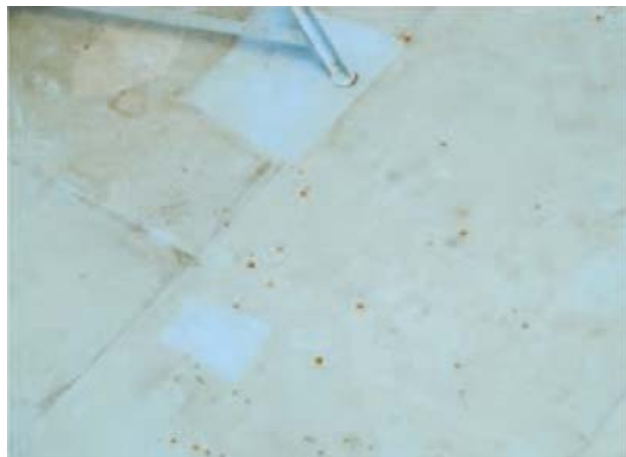
Fig. 3: What appeared to be pinpoint rust on the tank floor was actually embedded metallic fragments in the lining.

What initially appeared to be individual pinpoint of rust on the tank floor, upon microscopic examination, turned out to be small metallic fragments that were embedded in the surface of the lining (Fig. 3). The particles were located on the tank floor adjacent to piping that was attached by angular steel brackets to the tank shell wall. The fragments had an appearance consistent with fine shards or particles of metal that is produced by grinding, burning (i.e., torch cutting), and welding operations.

Microscopic examination (with magnification up to 200X) of lining chip samples supported the observations made in the field. The pinpoint rust observed on the floor was confirmed to be small rusted metallic fragments that were embedded in the surface of the lining.

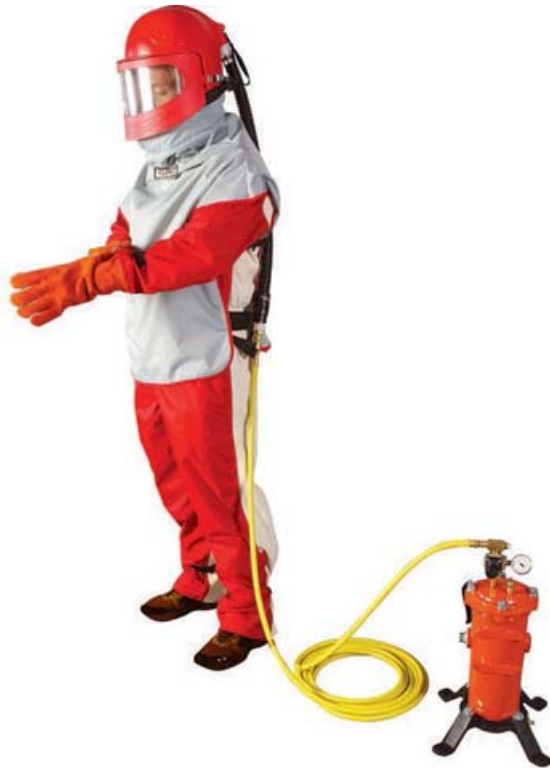
Fig. 1: Supplied air respirators must be used with an in-line sorbent bed filter. Photos courtesy of Clemco Industries Corp.

OSHA requires users of Supplied-Air Respirators to use an in-line "Sorbent Bed Filter" ([Fig. 1](#)).

The sorbent bed removes the objectionable oil odors and mists mentioned in the OSHA standard. It contains a replaceable filter that enables the user to comply with the standard, which requires maintenance of such a filter.

An abrasive-blasting respirator is shown in Fig. 1.

The supplied-air respirator shown in Fig. 1 includes the hood, lenses, cape, air valve and yellow respirator air hose connected to the point of attachment (POA) located on top of the sorbent bed filter. While the respirator assembly begins at the POA, this attachment is mandated by 42 CFR Part 84, Subpart J.149 and shown in Fig. 6.

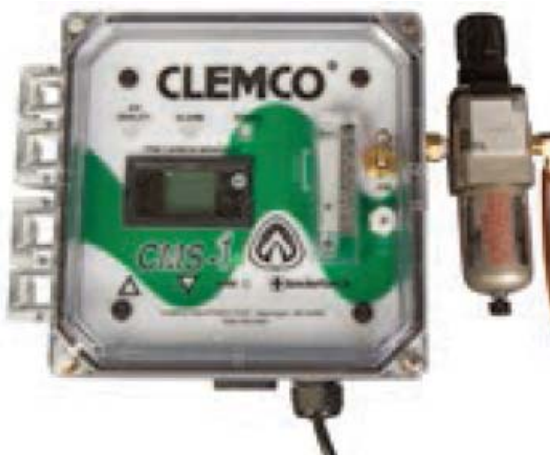
Fig. 2: Permanently installed carbon monoxide monitor

Unless using a compressor which specifically states it is a "Breathing-Air" compressor, the employer must install a carbon monoxide monitor in the air-supplied system. Historically, there were two types of carbon monoxide monitors: a permanently installed type (Fig. 2), and a portable type (Fig. 3).

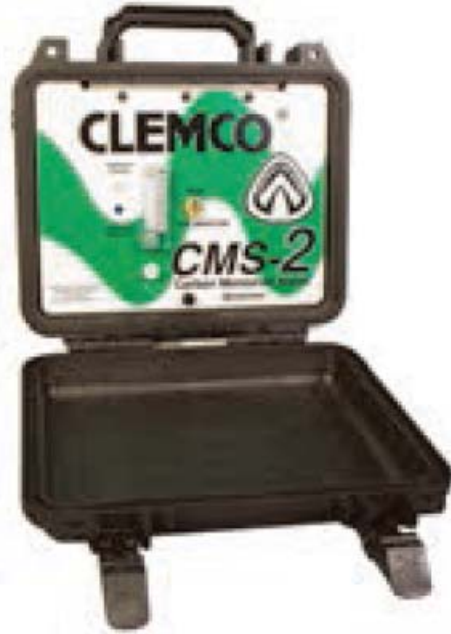
Fig. 3: Portable carbon monoxide monitor

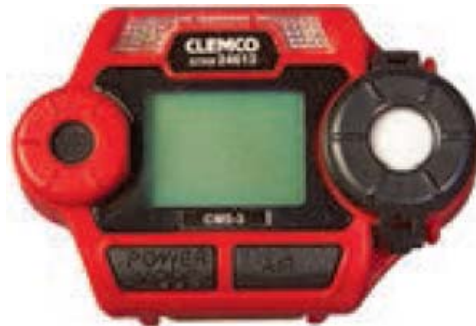
Fig. 4: CO monitor that may be used as an individual CO monitor

In early 2011, OSHA issued a letter of interpretation stating that the CO monitor shown in [Figure 4](#) may be used as an individual CO monitor, meeting the standard stated in 29 CFR Section 1910.134(i), provided NIOSH would approve its placement inside the respirator. [Figure 5](#) shows the only approved respirator and the monitor's placement.

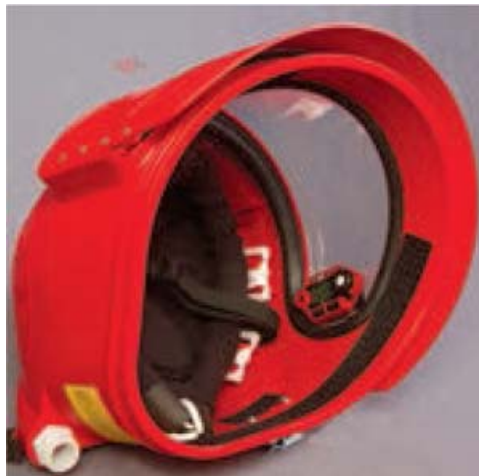
Fig. 5: CO monitor placement in the only respirator approved for the monitor's use

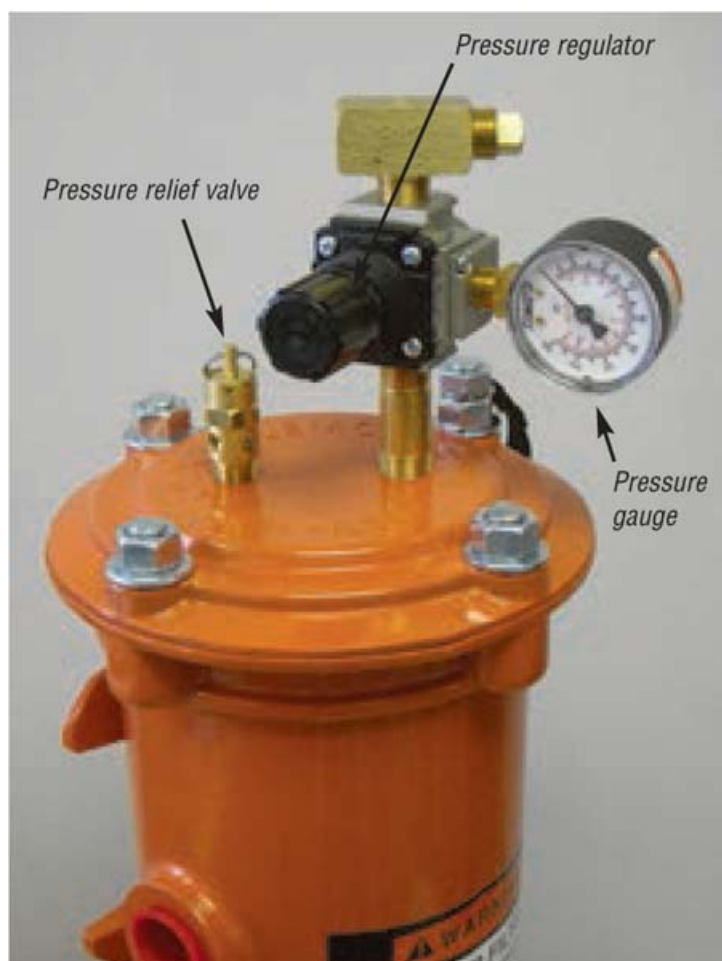
Fig. 6: Point of attachment on top of sorbent bed filter

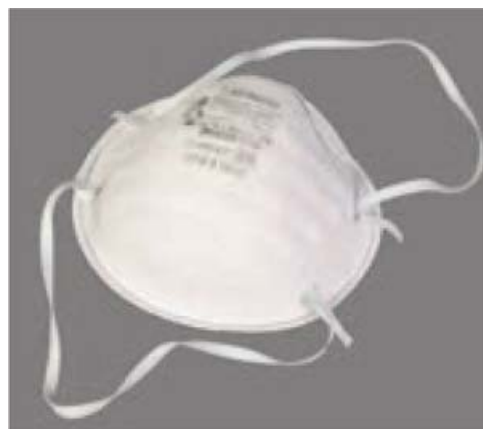
Fig. 7: Standard dust mask

Many employees working around abrasive blasting operations use a standard dust mask (Fig. 7). These masks most often have an Assigned Protection Factor of five (5), which means the employee may be exposed to inhalation hazards up to five times the PEL. When inhalation hazards, such as free silica, lead, cadmium, asbestos, and chromium, are present, these dust masks are inadequate. While these workers are not required to wear supplied-air respirators, employers should seriously consider providing them to employees working in the vicinity of blasting operations.

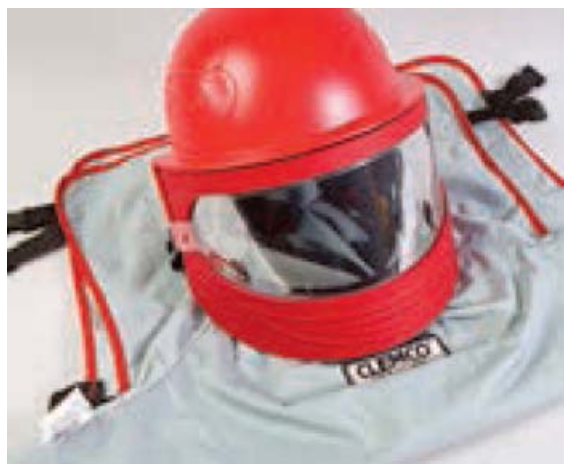
Fig. 8: Supplied air respirator with an ANSI 3.19 Noise Reduction Rating

NIOSH Publication No. 98-126, titled *Criteria for a Recommended Standard Occupational Noise Exposure*, states in part: "It is important to note that using such double protection will add only 5 to 10 dB of attenuation [Nixon and Berger 1991]." Using secondary hearing protection such as muffs over earplugs or a supplied-air respirator with an ANSI 3.19 Noise Reduction Rating, like the one shown in [Fig. 8](#), can add an additional 5 dBAs of hearing protection.
