The Voice of SSPC: The Society for Protective Coatings

34 Developments in Zinc Primers for Corrosion Protection

15 Cases from the F-Files

Performance or preference? City of Anoka water tank reconditioning revisited By Dan Zienty, Short Elliott Hendrickson Inc.

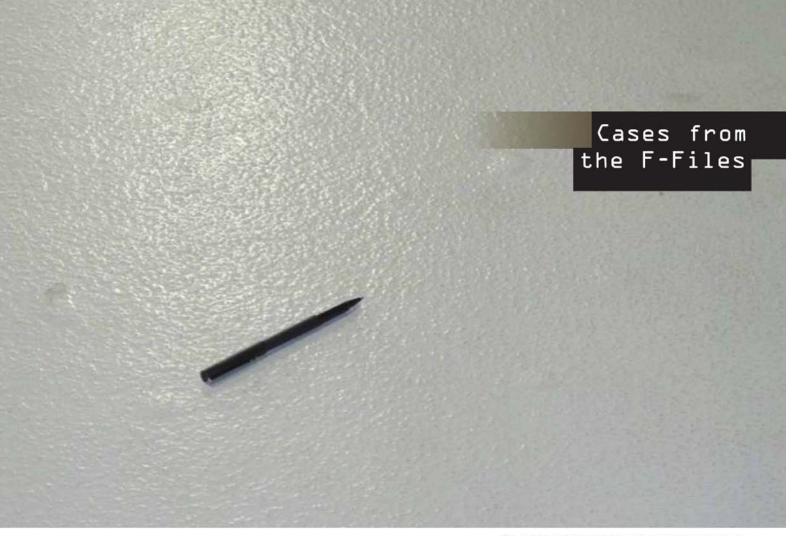
Fig. 1: Blistered floor coating with a writing pen for scale.

filled epoxy base coat, an epoxy grout coat, and an epoxy finish coat. It was reported that moisture vapor transmission (MVT) testing was performed by the contractor prior to the new coating installation. The testing indicated a low MVT of less than 2 lbs./1,000 square feet/24 hours. Blisters began to appear in the coating within a few months of the floor coating installation (Fig. 1). In this case, aggregate in a concrete

floor, in the presence of moisture, caused blistering of the coating system. It is a relatively uncommon problem that could have easily been blamed on the contractor as mis-application of the coating, void of a thorough scientific analysis of the problem (in the field and laboratory) as well as knowledge of concrete substrates. Let's take a closer look.

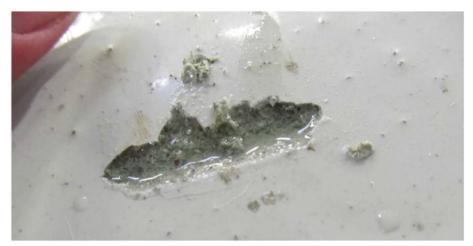
Fig. 2: Opened blister/bump in the floor coating surface revealed water.

The intact blisters varied in size, having diameters that ranged from ½" to 2". When evaluated in accordance with ASTM D714, the blisters were categorized as blister size No. 2 with a frequency between few and medium. When intact blister caps were removed, standing water was observed on the underlying surface (Fig. 2).

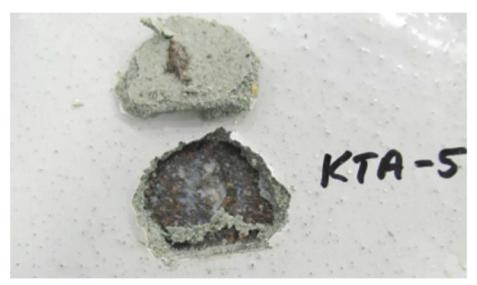
Fig. 3: An opened blister shows the plane of separation between base and cap.

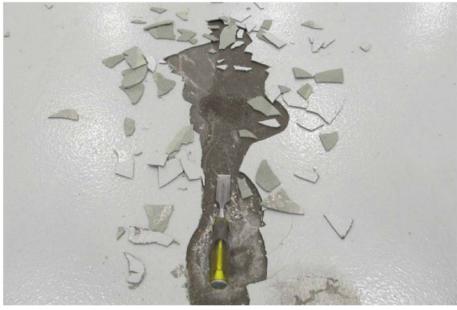
Fig. 4: Running a chisel against an exposed edge caused cracking and delamination of the coating.

Adhesion was generally poor in most areas where sound blisters were present that were tested. The coating could be easily removed with a knife or chisel. Again, an opaque material was found on the surface of the concrete (Fig. 4).

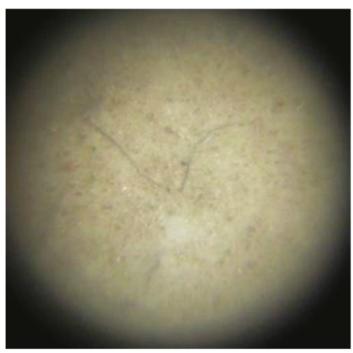
Fig. 6: Cracks in the film at the bottom of blisters were visible under magnification (30X).

Cracks were visible when the amber material was removed and the surface of the coating at the bottom of the blisters was examined under magnification (Fig. 6).

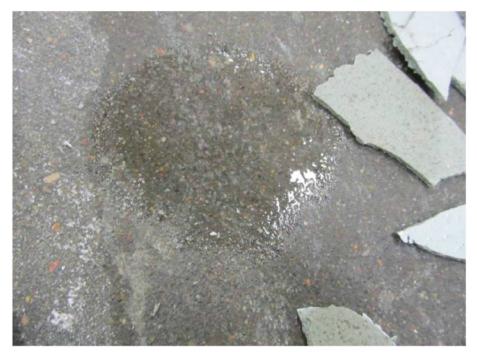
Fig. 7: Wet surface found below and intact blister.

When the intact blister caps were removed, again the underlying surface was wet, and an opaque layer was observed on the surface of the concrete. In some cases, there was a soft white liquid under the blister cap. Examples are provided in Fig. 7 and Fig. 8.

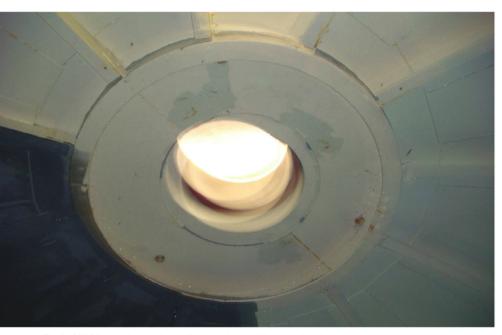
Fig. 3: 2009 inspection—minor failures typical to this type of tank

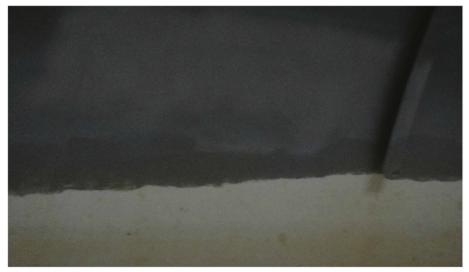
Fig. 9: 2011—Preparation of spot repair area of single-coat zinc

The entire repair process took two days. Surface preparation and priming of all areas were completed on day one. The contractor elected to spot abrasive blast all areas; this was followed by prime coat application with the MCU organic zinc system in the singlecoat zinc segment of the roof and roof support angles (Figs. 9-10). Spots disturbed by abrasive blasting in this designated test area were rolled and edges over-rolled to eliminate any possibility of holidays that could occur from fracturing of the system caused by blast cleaning. The spot repairs of the single-coat zinc accounted for approximately 30 square feet, or 3% of the original 2003 test area.

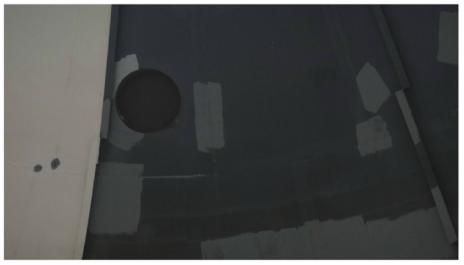
Fig. 10: 2011—Repaired areas of spot failure of single-coat zinc

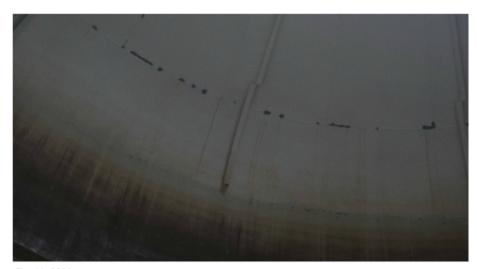
Fig. 11: 2011—Preparation of spot repair areas for two-coat epoxy

Next, the contractor prepared the epoxy system (primer) for spot application for both ICS No. 1 and No. 5 (Fig. 11, p. 30). The epoxy system was used for the repair of the original three-coat zinc-epoxy-epoxy (ICS No. 5) system because not only would the epoxy cover the areas disturbed by blasting, but also the areas would very likely be overlapped to ensure that no voids remained. The zinc coating was not used because the manufacturer's data sheets for the zinc indicated that it would not be compatible with the epoxy intermediate and finish coats, and would likely lead to delamination failures in

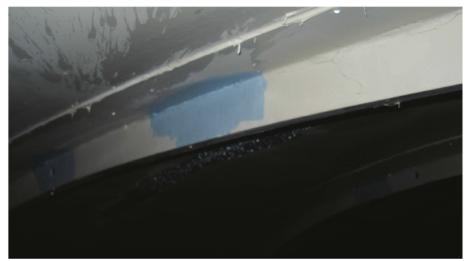
Fig. 12: 2011—Topcoated spot repair area with second coat of epoxy (used for repairs of two-coat epoxy and of three-coat zinc-epoxy-epoxy)

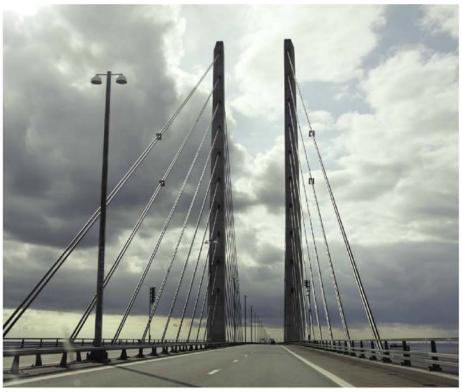
Fig. 2: The Øresund bridge, connecting Sweden and Denmark. The coating system (using a zinc-rich primer) has been designed to protect the bridge against corrosion for a period of at least 100 years.

Well-known examples of steel structures protected by zinc dust primers are the Beijing National Aquatics Center (the Olympic "water cube") and the Øresund bridge, which connects Sweden and Denmark (Figs. 1 and 2).

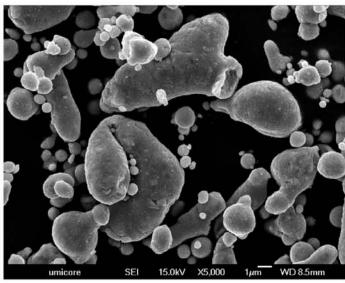
Fig. 3: Spheriodical morphology of an atomized zinc powder

Powders produced by the atomization and the distillation technology processes have different morphologies. While the atomization process produces spheroidical powders, the distillation process always leads to spherical pow-

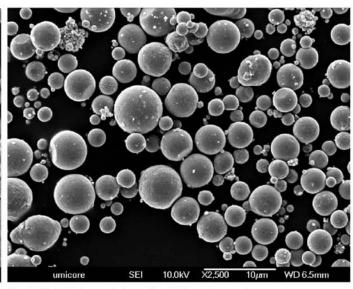
Fig. 4: Spherical morphology of a distilled zinc powder

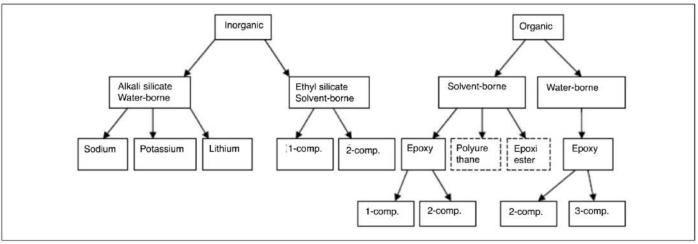
Fig. 5: Division of zinc paints generally used by the paint industry

Zinc-rich paints are paints in which zinc powder is the only active pigment, and it is present in levels above 80 wt% in the dry paint film. Because of these high levels of zinc powder, the paint has the qualities of a metallic zinc film, which allows the paint to protect the steel by an additional mechanism—cathodic protection. Zinc-rich paints provide excellent corrosion protection in heavy-duty and marine environments.

Zinc primers with lower zinc content (25%–70%) are used to protect steel in less aggressive environments and to provide temporary corrosion protection. Although they have a lower proportion of zinc, they also provide an excellent barrier coating and hinder the spread of rust from an edge or scratch. Well-known zinc primers are the shop primers—very thin zinc primers (with a thickness of on average 10–15 microns) are used for temporary protection of steel sheets (six months to one year) stored for the newbuilding of ships.

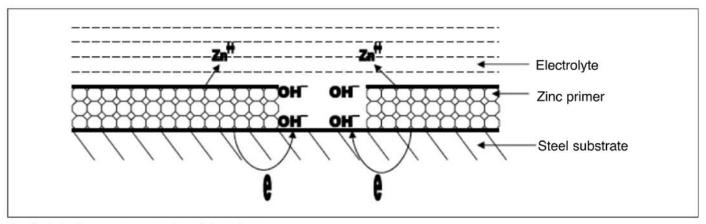
Fig. 7: Cathodic protection mechanism of zinc-rich primers

hydroxyl carbonates, etc.) and because of the formation of hydroxyl ions on the steel surface during the cathodic protection. This alkalinity certainly contributes to the protection of the steel once the cathodic protection is exhausted.

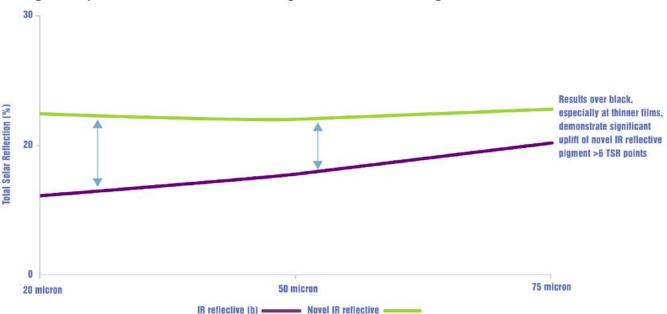
different thicknesses. The results in Fig. 3 show that the use of the new infrared reflecting pigment increased solar reflectance over a standard pigmentary TiO2.
