MARCH 2014

PAINTSQUARE.COM
jpcl

32 When Undercover Agents are Tested to the Limit: Coatings in Action (CIA) and Corrosion Under Insulation (CUI) at High Temperature

48 Preparing and Lining Concrete for Immersion Service: Steps and Procedures to Avoid Failures

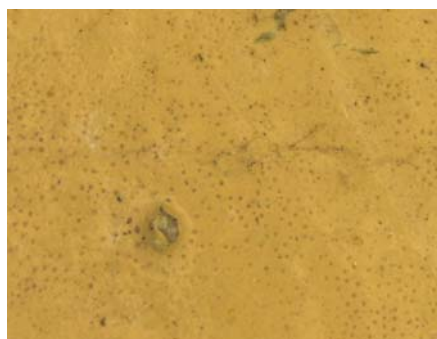
Fig. 2: Pinholes in a film due to solvent entrapment

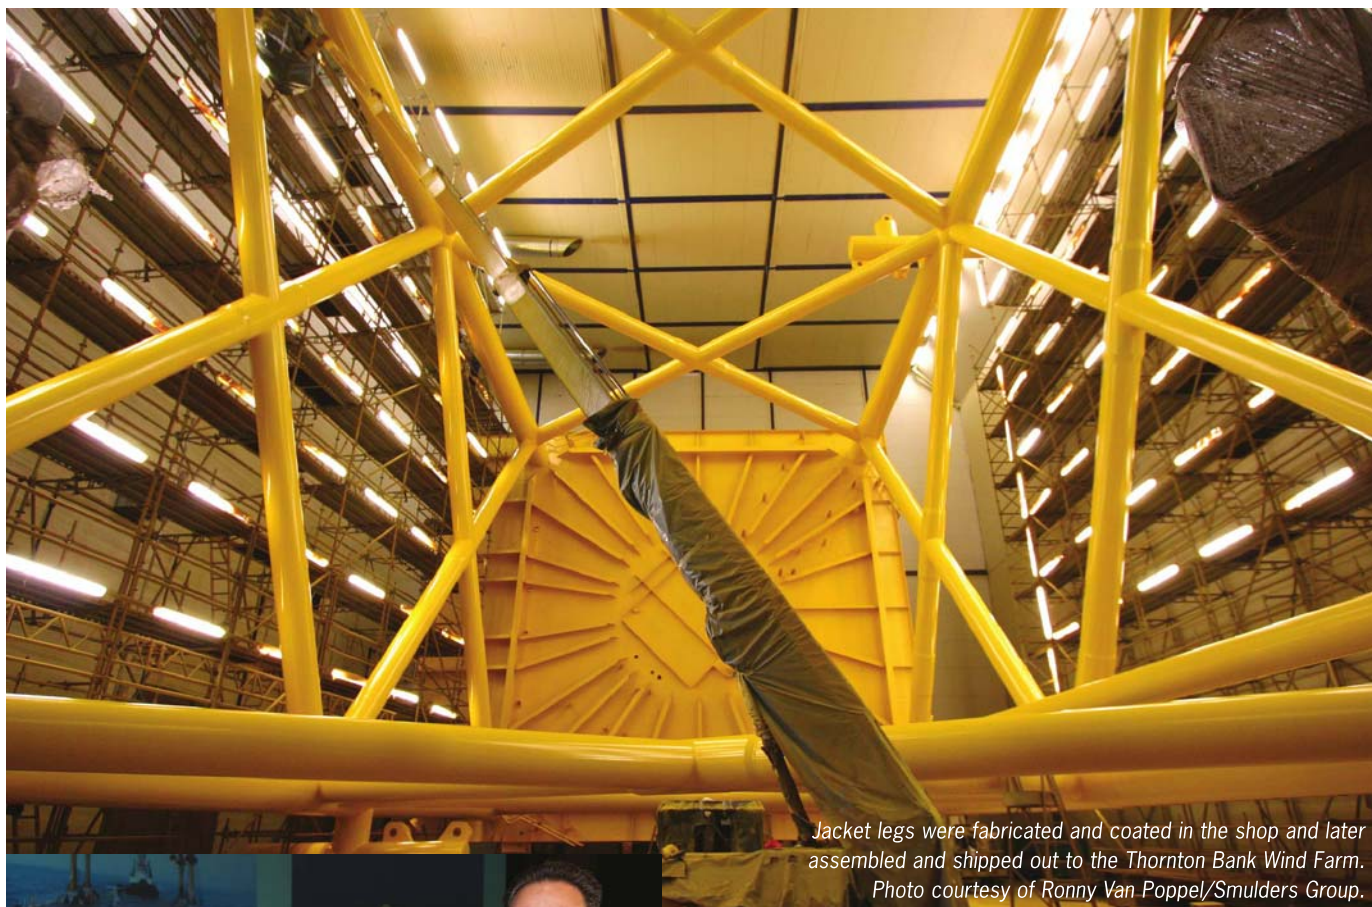
Jacket legs were fabricated and coated in the shop and later assembled and shipped out to the Thornton Bank Wind Farm.
Photo courtesy of Ronny Van Poppel/Smulders Group.

Thornton Bank is an offshore wind farm located off the coast of Oostende, Belgium. This challenging project involved constructing 48 steel jacket foundations for wind turbine generators and one steel jacket foundation for an offshore transformer station.

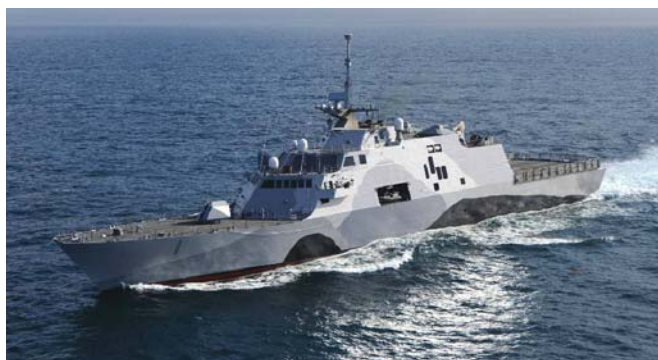
The four-color camouflage pattern on the *USS Freedom* was applied with a color-stable, low solar-absorbing, low-VOC coating system. Photo courtesy of David Clapp.

One coat of edge-retention epoxy was applied from the water line to the rail, and the four camouflage colors—black, haze gray, light gray, and ocean gray—were a semi-gloss

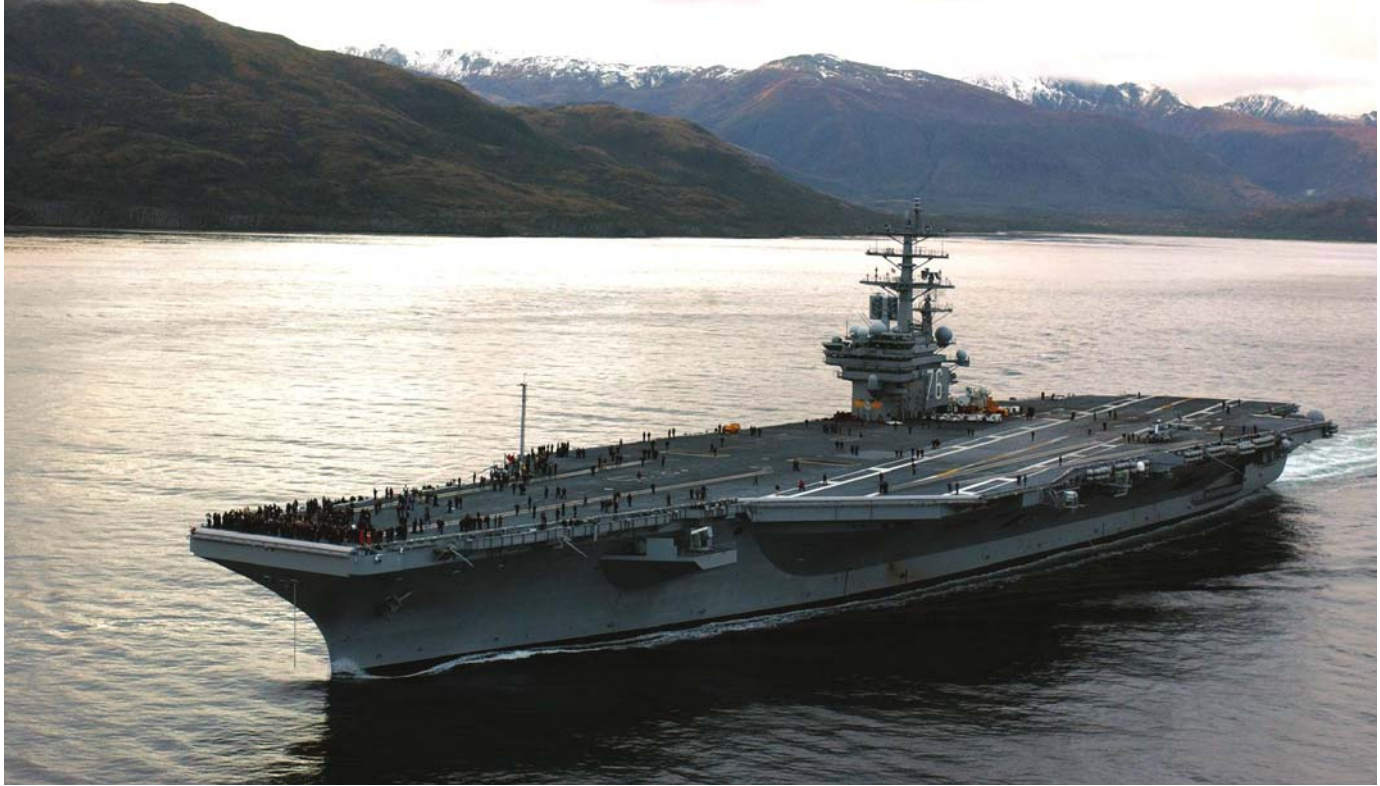
Approximately 17.3 acres of steel onboard the USS Ronald Reagan were prepared and repainted. Photo courtesy of IMIA.

Coatings preservation work was performed on the freeboard, underwater hull, sea chests, catwalks, various tanks, voids, and vent plenums. Approximately 17.3 acres of steel were staged, encapsulated, and preserved.

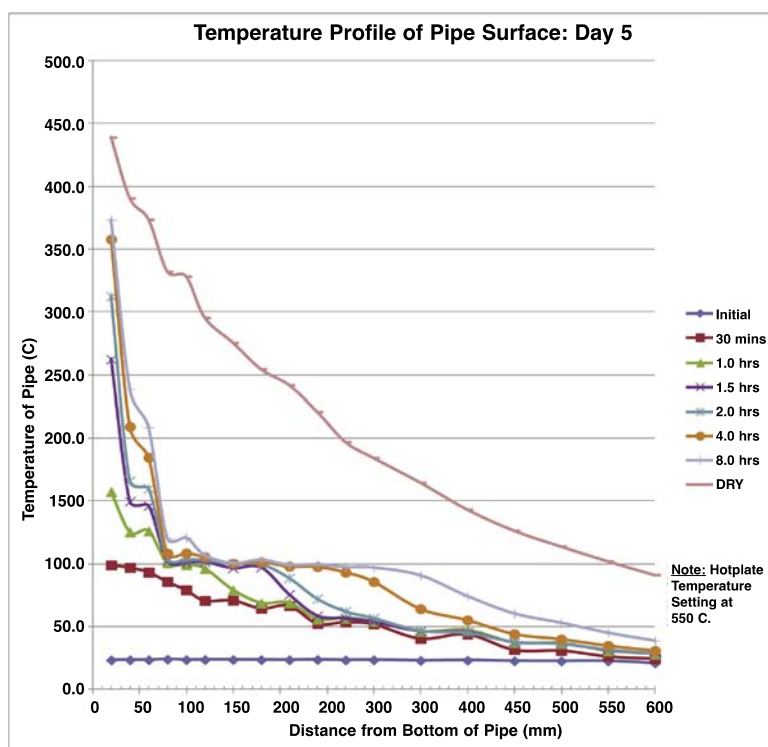
Fig. 4c: Day 5 of CUI cyclic testing with hydration

The temperature profiles showed little further change after day 5, indicating a steady state had been achieved where evaporation

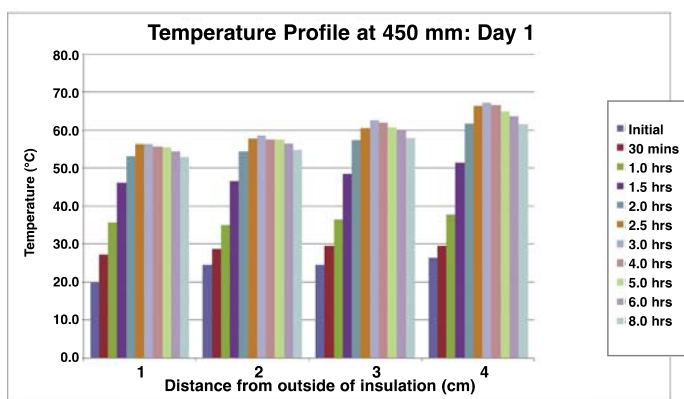
Fig. 5a: Day 1 of CUI cyclic testing with hydration
(Top: 150 mm, Bottom: 450 mm)

Fig. 5b: Day 5 of CUI cyclic testing with hydration
(Top: 150 mm, Bottom: 450 mm)

From day 2 to day 10, as the insulation became progressively more saturated with water, the temperature gradient across the insulation dropped and the overall temperature remained progressively closer to room temperature. After 4 to 8 hours of heating, the insulation temperature finally started to increase toward pipe temperature, but no significant temperature gradient developed, presumably due to the thermal conductivity of the brine. The pipe surface temperature dropped from 80 C on day 1, to 62 C on day 5, to 50 C on day 10. The difference between pipe surface temperature and insulation temperature gradually decreased over the 10-day interval from 20 C after 1 day to 6 C after 10 days (after 8 hours of heating).

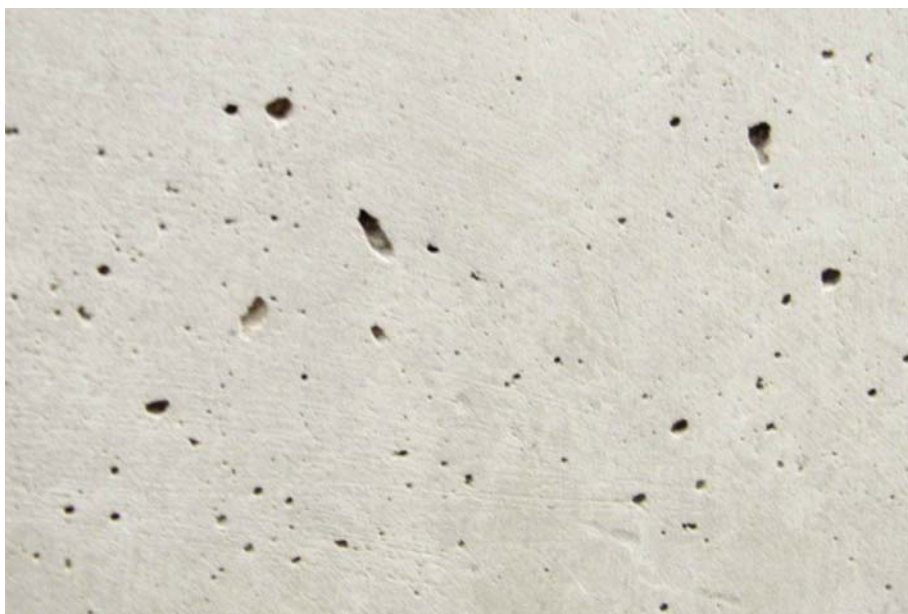
Fig. 5: Typical bug holes on formed concrete

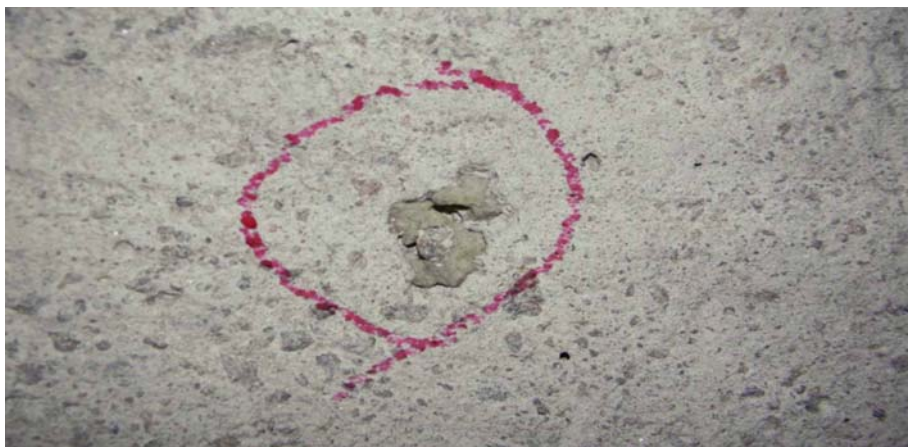
Fig. 6: Residual lining material (substrate was prepared by UHPWJ followed by abrasive blasting)

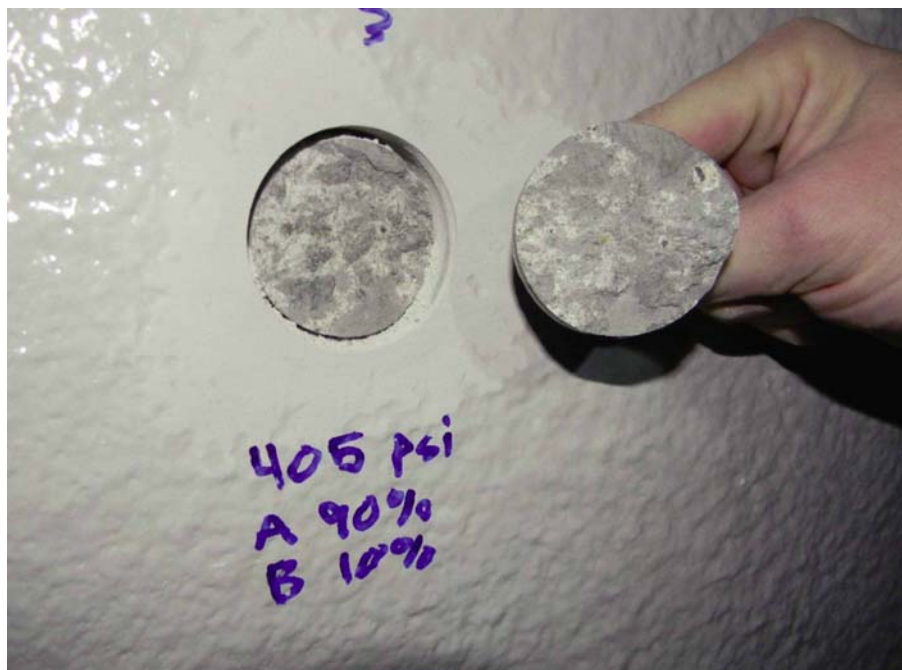
Fig. 9: Pull-off adhesion testing. 90% of the failure occurred cohesively within the substrate, whereas 10% of the failure occurred cohesively within the filler/surfacer.

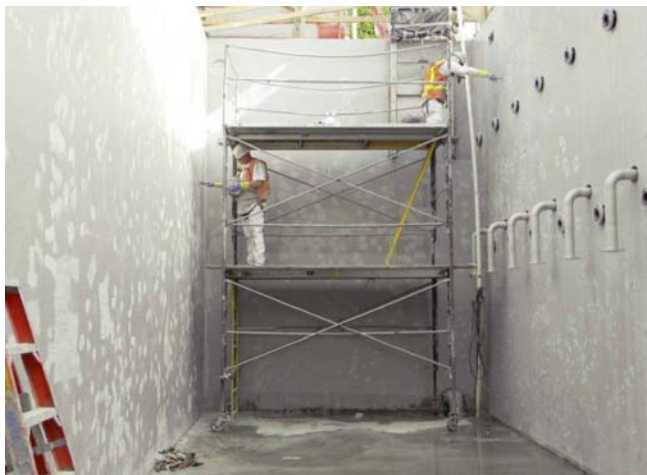
Fig. 10: Repairing holidays. Most specifications do not set a limit for the maximum number of holidays allowed, either for the entire structure or expressed as a holiday to substrate area ratio.

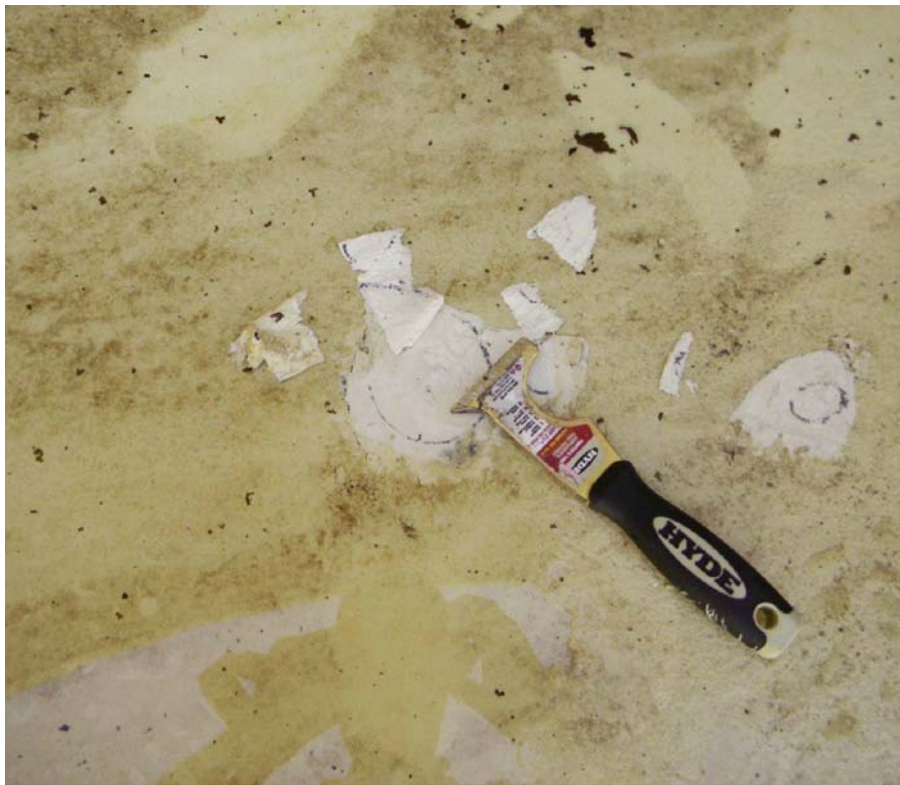
Fig. 12: Off-ratio repair material found during anniversary inspection
