FEBRUARY 2016

VOLUME 33, NUMBER 2

PAINTSQUARE.COM
jpcl

The Voice of SSPC: The Society for Protective Coatings

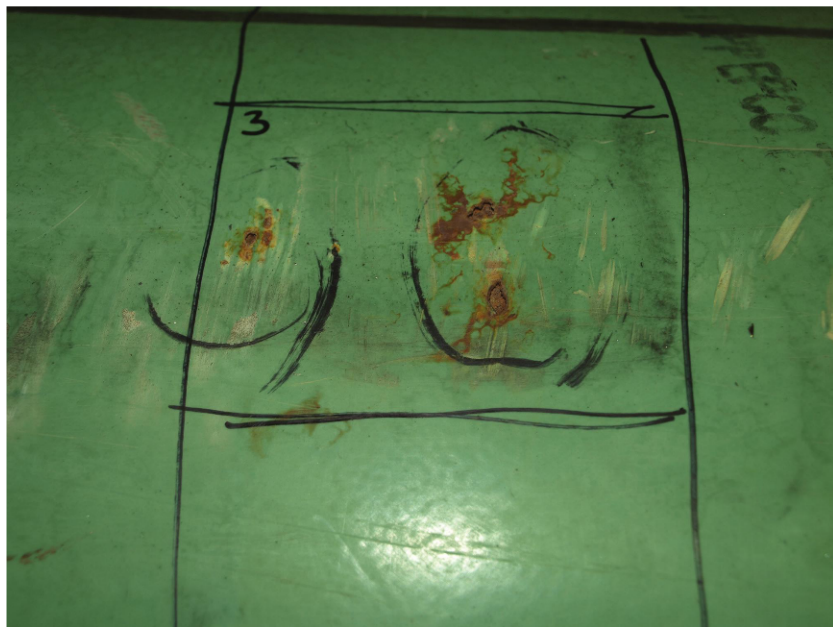
Fig. 1: Pipe section with pits marked for removal.
All photos courtesy of KTA-Tator, Inc.

A section of pipeline needed to be excavated in a relatively small area to accommodate new construction in the surrounding area. The pipeline was buried and put into service only about six months earlier, so corrosion and coating failure were not expected. However, failure of the powder coating system and severe pitting was evident on the excavated pipe section. The pipeline owner was notified to witness the excavation and to examine the condition of the pipe.

After the initial section of pipe was excavated, additional lengths of pipe were exposed to determine the extent of the corrosion which was occurring in relatively deep pits that appeared randomly on the pipe sections in two areas. The other sections of excavated pipe revealed no visible corrosion. A section of the 24-inch pipe was removed and replaced (Fig. 1). From this section a smaller 15-by-48-inch section was delivered to the laboratory along with a copy of the specification governing the application of the powder coating.

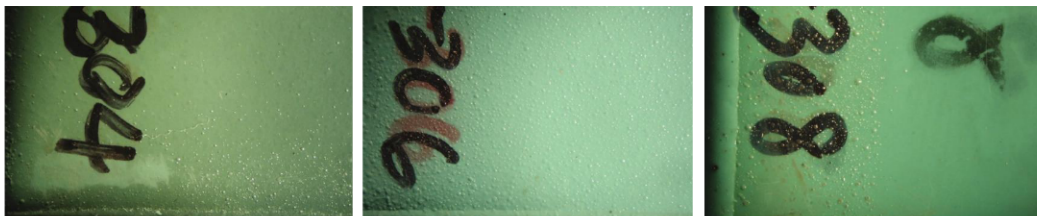
Fig. 3: Surface blisters on SFE 1 in prequalification testing.

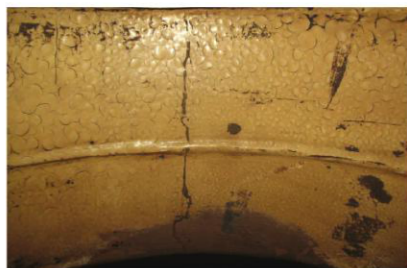
Fig. 4: Photos of SFE 1 in WAC vessels after two years of service.

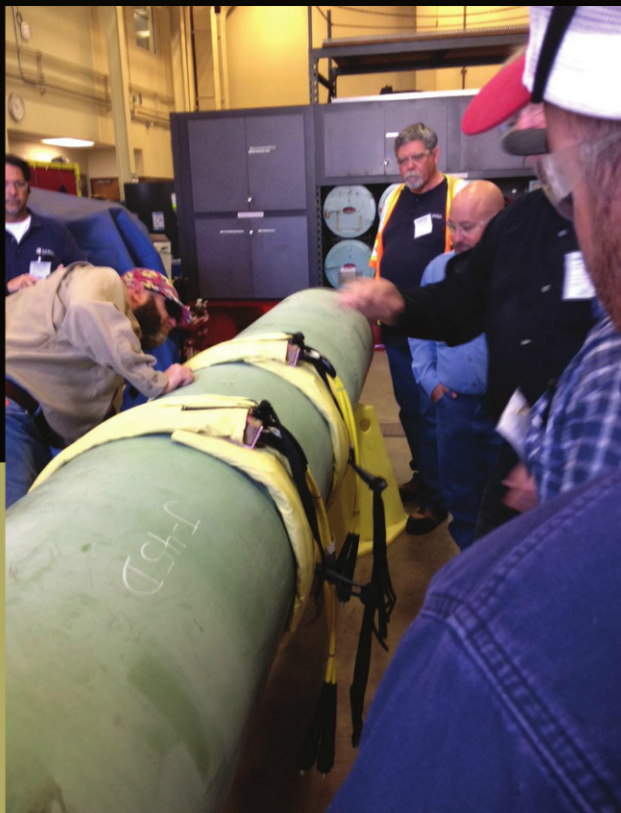
Fig. 1 (Left): Induction heating equipment set up for demonstration at PG&E Applied Technology Services facility.

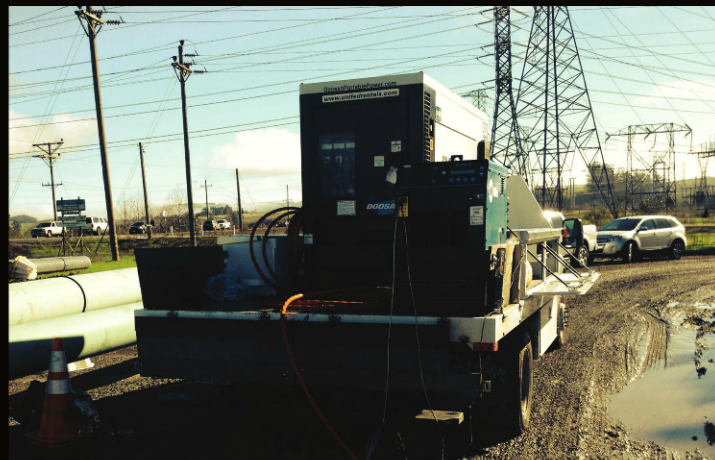
Fig. 3: Induction heating system mounted on a vehicle for use in pipeline right-of-way.

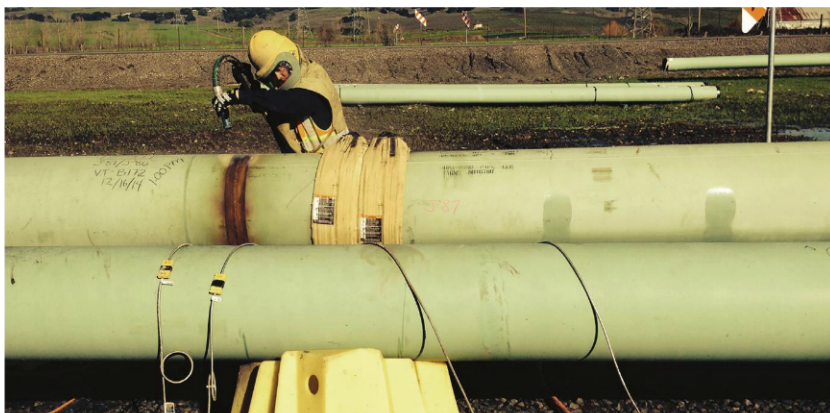
Fig. 5: Abrasive blasting of the heated girth weld. Note that blankets have been moved to avoid damage.

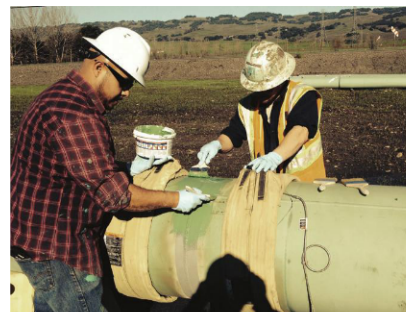
Fig. 6: Heating blankets are reinstalled for coating application and cure.

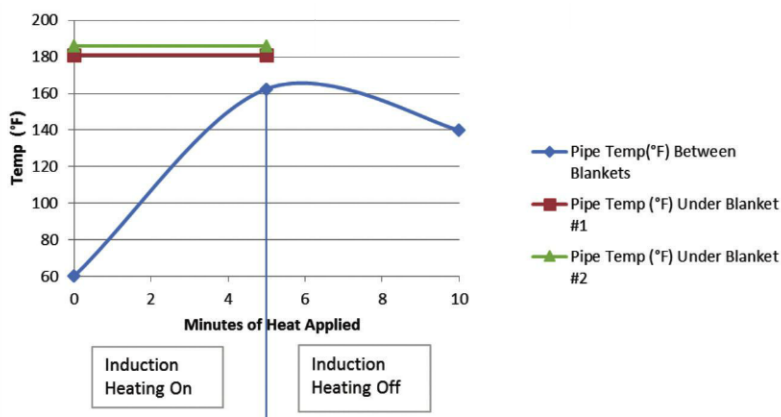
Fig. 8: Pipe temperature profile with 3 inches between induction heating blankets.

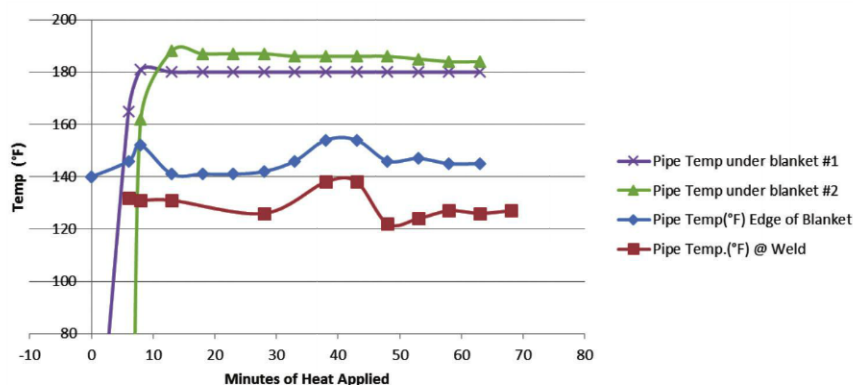
Fig. 9: Pipe temperature profile with 11 inches between induction heating blankets.

Steel surfaces several inches away from the induction coils can take considerably longer to heat and will not reach the same temperature as the steel under the coils. Figure 9 (p. 50) shows that with an 11-inch spacing between the

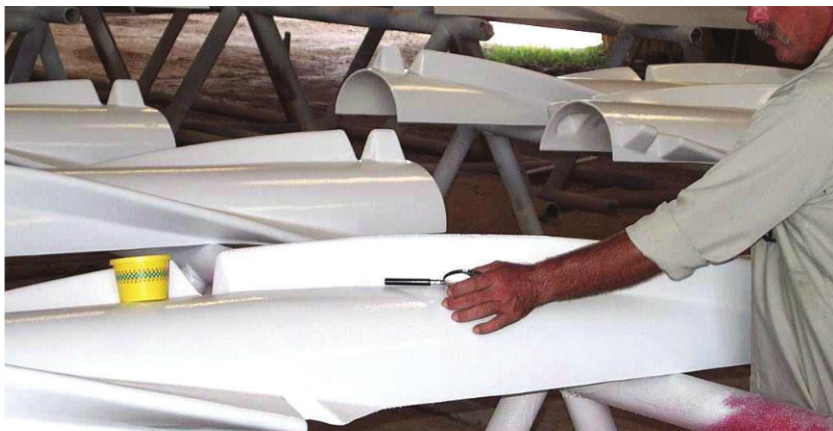
Fig. 1: Prepared surfaces of the riser covers had to be 100-percent checked with low magnification, and filling in pinholes was a process similar to final preparation of auto body panels in a body and fender shop before application of the first coat of paint.

Even with light abrasive sweeping using the very fine abrasive, pinholes and bubbles in the gel coat were exposed. When such defects were primed with the recommended epoxy, unacceptable craters or blisters developed. Prepared surfaces

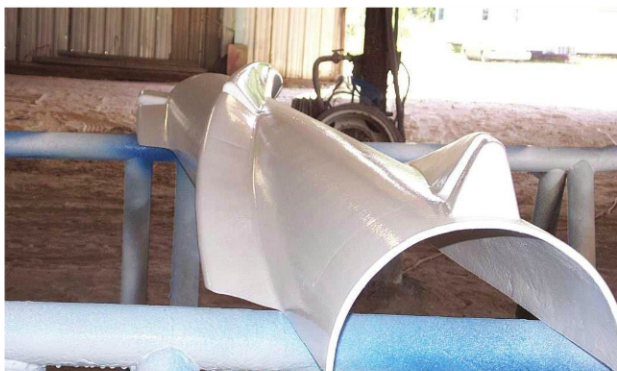
Fig. 2: As a test of effectiveness, the fiberglass fabricator prepared a single half-shell, which was then blasted and coated, to be shipped offshore for a test on an actual riser in the Gulf of Mexico.

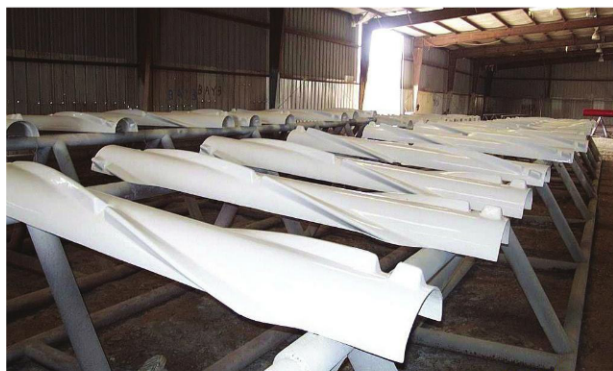
Fig. 3: What had for months been a one-off test program came to take over an entire building, as abrasive sweeping and coating of the riser cover half-shells expanded into a multi-year, multi-million-dollar assembly-line project.

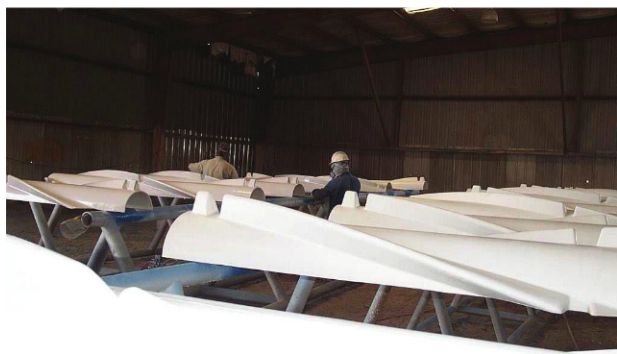
Fig. 4: An entire yard crew was trained in the special abrasive sweeping and coating application requirements of the project, and close quality control was maintained cooperatively by all the parties involved.

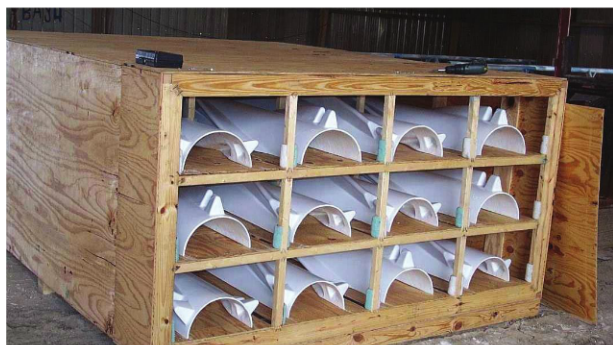
Fig. 5: Special plywood housings were fabricated for the smaller-diameter riser covers, as much to prevent damage to the NBFRS antifouling as to be sure the covers floated if they went overboard from the back deck of a supply boat.

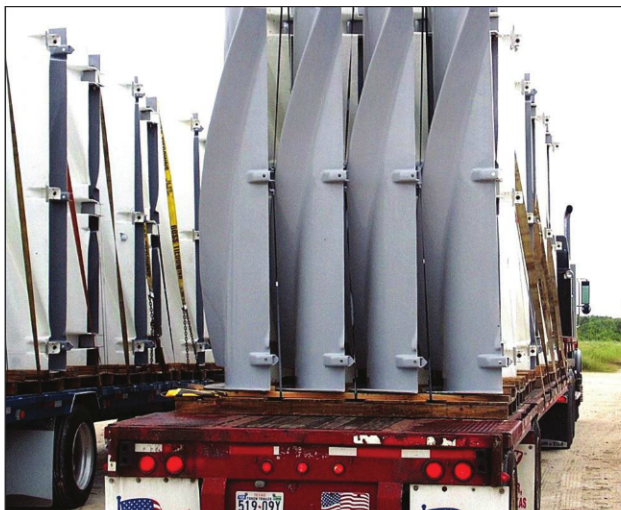
Fig. 6: Larger-diameter covers were shipped standing on edge on a flatbed truck, and were laid flat on the back deck of the supply boat to prevent damage to the applied coating.

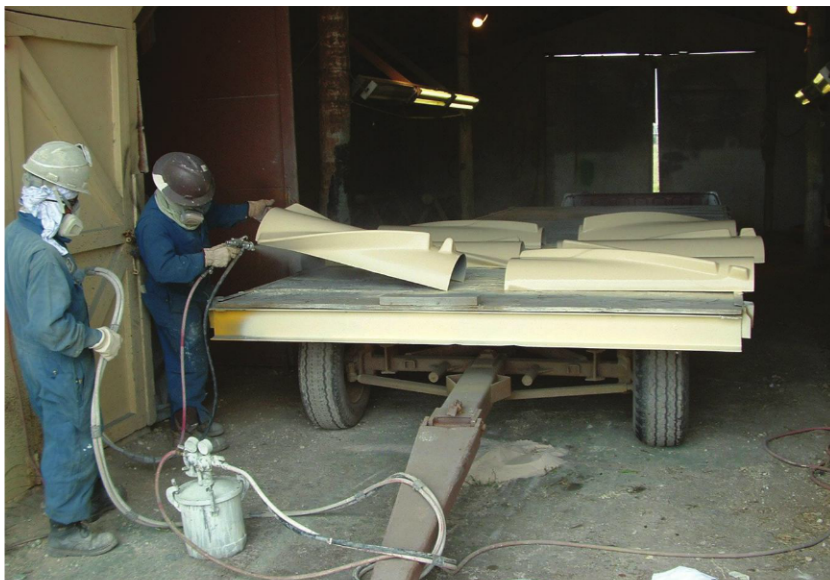
Fig. 7: After having been abrasive swept, stub riser cover pieces, too short for the pipe racks, were coated on the back of a shop trailer.

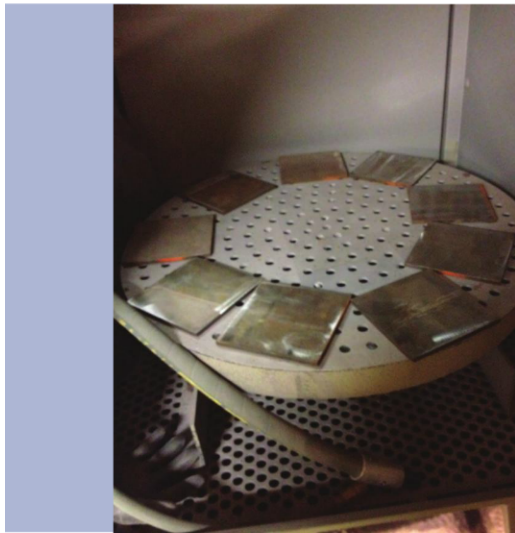
Fig. 1: Panels arranged for blasting in glove box blasting cabinet.
