The Voice of SSPC: The Society for Protective Coatings

7 ALL SILICONES ARE NOT CREATED EQUAL

THE PRINCIPLES OF WORKING AT HEIGHTS

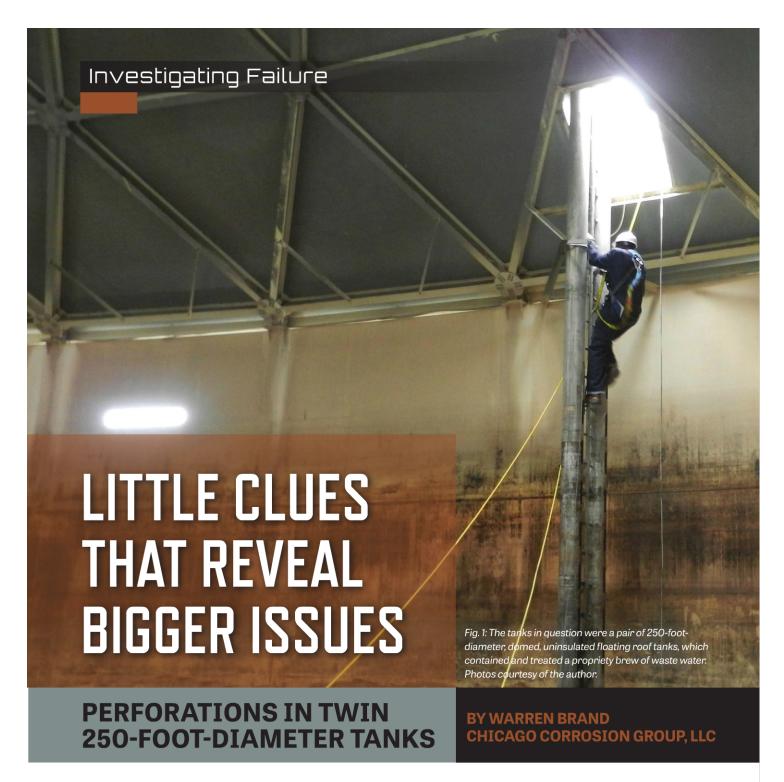
The patient was a 250-foot-diameter, domed, uninsulated floating roof tank, which contained and treated a propriety brew of waste water (Fig. 1). There are two of them — twin tanks — and their modes of failure were virtually identical.

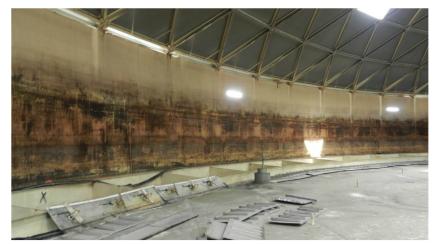
Fig. 2 (Top): The concept behind a floating roof is to prevent liquid from evaporating. In this case, the top of the discolored area on the walls indicates the upper limit of the liquid level and how far the roof will travel upward when filled.

Fig. 4 (Bottom right): At first glance, the floor coating systems appeared to be intact overall, but closer inspection revealed areas that caused concern.

There were areas of the tank walls which were submerged most of the time and areas above the floating roofs which were submerged when the liquid in the tanks was high and exposed when the liquid in the tanks was lower (Fig. 2). UV degradation was not a serious issue here, as the tanks were domed.

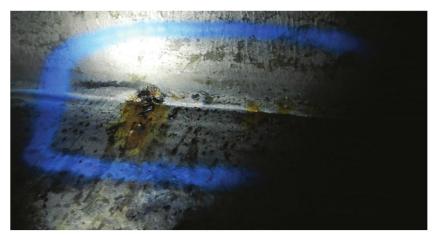
Fig. 5 (Top): Liquid oozing from what appeared to be a compromised area along a seam in the floor.

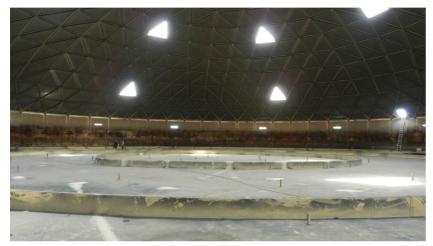
Fig. 8 (Top): At first glance, the walls looked dirty and discolored, but a closer look revealed blisters and delamination.

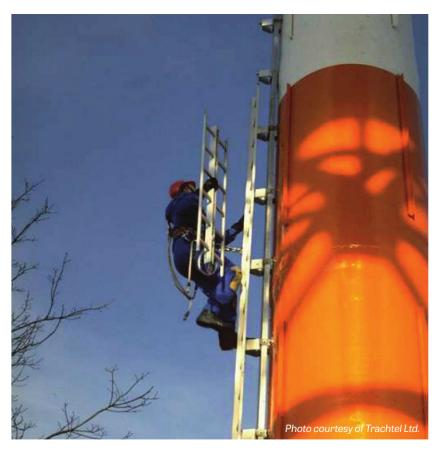
A body harness is a tool that must be chosen properly in reference to the work application. There is no "one harness to do all applications" and no "one size fits all." One should consider the following when choosing a body harness.

The harness should fit snuggly on the user — not too tight and not too loose. It should be easily adjustable and comfortable to wear. Workers have more of a tendency to wear and regularly use a properly fitting and comfortable harness. Therefore, a better harness selection will result in improved compliance and increased safety on the job.
