The Voice of SSPC: The Society for Protective Coatings

26 COATING EVALUATION PROCESS FOR MUNICIPAL MANHOLES

34 THE DIFFERENCE BETWEEN WATERJETTING AND WET ABRASIVE BLASTING

42 SHOP COAT VERSUS FIELD COAT THE PROS AND CONS

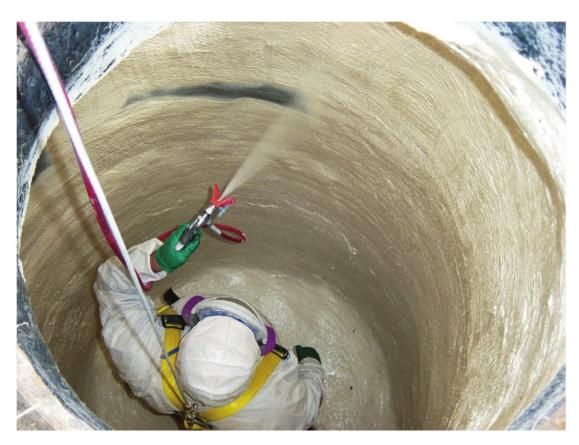
Fig. 1 (Left): For manholes facing more aggressive service environments, it is advisable to apply a protective lining material as a topcoat to mitigate the effects of corrosion on the restored surfaces.

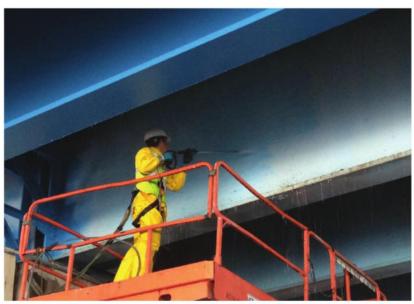
Fig. 2: Low Pressure Water Cleaning (LPWC) being done on a Florida Department of Transportation project to meet SSPC-SP WJ-4/NACE WJ-4, "Light Cleaning."
