PREVENTING CREVICE CORROSION IN NEW AND EXISTING STEEL STRUCTURES

ON THE CORROSION EFFECTS
OF REBLASTED STEEL

THIN-FILM COATINGS FOR PROTECTING REINFORCED CONCRETE BRIDGE ELEMENTS

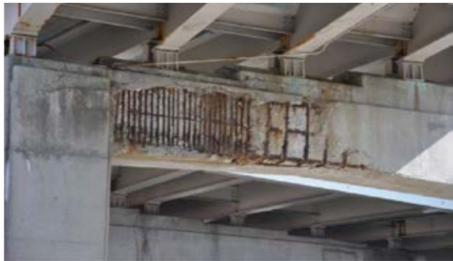
Fig. 1: Deteriorated pier cap under a leaking expansion joint. Figures courtesy of the authors.

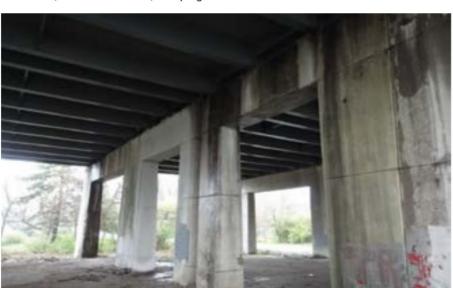
Fig. 4: Pier where thin-film concrete coatings were field tested.
