The Society for Protective Coatings

### MEETING EXPECTATIONS WHEN SELECTING CONCRETE REHABILITATION SYSTEMS

### SELECTING PIPELINE COATINGS: DO CURRENT STANDARDS HELP?

### THE NEED FOR AN INDEPENDENT THIRD-PARTY COATINGS INSPECTOR

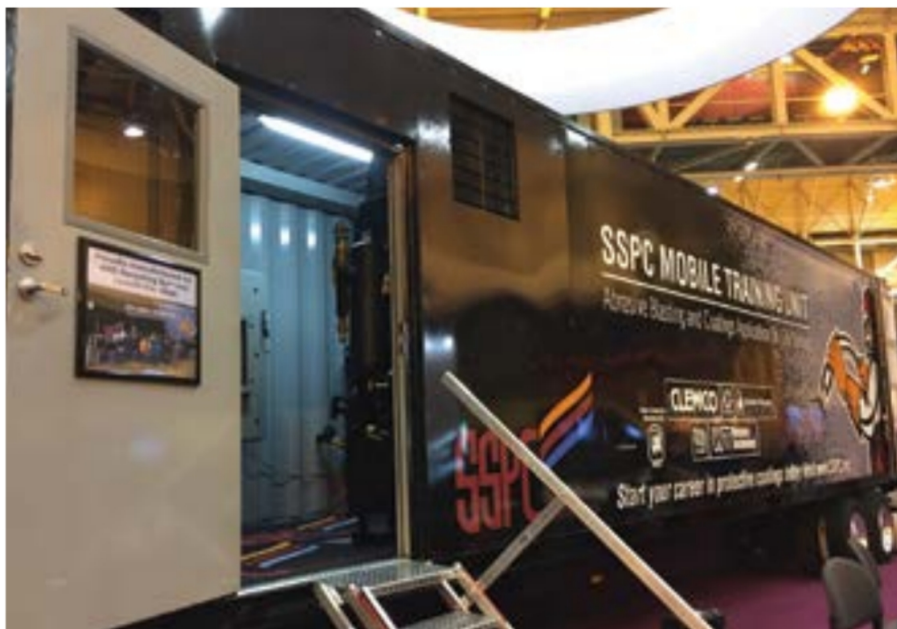
SSPC's new Mobile Training Unit (MTU) will be able to travel throughout the U.S. to provide on-site coatings training later this year. Photos courtesy of Technology Publishing Company.

The MTU will allow SSPC to train and certify blasters and sprayers according to the SSPC C-7 Abrasive Blasting Program and C-12 Spray Application Certification Program. For the immediate future, SSPC will conduct classes using the unit at its world headquarters in Pittsburgh, but the MTU will later be available for the industry to use in any location to which it can travel.

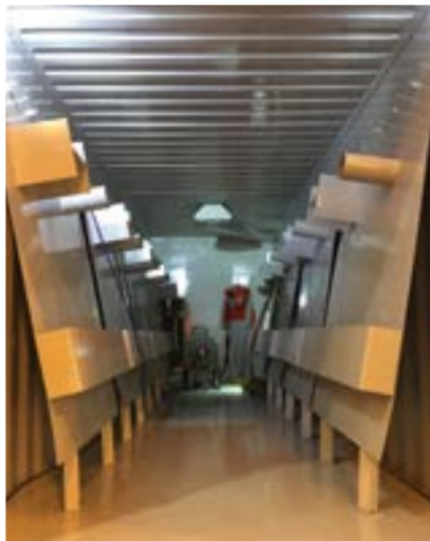
The MTU is outfitted with all of the necessary blasting and painting equipment, including PPE, required to train protective coatings applicators.

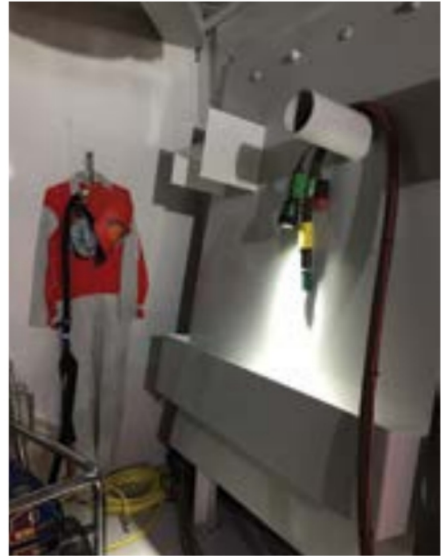
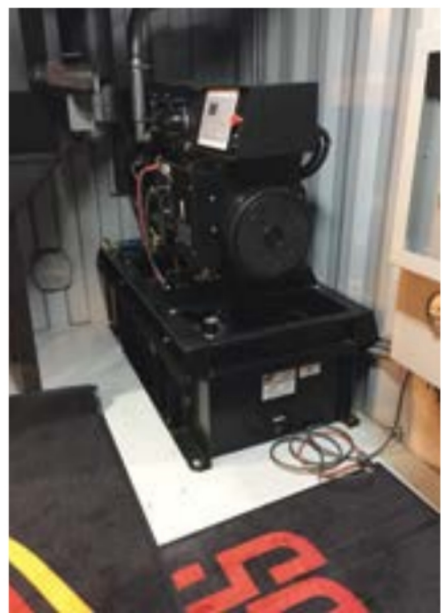
generator, abrasive for the blasting and paint for the application. SSPC estimates that between 8 and 12 individuals can be trained at one time.

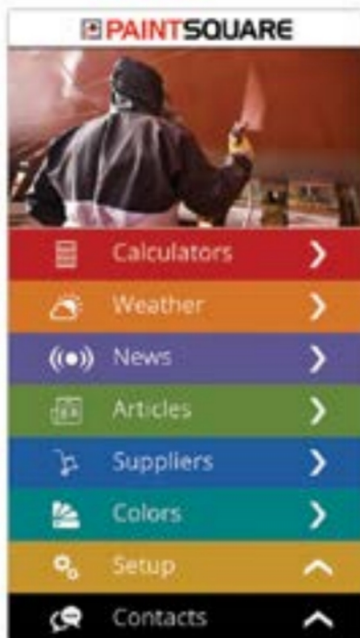
The app features calculators to help the user quickly determine the rate of paint consumption based on the desired dry film

thickness and percent solids of a given coating; estimate the wet film thickness needed in order to achieve the specified dry film thickness; determine soluble salts concentration based on surface conductivity; and several other important operations used on jobsites.

Choosing "Weather" takes the user to a weather map with current conditions in the area, and to a calculator to determine whether the surface temperature is high enough in relation to the dew point so that coating application can be performed. The app also has an option to quickly calculate dew point using observations from a sling psychrometer in the field.

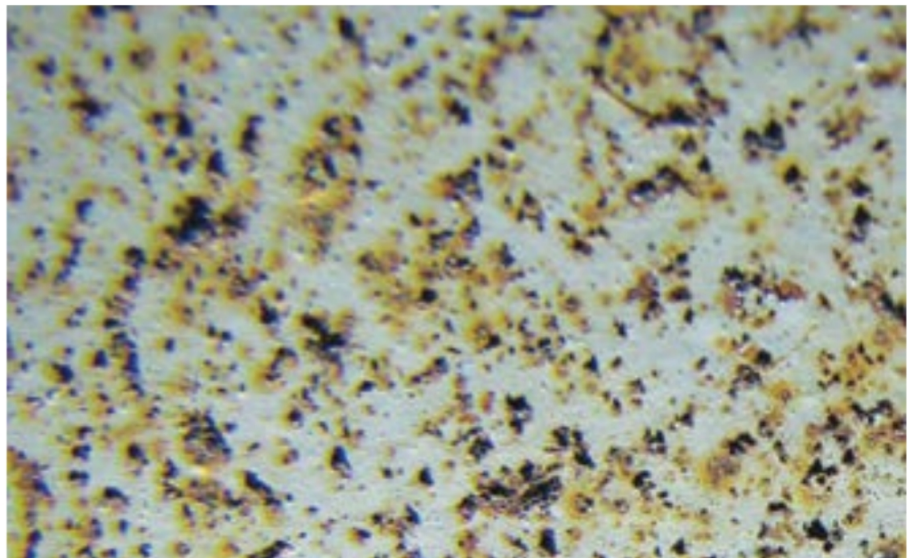
There were two major concerns with the interior lining. The first concern was the prevalence of rust staining. In several of the pipes that had been flooded and subsequently flushed with water, there was a pattern of pinpoint rusting that was prevalent, typically on one side of the pipe. The areas of pinpoint rusting were closely examined using a field microscope and it was clear that the rusting was the result of deposits of metal on the surface of the lining. The rust staining did not

Fig 1: Rust staining on the surface of the lining. All figures courtesy of KTA-Tator, Inc.

penetrate through the topcoat, and there was no noticeable associated rust staining on the surface of the pipe when the coating was removed. Typically, small particles of metal were visible on the surface of the lining, and rust stains were visible surrounding the metal particles. The metal particles could be removed by scraping the surface with a knife.

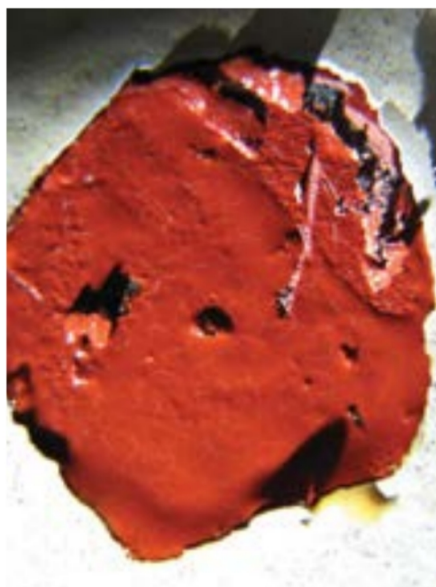
Fig. 2: An exudate is visible on the surface of the primer.

blistering and coating delamination of the interior lining. Blisters in the coating were found in several of the Lot 2 pipes. In all cases, the blisters occurred between the topcoat and the primer. No blistering or delamination of the primer from the substrate was found. The blisters ranged in size from ¼-inch in diameter up to approximately 3 inches in diameter.

colored translucent viscous liquid was found on the surface of the primer. The blister liquid had a slight unidentifiable odor. In some cases, when the blister was pulled away from the surface, the clear viscous liquid formed a string between the surface and the blister cap.

delamination of the epoxy phenolic pipe lining system to be the presence of an exudate on the surface of the primer. The exudate was an amber-colored, translucent viscous liquid that was clearly visible on the surface of the primer when blister caps were removed from pipes

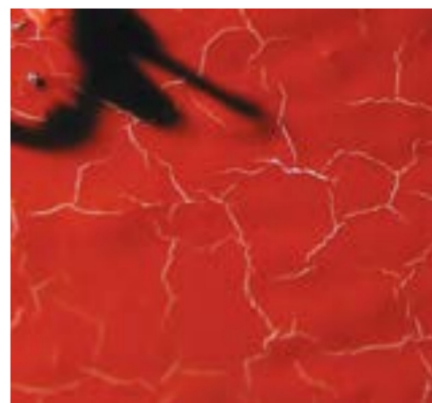
On the Lot 2 pipes that experienced blistering, there was also an unusual surface deformity on the topcoat, which was present on approximately one half of the circumference of the pipe, but extended much of the length of the pipe. The deformity was present as a pattern of furrows or valleys and the surface had the appearance of mud cracking, although there was no actual crack in the topcoat. When blisters were removed, there was often a similar mud cracking pattern on the red primer, although that pattern appeared to be the result of deposits of the gray primer on the surface of the red primer that matched the pattern of the furrows on the topcoat surface.

Fig. 3: Cracking pattern on primer consisting of traces of the gray topcoat.

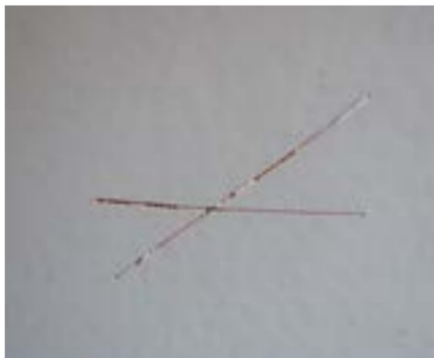
Generally, the adhesion of the coating was found to be good (3A to 5A) even in areas immediately surrounding the blisters. When the coating was picked and probed with a utility knife, it was found that the topcoat could be separated from the primer, although in very small chips, in areas generally on the same half of the pipe as blisters and in areas where the topcoat surface cracking pattern was present. In areas where cracking was not present and on new pipes from Lot 1 and Lot 3, the topcoat could not be separated from the primer.

Fig. 4: Good adhesion of the coating on Lot 1 pipe.

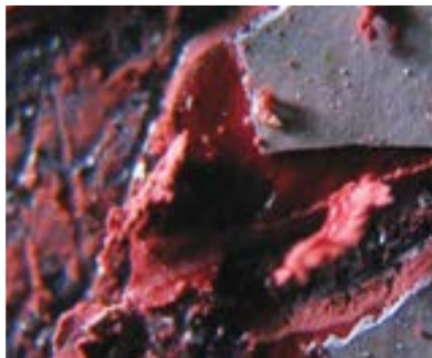
Fig. 5: Cracking pattern on topcoat and primer.

Along with the blistering and delamination of the topcoat from the primer, there was also the unusual visible pattern on the surface of the epoxy topcoat consisting of furrows or valleys, which resembled something similar to a mud cracking pattern even though the topcoat did not actually crack, but instead formed connected valleys in the coating. The pattern that was formed is most likely a result of the exudate present on the surface of the primer, which was soft, while the topcoat developed considerable hardness and shrinkage stress during the curing process. It is clear that the topcoat shrank during the curing process and while the topcoat was still a semi-liquid, it stretched in certain areas to relieve the shrinkage stress. The areas that stretched were the valleys in the unusual mud cracking pattern. Typically, when a coating develops shrinking stress during the curing process, the coating is unable to move because the underlying surface is hard, and the coating is attached to the surface. In this case, the soft exudate allowed the topcoat to slide over the surface during the curing and shrinking process, eventually leading to the unusual mud cracking pattern.

The unusual cracking pattern on the surface of the topcoat was created during the initial curing process. Once the topcoat has cured and hardened, the coating can no longer be deformed to create the valleys that were present in the topcoat. These valleys can only be created while the coating is still in a semi-liquid state. Once a coating has hardened, the curing stresses are relieved only by cracking of the coating, not by stretching or deforming of the coating.

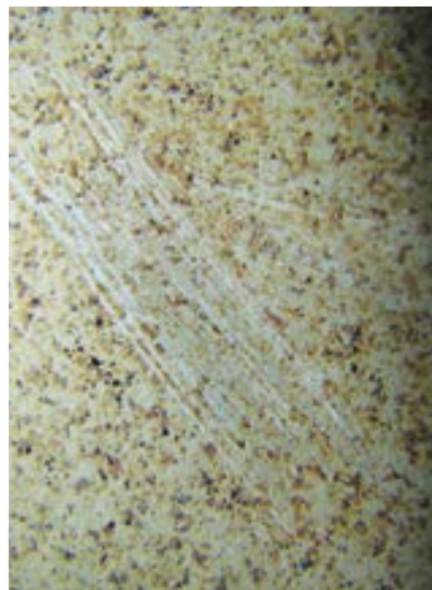
Fig. 6: Rust staining could be scraped away with a knife.

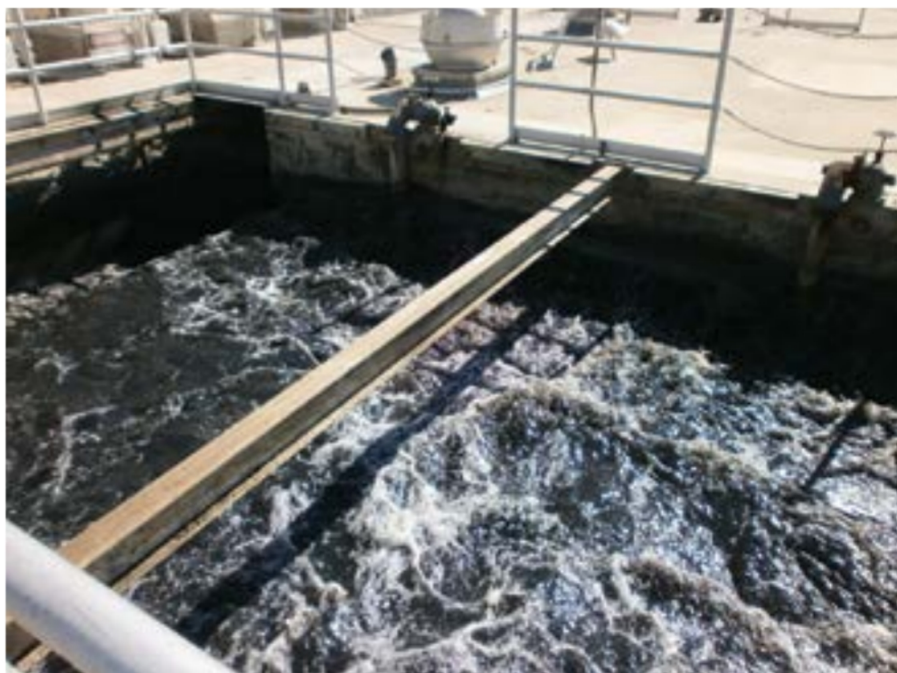
Fig. 1: This photo shows the site before the project was bid. The best access available was by removing the covers from the full grit basins. Photos courtesy of the author.

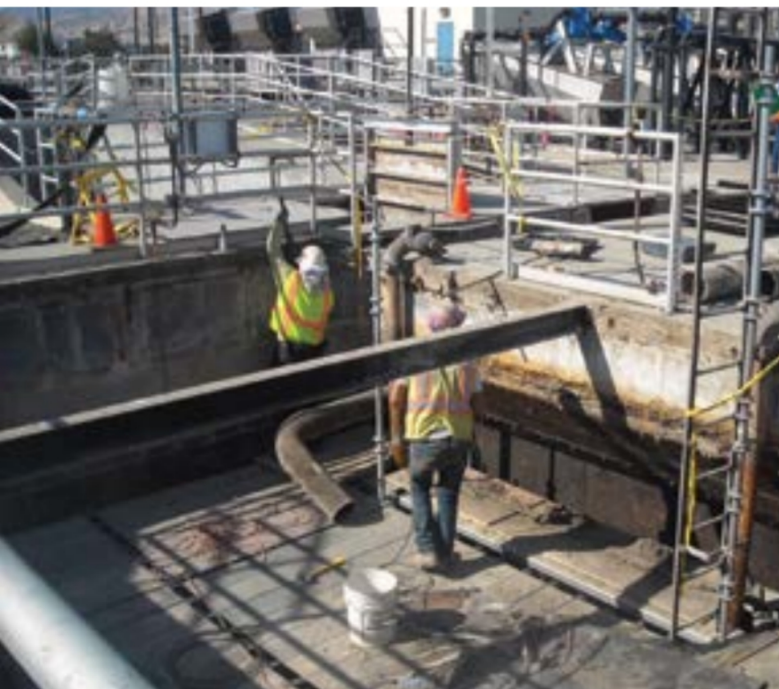
Fig. 2: The contractor begins work removing the lining system to uncover extensive  $H_2S$  damage.

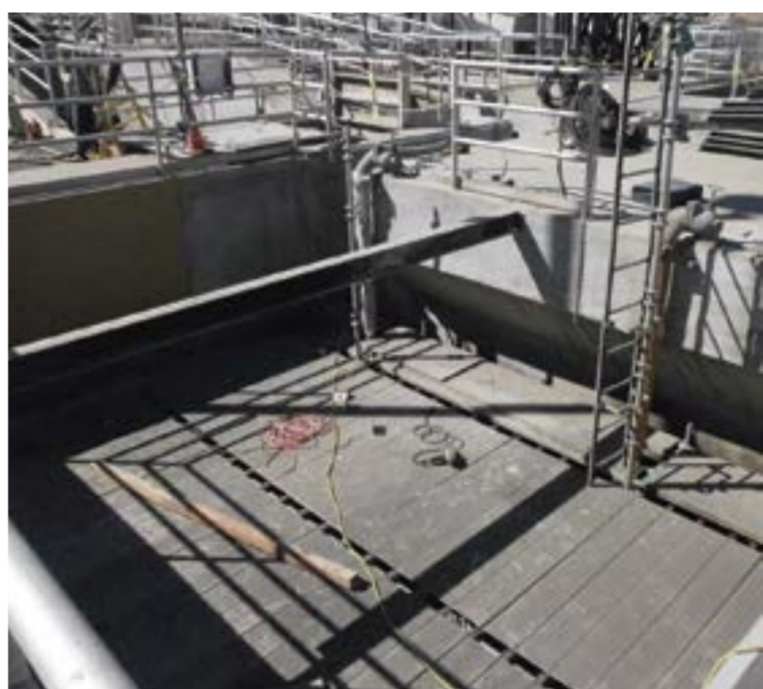
Fig. 3: The finished project used calcium aluminate cement.

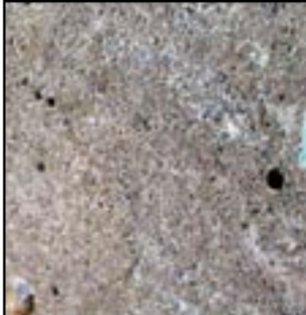
<p><b>1. Smooth, hard surface – nearly new</b></p> <p>a. Quality: sound when struck with a pick, freshly exposed pH &gt;10.  b. Texture: smoothness.  c. Cracking: drying or plastic shrinkage cracks.  d. Spalls: none.</p>

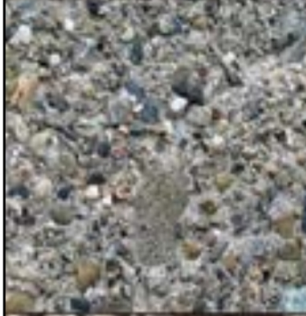
<p><b>2. Initial surface deterioration</b></p> <p>a. Quality: 1/8 to 1/4 inch easily removed with a pick, freshly exposed concrete pH &gt;10.  b. Texture: some exposed aggregate.  c. Cracking: cracks greater than 15 mils, localized or widespread.  d. Spalls: none.</p>

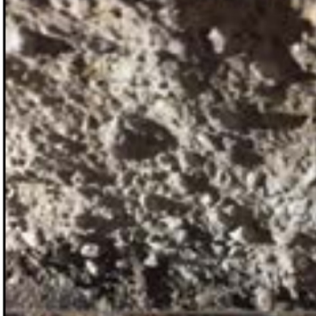
<p><b>3. Advanced surface deterioration</b></p> <p>a. Quality: 1/4 to 1/2 inch easily removed with a pick, freshly exposed pH &lt;10.  b. Texture: widespread exposed aggregate.  c. Cracking: 1/16 inch to 1/8 inch cracks, moderate frequency.  d. Spalls: localized, infrequent if any.</p>

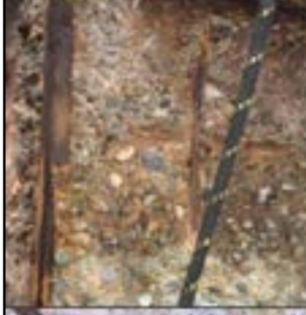
<p><b>4. Advanced surface deterioration with initial reinforcing deterioration</b></p> <p>a. Quality: 1/4 to 1/2 inch easily removed with a pick, freshly exposed pH &lt;10.  b. Texture: widespread exposed aggregate.  c. Cracking: Widespread cracks, some greater than 1/8 inch.  d. Spalls: spalls or rust staining.</p>

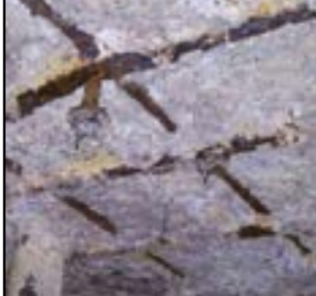
<p><b>5. Advanced surface deterioration with reinforcing deterioration</b></p> <p>a. Quality: 1/4 to 1/2 inch easily removed with a pick, freshly exposed pH &lt;10.  b. Texture: widespread exposed aggregate.  c. Cracking: Widespread cracks, some greater than 1/8 inch.  d. Spalls: widespread or localized easily removed spalls, exposed reinforcing, widespread rust staining.</p>
