The Society for Protective Coatings

REFURBISHMENT OR REPLACEMENT? COST-EFFECTIVE SOLUTIONS FOR AGING WATER-STORAGE TANKS

THREE-COAT & EPOXY MASTIC BRIDGE COATING SYSTEMS IN ADVERSE ENVIRONMENTS

COST SAVINGS AND BEST PRACTICES IN AIR ABRASIVE BLASTING

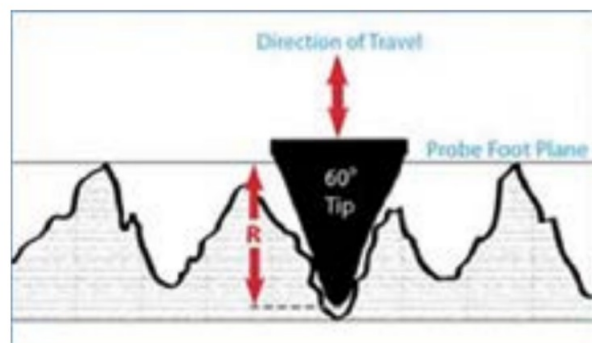
Fig. 3: Depth micrometer principle of measurement.

A depth micrometer uses a flat base that rests on the peaks of the surface profile and a spring-loaded probe tip mounted inside the base which drops into the valleys of the profile. Therefore, each measurement is the distance between the highest local peaks and the particular valley into which the tip has projected, as illustrated in Figure 3. Depth micrometers have the advantage of being able to measure profile heights that exceed the range of many other instruments.

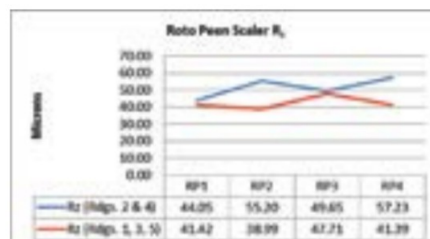
Fig. 11: Averaged R_z with (red) and against bias (blue), roto peen scaler.

Measurements taken with the bias and against the bias yielded distinctly different results. Measurements taken by this method could lead to improper characterization of the surface if directional bias is not taken into account, or not known. This could lead to incorrect or insufficient application of a coating. Measurements taken by replica tape or depth micrometer instruments were not affected by directional bias.

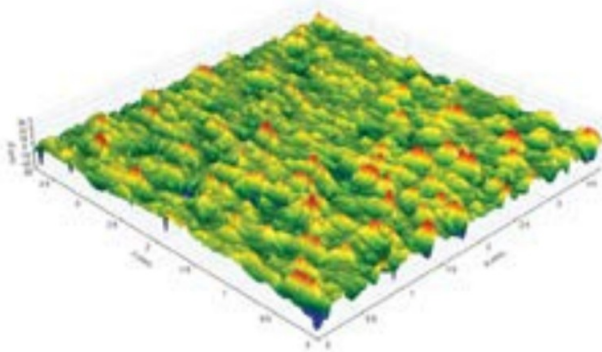
Fig. 12: 3-D rendering of bristle-cleaner-produced surface, obtained using a digital replica tape reader with 3-D imaging.

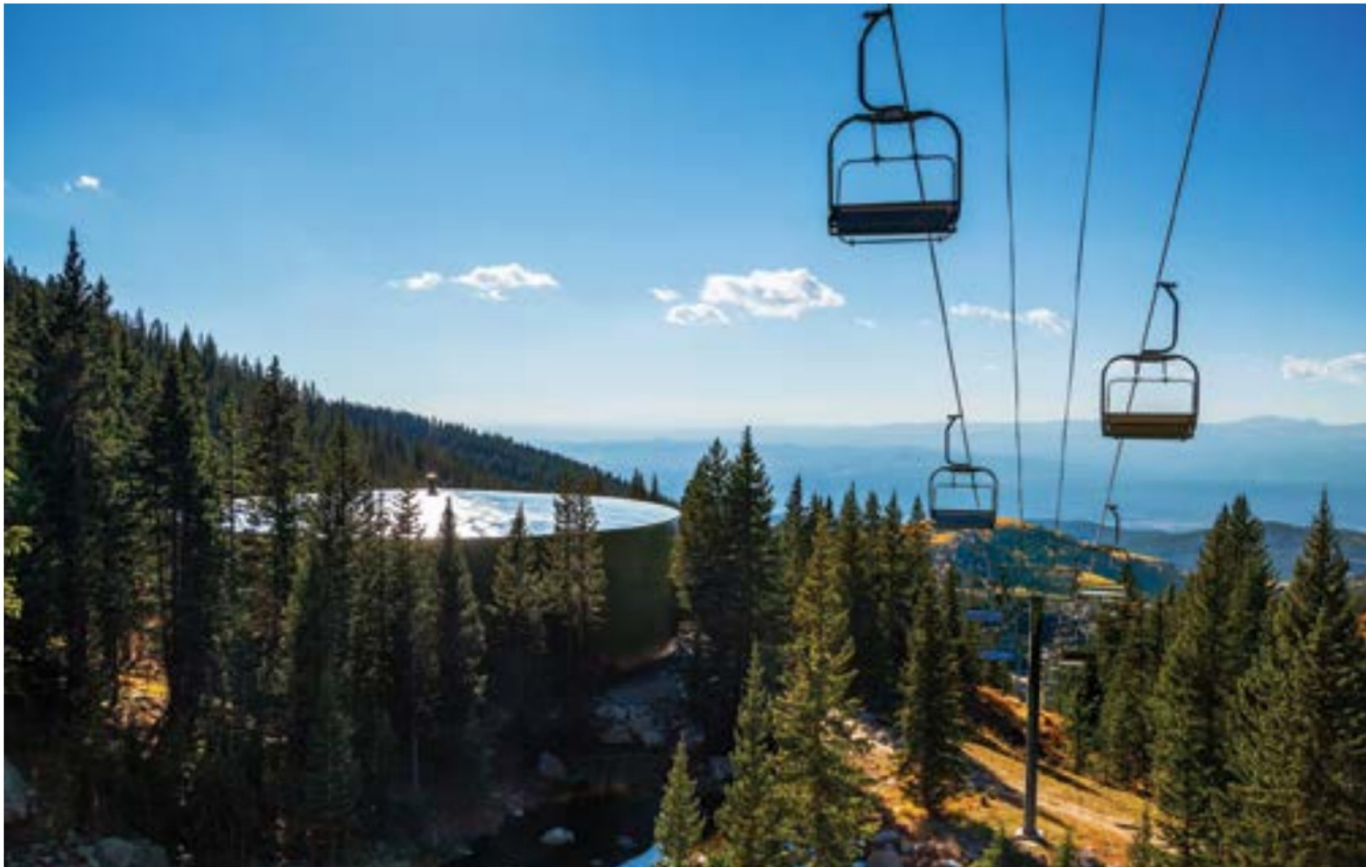
Fig. 2: Construction and coating materials were transported up the mountain to the jobsite via bulldozer and other heavy vehicles.

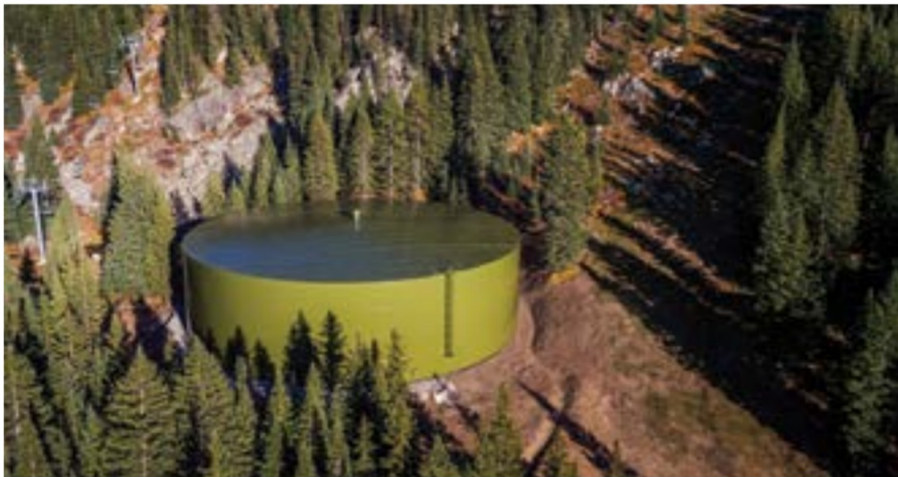
Fig. 3: Using a primer with a long recoat window and fast-cure intermediate and finish coatings helped the contractors overcome some of the project challenges.

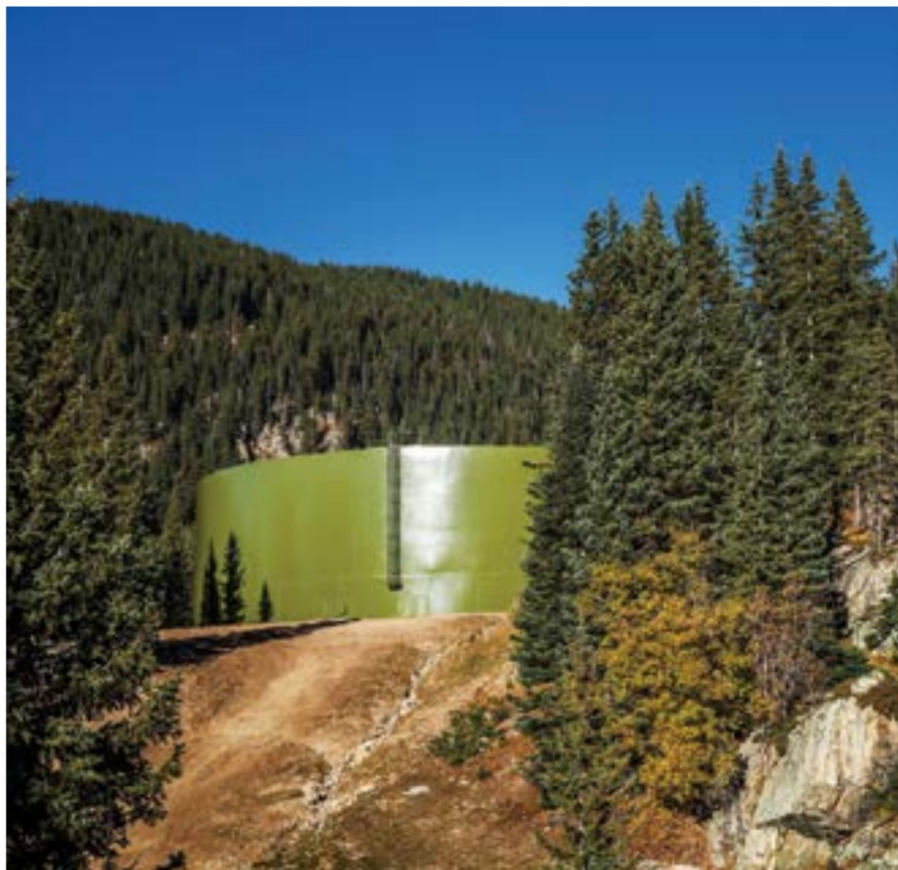
Fig. 4: The finished tank serves its utility while blending into the surrounding environment.

At just the right height relative to the tree line, the tank blended into its surrounding environment perfectly. The tank fabricator and owner were both pleased with the result, and the resort continued to operate regularly.

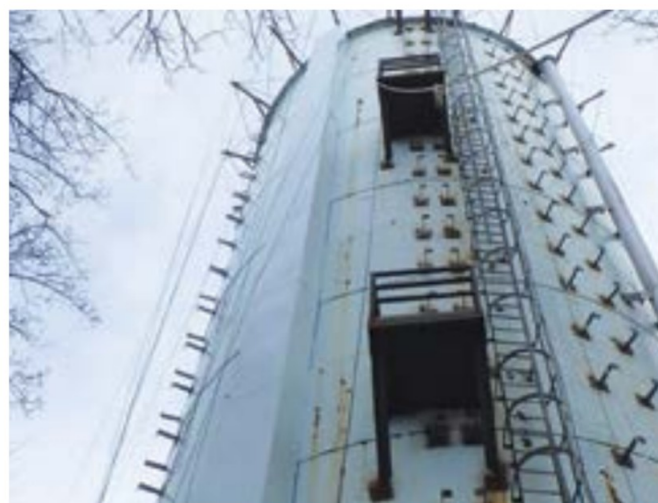
Fig. 1: Built in 1924, the Montgomery County, Maryland Alta Vista Standpipe tank was the oldest in the owner's inventory and in dire need of rehabilitation or replacement. Photos courtesy of the author

The first order of business was to conduct a comprehensive tank evaluation in order to determine the overall condition and compile an inventory of deficiencies, repairs and upgrade objectives so that the project manual for the bid phase would include all necessary work to bring the tank to current AWWA standards while feasibly achieving the customer's long-term goals. These goals included 1) investing and maintaining their assets through capital improvement projects and maximizing dollars spent, 2) continuing to provide clean potable water with sufficient pressure to an expanding customer base and 3) improving the Alta Vista Standpipe in order to afford the Commission more time to plan and locate additional sites for future tank construction without a disruption in service (Fig. 1).

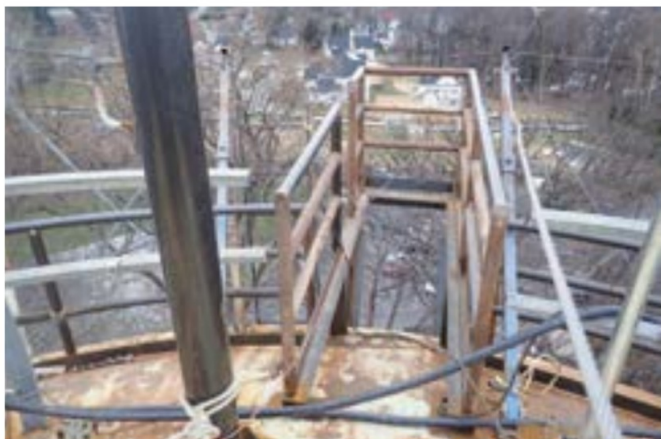
Fig. 2: The proposed improvements included new manways for improved internal access and confined-space access, a new roof ladder access system with resting platforms, new circular roof guardrails, a frost-resistant roof vent and other miscellaneous items.

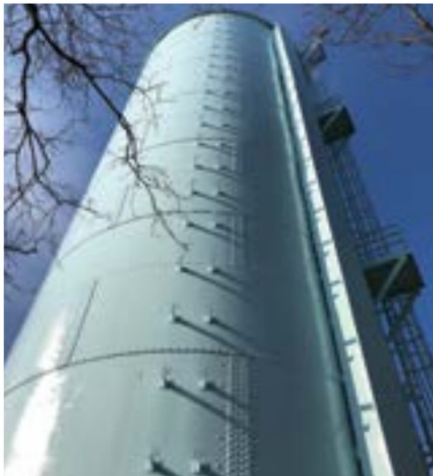
Fig. 4: Aesthetic improvement was an important consideration in the design phase from a public outreach standpoint.

Aesthetic improvement was an important consideration in the design phase from a public outreach standpoint (Fig. 4). As mentioned, the Alta Vista Standpipe is located on a small hill and is visible to thousands every day. The intent here was to provide a message to the public and taxpayers that WSSC is fully committed to maintaining its assets and investing in capital improvements (Fig. 5). Allocation of revenue to this project would also emphasize the Commission's continued dedication to deliver clean and potable water to the public. To achieve these objectives in a cost-effective manner, the following requirements were included in the design phase and scope of work.

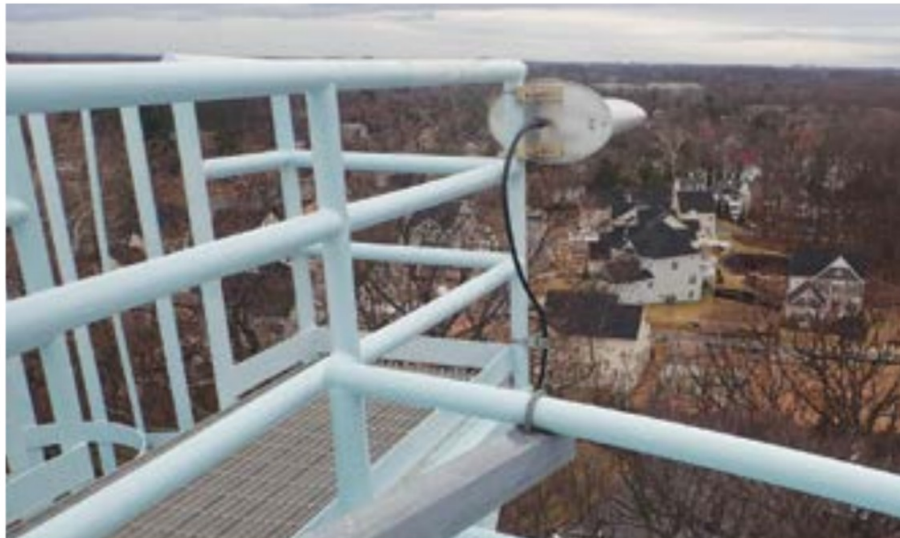
Fig. 5: The Alta Vista Standpipe is located on a small hill and is visible to thousands every day. The owner's intent was to provide a message to the public and taxpayers that WSSC is fully committed to maintaining its assets and investing in capital improvements.

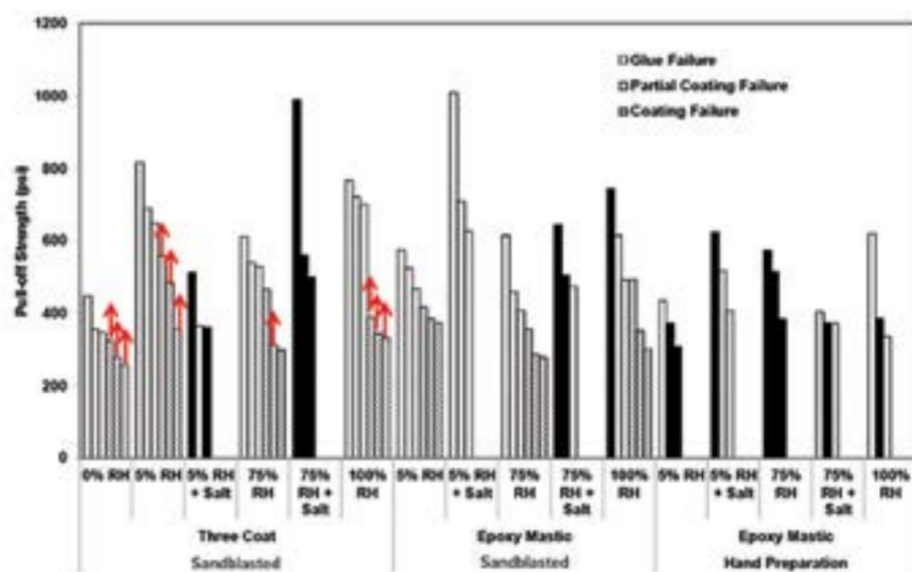
Fig. 1: Coating pull-off strength in as-received condition. Figures courtesy of the authors.

The majority of tests resulted in pull-off failure of the two coatings even at the low and ambient relative humidity conditions

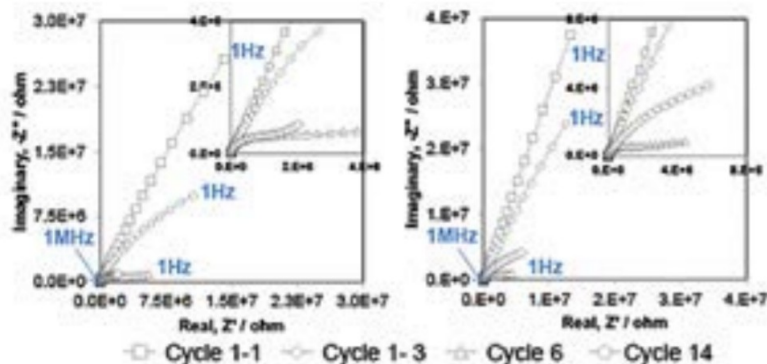
Fig. 4: Typical Nyquist plot of three coat system 5-percent RH (left) and 5-percent RH plus salt (right).

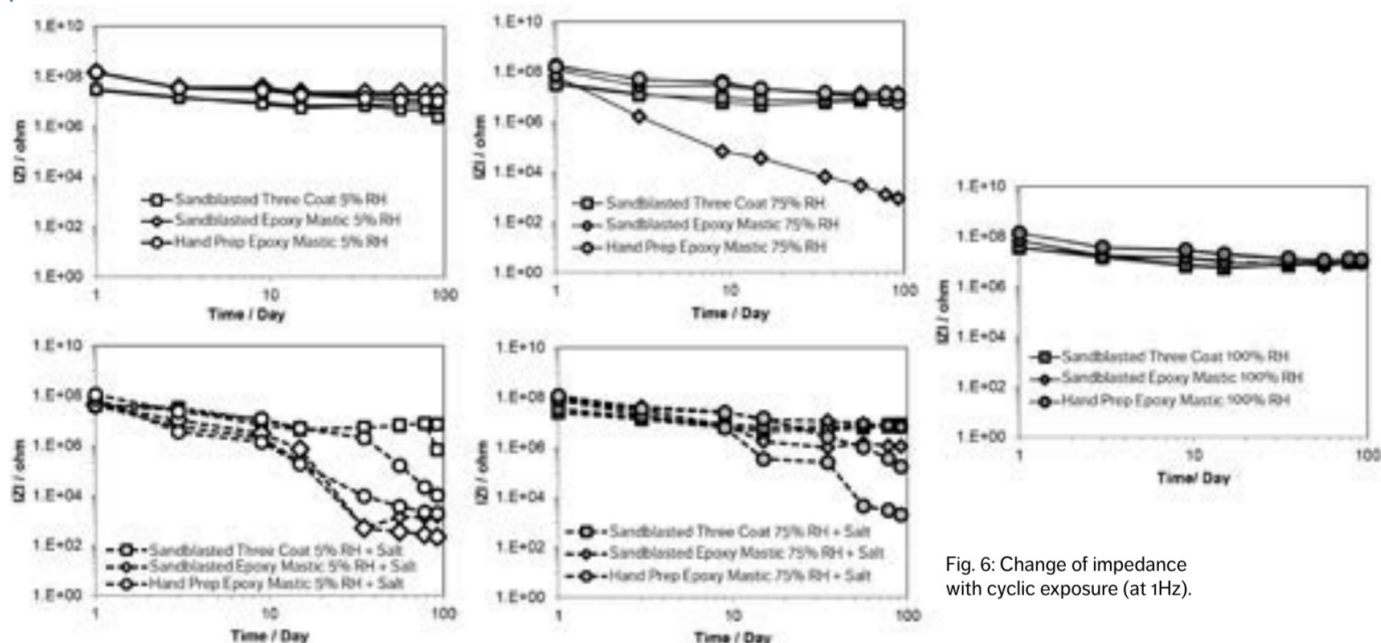
Fig. 6: Change of impedance with cyclic exposure (at 1Hz).

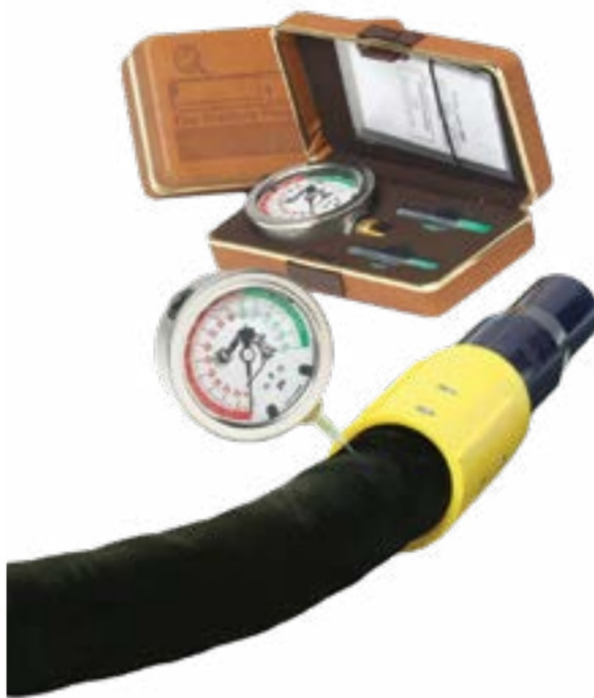
Fig. 1: A hypodermic needle-style nozzle pressure gauge kit. Images courtesy of the author.

You can also use this gauge to test the rest of

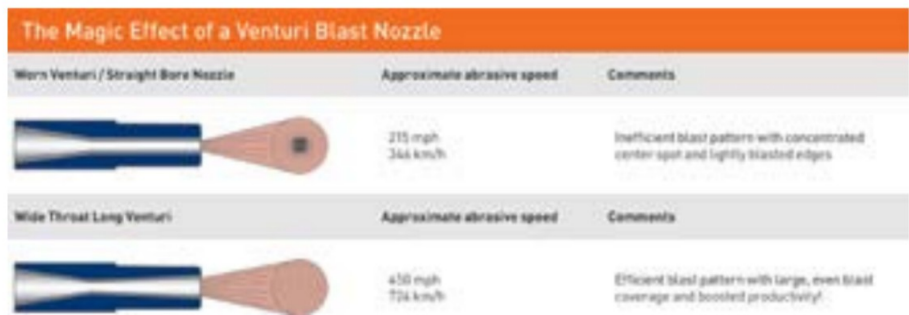
Fig. 3: A Venturi-style abrasive blasting nozzle works like a jet engine. Air is compressed rapidly in a cone, then passes through a small orifice and then expands at a more gradual rate than it compressed.

This rapid compression and expansion allows the abrasive in the airstream to pick up speed very quickly. For example, abrasive travels down the blast hose at about

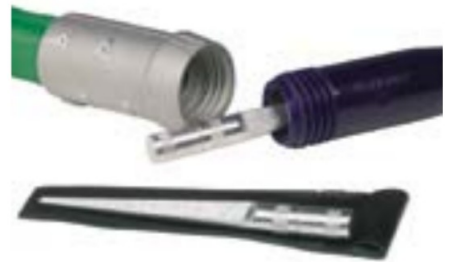
Fig. 4: A nozzle size analyzer gauge is most frequently used to measure the diameter of a blasting nozzle.
