#### LINING STEEL POTABLE-WATER STORAGE TANKS: BENEFITS OF 100% SOLIDS ELASTOMERIC POLYURETHANES

## Partially Galvanized Steel Columns: What Could Wash-ably Go Wrong?

# LINING STEEL POTABLE-WATER STORAGE TANKS: BENEFITS OF 100%-SOLIDS ELASTOMERIC POLYURETHANES

## LARGE-DIAMETER COOLING WATER PIPE AND PENSTOCKS: Selecting and Applying Linings

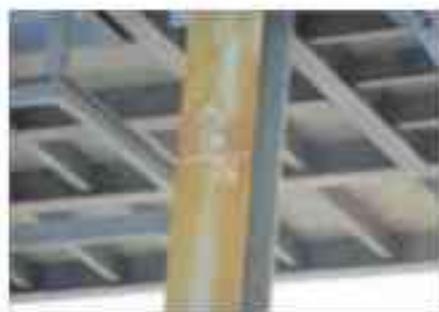
Fig. 3: Columns 62 and 7 on line J1 show rust-staining below the apparent active corrosion zone.

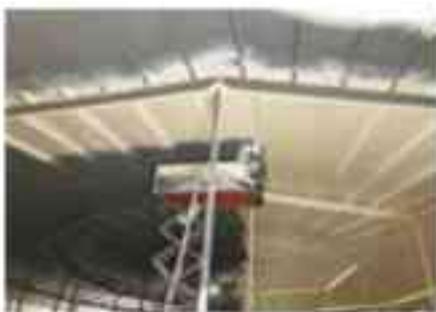
Fig. 4: Lower area of active corrosion on Column 6, J1 line indicated by a horizontal white chalk line.

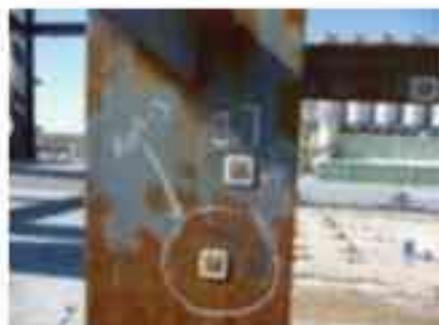
Fig. 5: Visual example of a corrosion zone on one of the supplied columns (Column J-7).

- **Soluble-Salt Sampling:** Soluble-salt sampling was performed in the field using latex patches, a syringe and deionized water. A patch is shown in place in Figure 5 and partially removed in Figures 6 and 7. Deionized water (2 ml) was introduced.

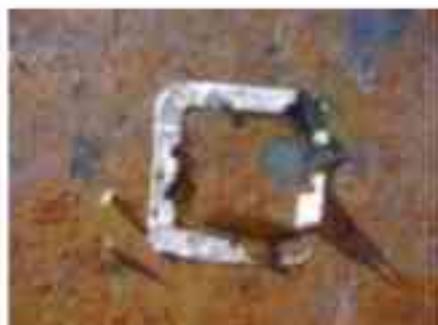
Fig. 6: This example shows a crust-like material, stained coating, blisters and substrate corrosion.

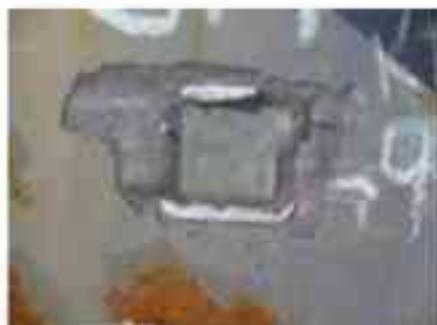
Fig. 7: This example exhibits pickling.

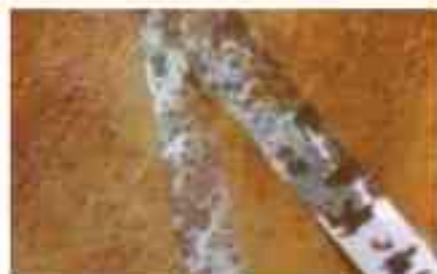
Fig. 8. Adhesion test tape was applied per ASTM D1358, but without scribing. The back of the tape and underlying surface are shown as the tape was being removed.

- **Coating Adhesion:** Adhesion was assessed by ASTM D6677, "Standard Test Method for Evaluating Adhesion by Knife," and ASTM D3359, "Standard Test Methods for Measuring Adhesion by Tape Test, Method A." The coating was scribed with an "X" and adhesion assessed by probing and picking the coating with the tip of a knife blade (knife test), or by application of tape and then removing the tape and grading adhesion based on the amount of coating that is removed (tape test). The coating on the lower portions of the columns exhibited good adhesion. Coating adhesion in the corroded zone was very poor where active corrosion was present and fair-to-poor on surfaces where coating was unstained and appeared intact. The degraded condition of the coating in areas of active corrosion was demonstrated by use of adhesion test tape applied without scribing the surface. Coating and rust were pulled from the surface with the tape. It should be noted that during removal of the gray

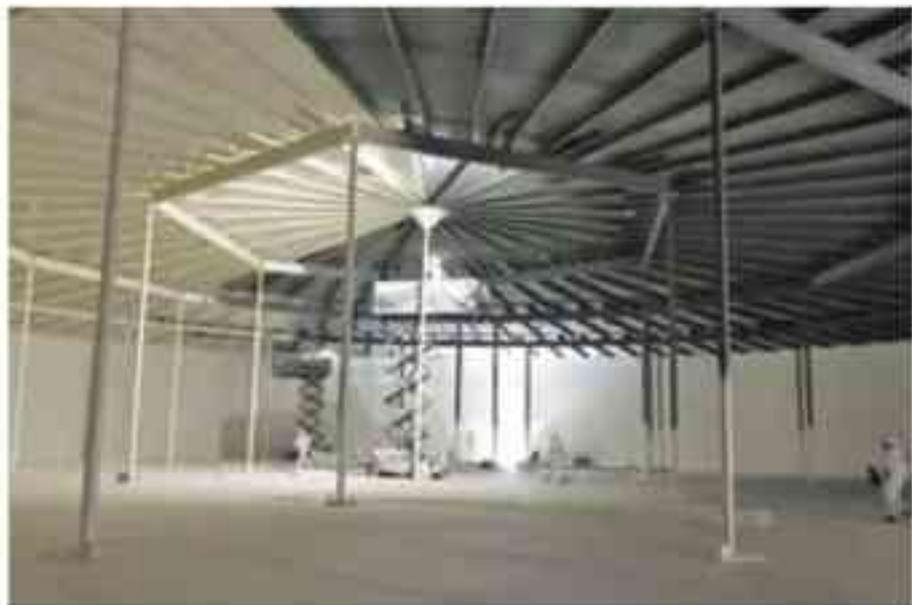
Fig. 2: Applicators can achieve film builds of up to 250 mils' (¼ inch) DFT when spraying elastomeric polyurethane linings.

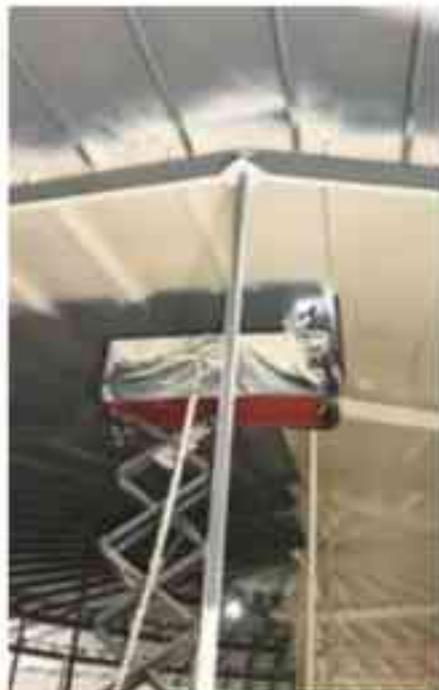
Fig. 3: Elastomeric polyurethanes serve well on lap seams on tank ceilings due to their excellent elongation properties, often allowing applicators to skip caulking seams.

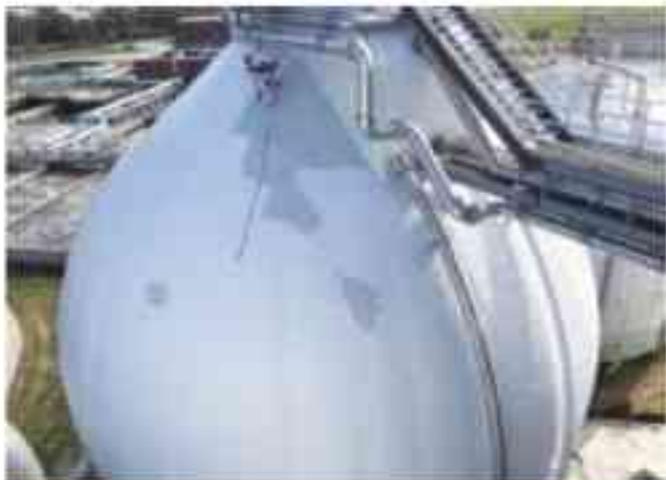
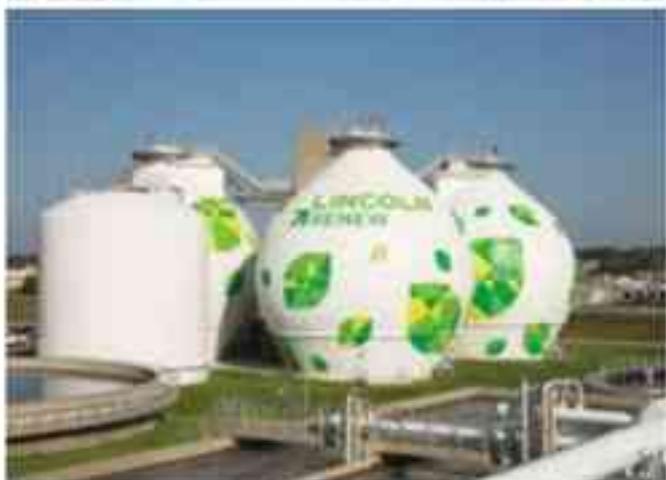
(Clockwise from top left): Before the project, the digesters and tanks were painted a gray color that did not stand out from the surrounding environment. After pressure-washing the exteriors and making insulation repairs, contractors applied a new white topcoat.

The newly painted digesters and tank display a sustainability-themed design scheme that is not only an aesthetic improvement, but represents the city's commitment to sustainability.
