The Society for Protective Coatings

Considerations for Reconstruction
of a Bridge Exhibiting Staining
By Cynthia O'Malley, PCS, KTA-Tator, Inc.

Considerations for Reconstruction of a Bridge Exhibiting Staining

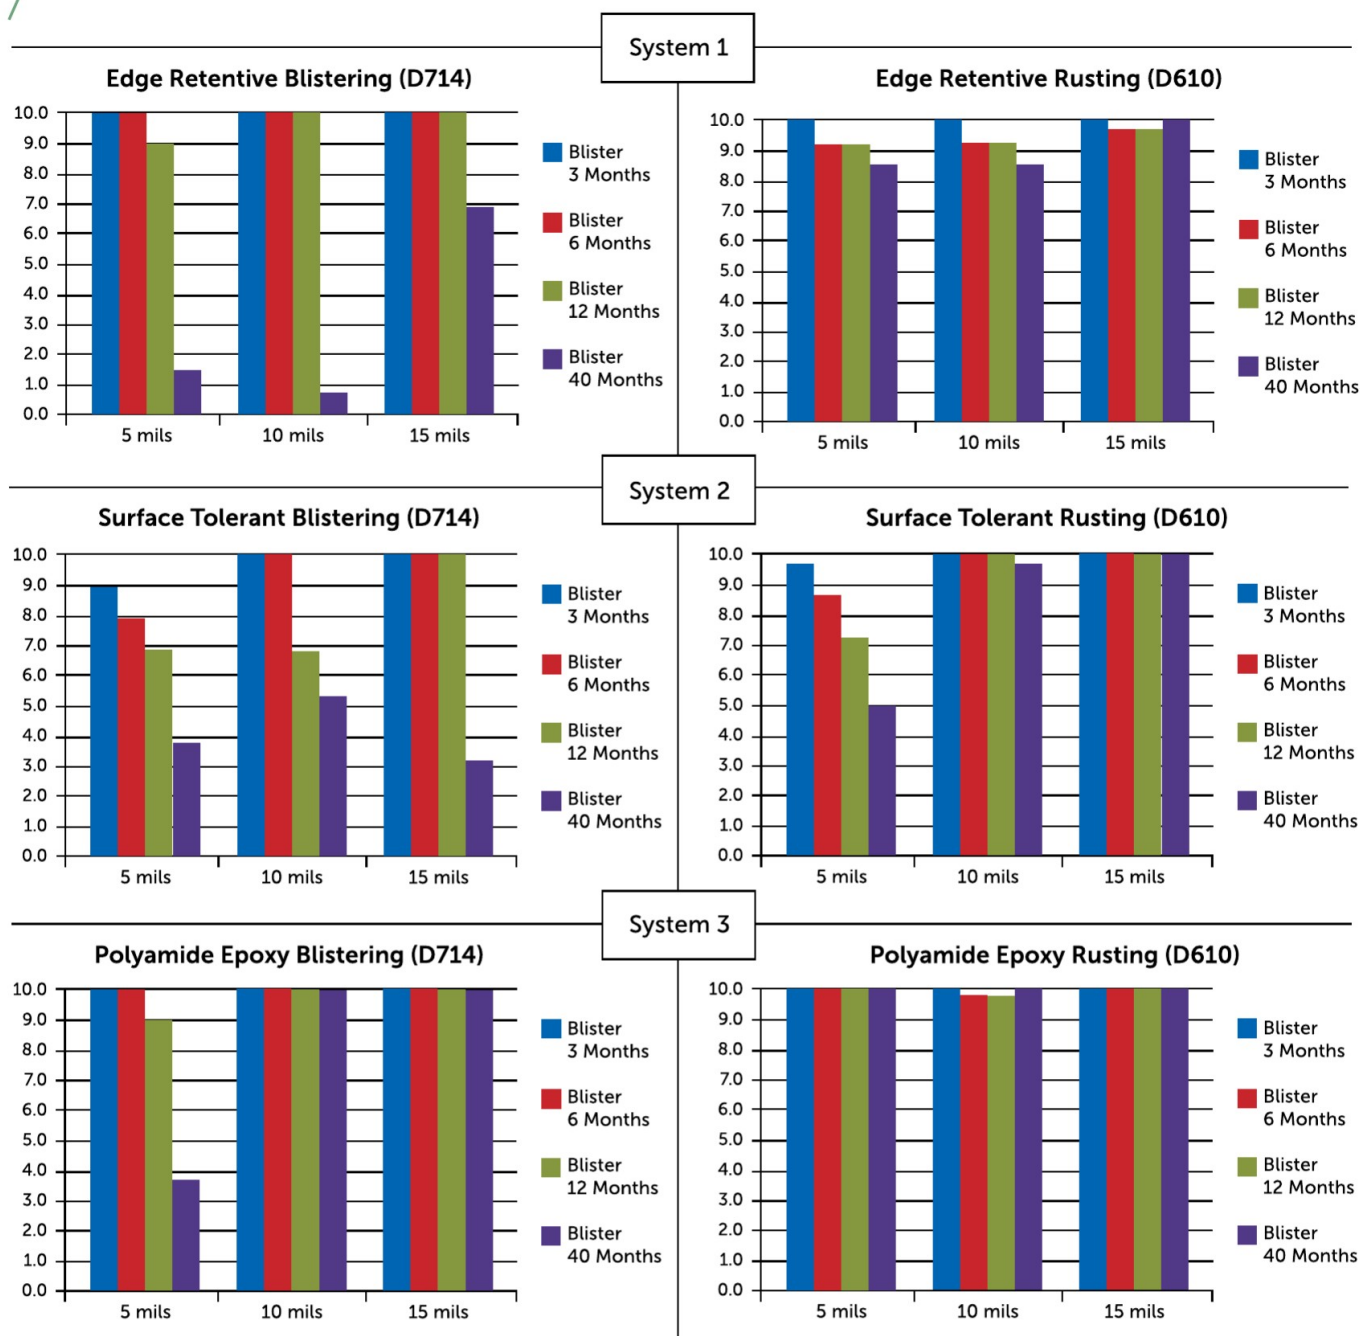
Fig. 3: Summary of blistering and rust-through data via visual inspection: System 1 (top), System 2 (center) and System 3 (bottom).

tion at the weld bead and on the general panel surface. Figure 3 provides the summary of the visual inspection data via ASTM D714 and D610 for all three coating systems at the three different film thicknesses over the exposure period^{8,9}.

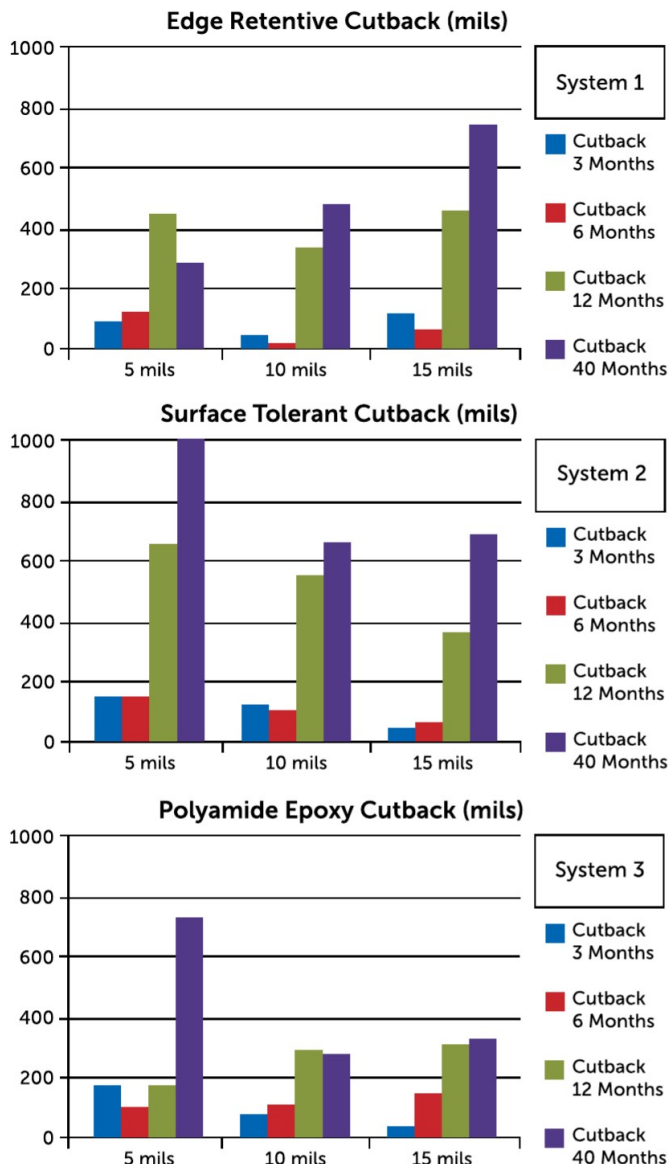
Fig. 4 (left): Summary of cutback measurements via destructive inspection: System 1 (top), System 2 (center) and System 3 (bottom).

Figure 4 (p. 28) provides a summary of the cutback data for these same systems and thicknesses over the exposure period.

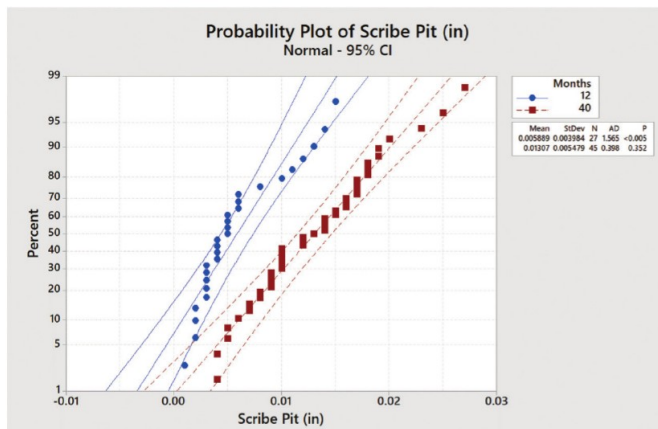
Fig. 7: Pitting corrosion depth adjacent to the scribe over time at 12 and 40 months of exposure.

Both Figures 5 and 6 (p. 28) show the presence of pitting corrosion under the previously intact coating systems. The deepest pits were observed adjacent to the scribe, though still not visible before coating removal. Figure 7 (p. 30) shows the distribution of the extent of pitting corrosion around the scribe over time. These data, and the subsequent similar plots, are presented as normal distributions of the data. This distribution was selected as a convenience, as some of the data do not fit well to a normal distribution.

From month 12 to month 40, the mean pit depth doubles from 6 to 13 mils. The deepest pits approach 30 mils after 40 months of alternate immersion exposure, suggesting a corrosion rate of 9 mils per year under the coating. Figure 8 shows the 40-month pit data adjacent to the scribe as a function of coating type.

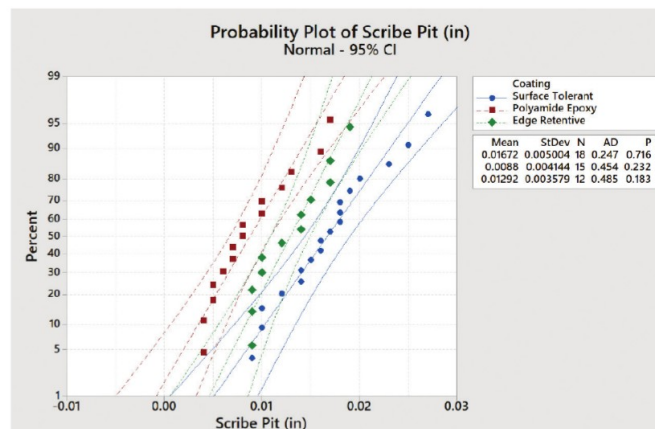
Fig. 8: Pitting corrosion depth adjacent to the scribe by coating type at 40 months of exposure, System 1 (green), System 2 (blue) and System 3 (red).

The surface-tolerant coating, System 2, performs quite differently than the polyamide epoxy System 3, and does so consistently. These

data show a real difference in barrier coating performance when compared to the visual inspection data in Figures 4 and 5.

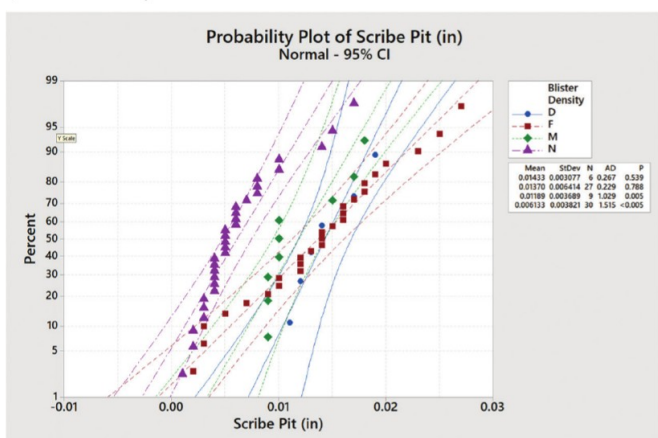
Fig. 9: Pitting corrosion depth adjacent to the scribe as a function of blister density, 40 months of exposure.

Figure 9 shows the pit depths adjacent to the scribe for all coatings as a function of the ASTM D714 blister density rating⁹. The panels exhibited visual ratings of dense, medium and few (D, M and F) blistering. The code "N" indicates none or no blistering.

Figure 9 also suggests that pitting corrosion is associated with

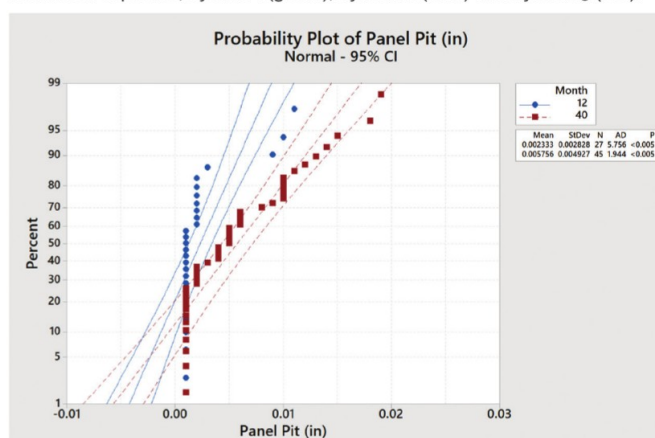
Fig. 10: Pitting corrosion depth on the panel face over time, at 12 and 40 months of exposure.

Figure 10 shows the distribution of pits found outside of the scribe on the face of the panel as a function of exposure time.

The figure exhibits at least two distributions: those panels without any sensible pitting and those with pitting. For the panels with pitting on the face, the depth approaches the depth of those at the scribe but appears to be of a slightly lower magnitude.

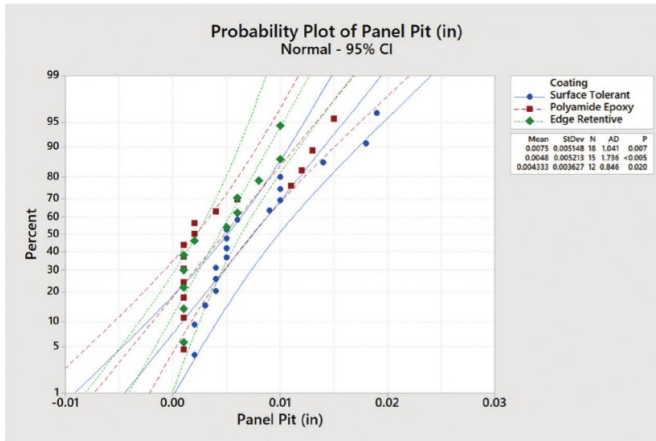
Fig. 11: Pitting corrosion depth on the panel face by coating type at 40 months of exposure, System 1 (green), System 2 (blue) and System 3 (red).

Figure 11 (p. 31) shows the panel face pit data as a function of coating type. In this condition, there is not a consistent impact of coating type.

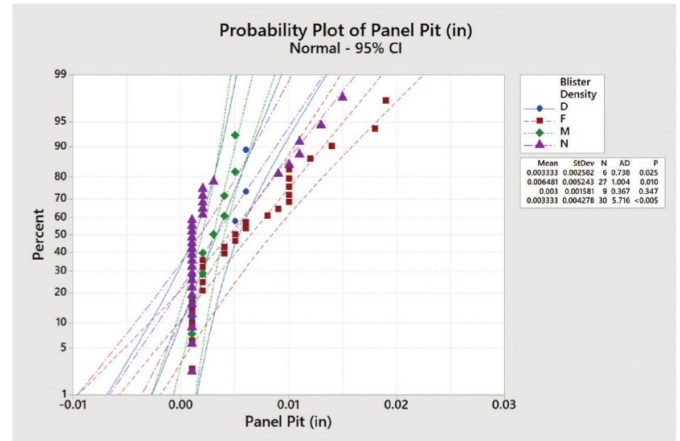
Fig. 12: Pitting corrosion depth on the panel face as a function of blister density at 40 months of exposure.

Figure 12 (p. 31) shows the impact of the blister density rating on panel pit depths outside the scribe area on the face of the panel.

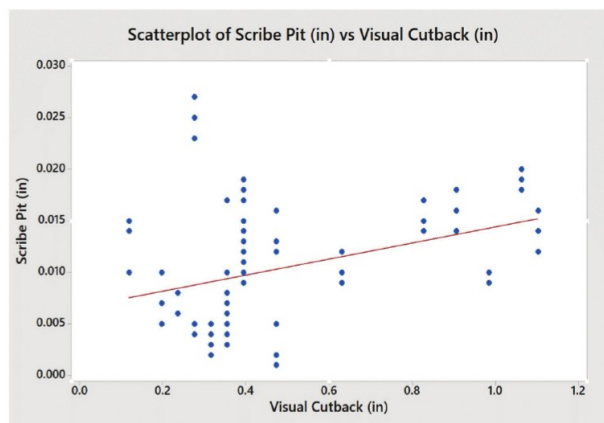
Figure 13 shows the relationship between the pit depth adjacent to the scribe and the maximum measured cutback (undercutting) of the coating adjacent to the scribe. There is no apparent correlation between these two coating-performance parameters; that is, panels with minimal undercutting of the coating did not necessarily have less pitting.

Fig. 13: Maximum pit depth adjacent to the scribe vs. measured coating cutback at the scribe.

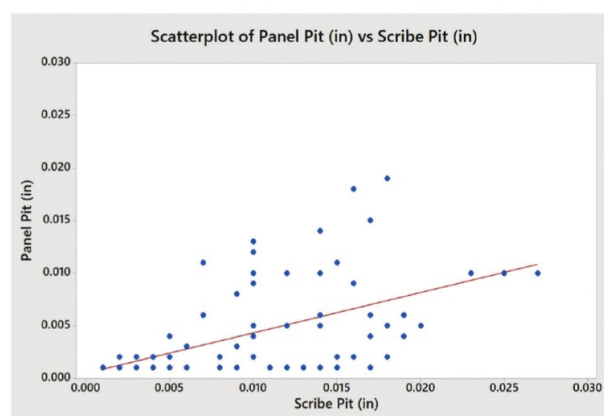
Figure 14 shows the relationship between pitting corrosion depth on the panel face versus pitting corrosion depth adjacent to the scribe area. Again, the correlation is weak.

Fig. 14: Pit depth on panel face vs. pit depth adjacent to the scribe.
